# **INDONESIA-JAPAN JOINT SEMINAR ON MAPPING-OUT STRATEGIES FOR BETTER SEISMIC DISASTER MITIGATION**

**February 2007**

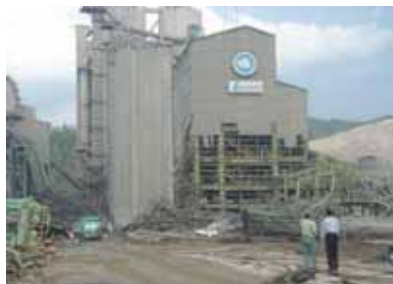
(a) Cement Factory

Basically, structures damaged by subsequent tsunamis are much severe than those by earthquake. Some examples are shown in Figure 5. Conveyor belts transporting cement material from plant to sea shore were washed away (Figure 5a), 600-ton generator ship was drawn 3 kilometers inland (Figure 5b), girders were ripped off from piers (Figure 5c), liquid tank was flown hundred meters away (Figure 5d), damages were more severe near the sea shore (Figure 5e), and a survived two-story house near the sea shore (Figure 5f).

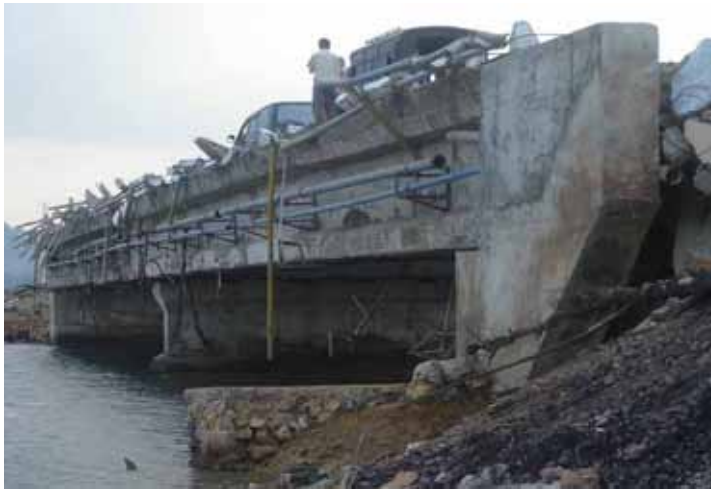
Figure 7. Asoe Nanggroe Bridge after the 2004 Tsunami

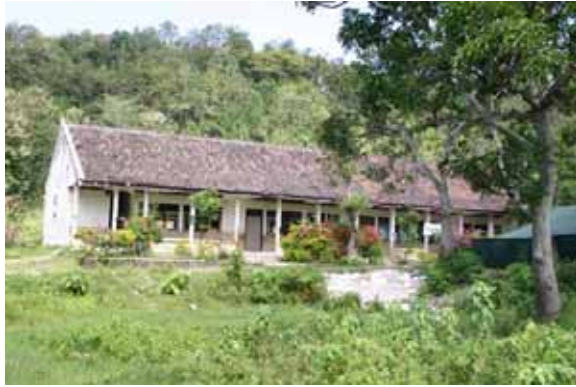
Building #1 : URM with RC columns

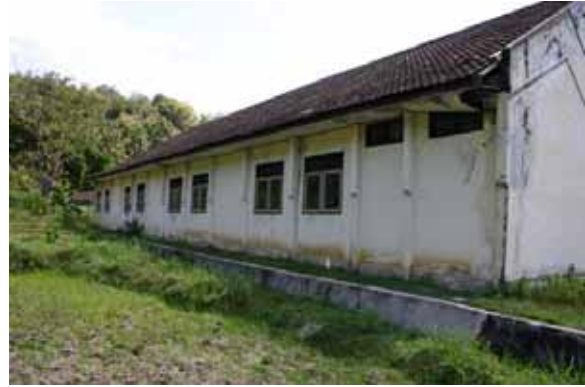
South side of building #1

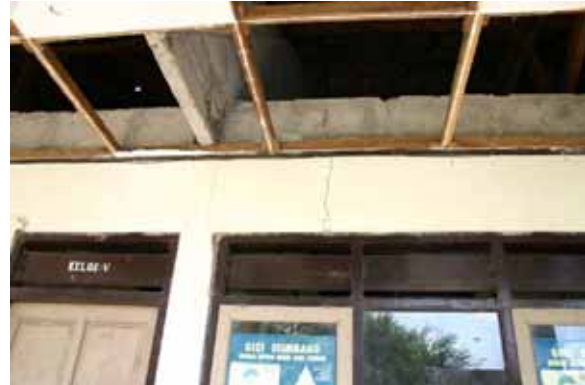
Building #1 : RC column and beam

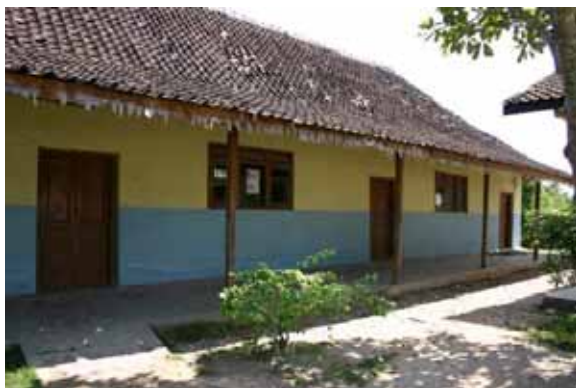
The school had 3 buildings, one of them (building #2) were stone masonry structure constructed in the 1970s while the other two buildings (#1 and #3) were URM structure with RC columns. Each classroom of the building #1 had 3 bays, each of which was 3m long. Damage to the roof system and ceiling boards was found in buildings #1 and #3 while cracks in URM stone walls were found in building #2.

Building #2: Stone masonry structure

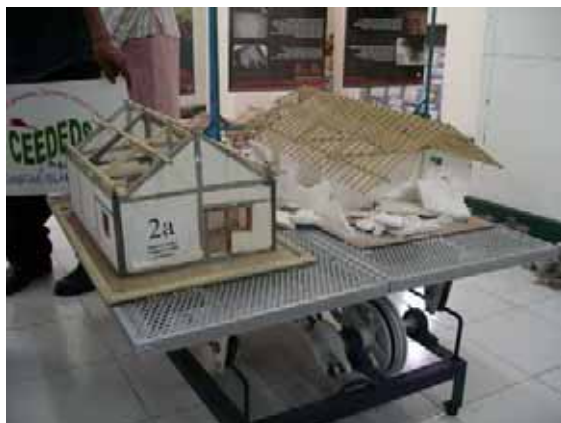
Photo12 Demonstration of the different failure mode between brick wall house confined by RC frame(left) and usual unconfined brick wall house(right) on the shaking table at Indonesian Islam University

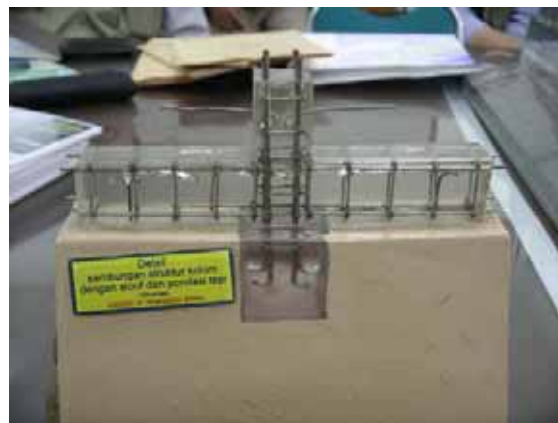
Photo13 Desirable foundation for a house

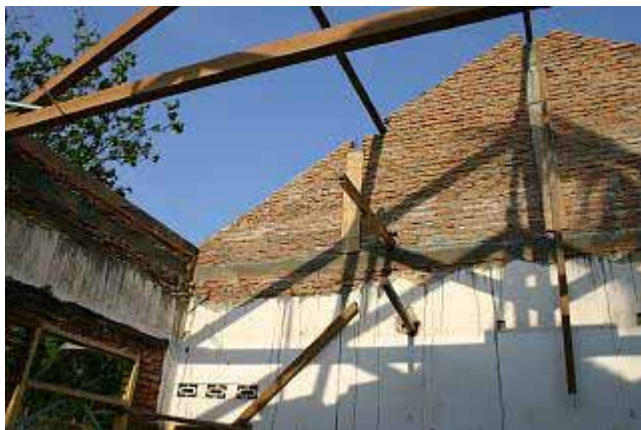
2006.09.16 SD2 Parangtritis Under repair

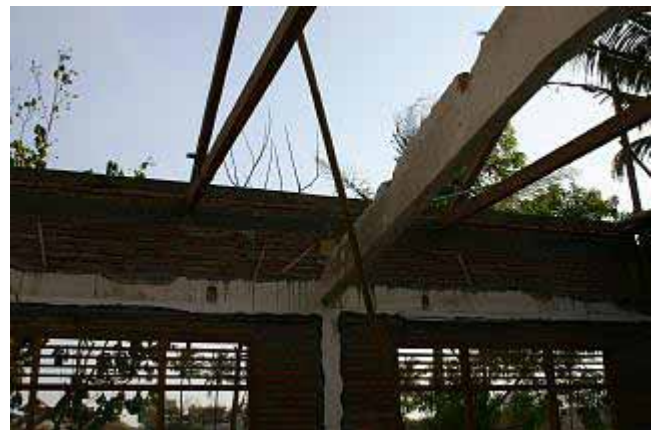
2006.09.16 SD2 Parangtritis Under repair

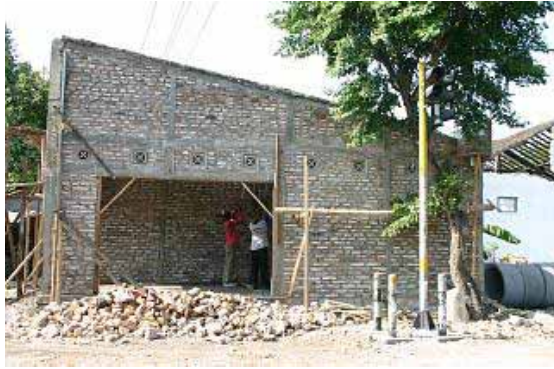
Shop house? At the corner of cross section of Bantul to Imogiri. RC frame confines brick wall.

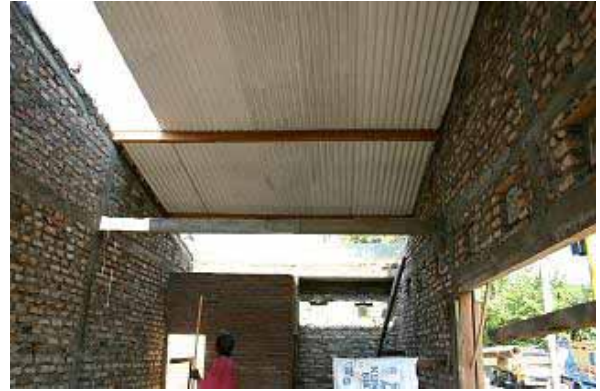
Connection beam is observed
