A RECONNAISSANCE REPORT
ON
THE BENGKULU EARTHQUAKE OF SEPTEMBER 12, 2007

2007 Bengkulu Earthquake Reconnaissance Team

Japan Society of Civil Engineers (JSCE)

Japan Association for Earthquake Engineering (JAEE)

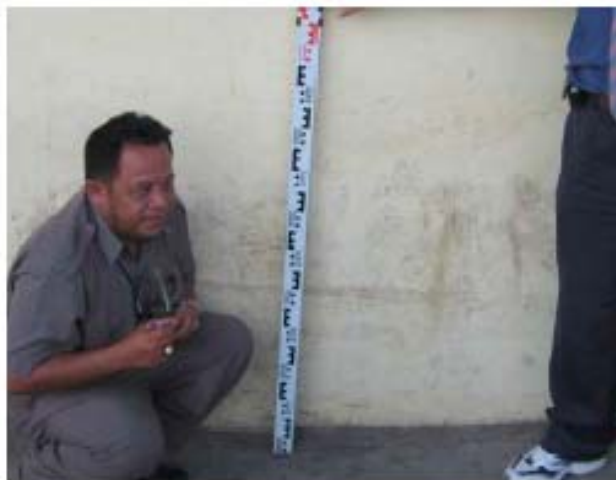
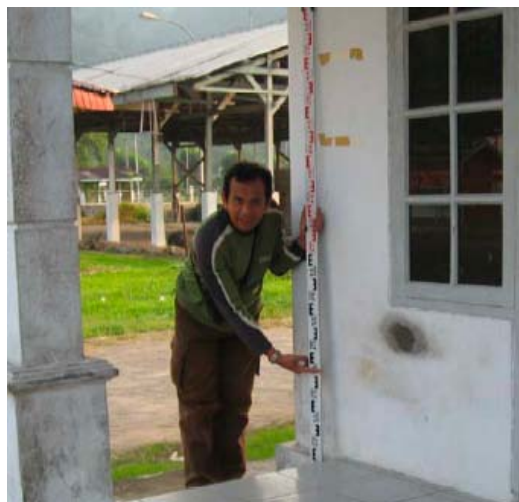
Fig.6.8 Measuring tsunami height of water marks on the wall above the ground

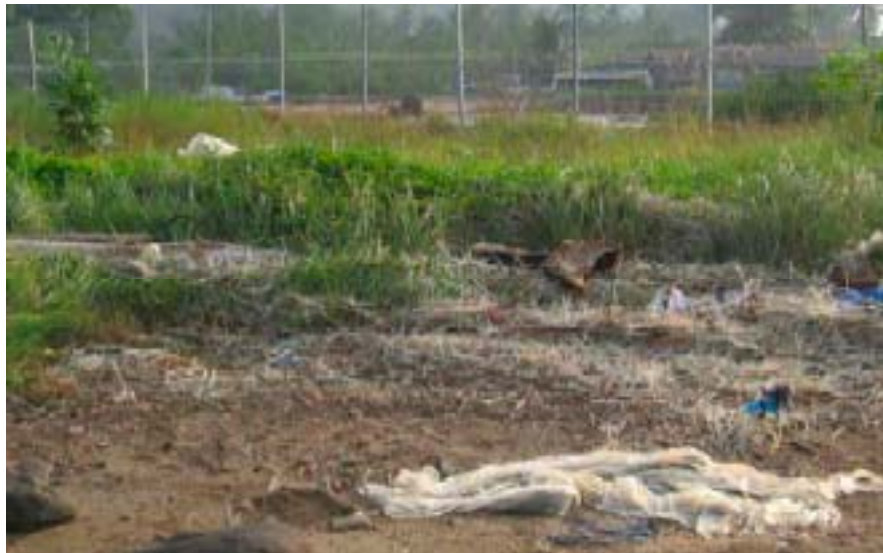
Fig.6.9 Example of the tsunami trace

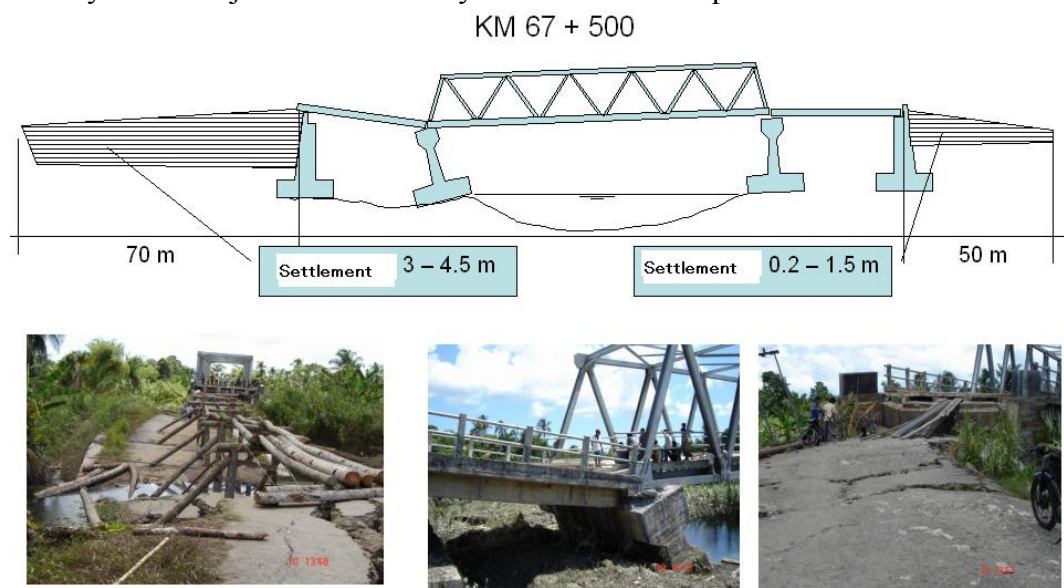
Another important issue is the vulnerability of ground against liquefaction. The critical infrastructures such as bridges, telecommunication facilities and lifelines may be damaged by the ground failures and ground liquefaction (Figure 8.3). Therefore, **it is urgent to check the vulnerability of ground against ground liquefaction in relation to the foundations of superstructures and infrastructures.** Bridges are probably of the major concern as they facilitate the transportation and evacuation.

Fig.8.3 Liquefaction induced damage to Muzoi River bridge by 2005 Nias earthquake

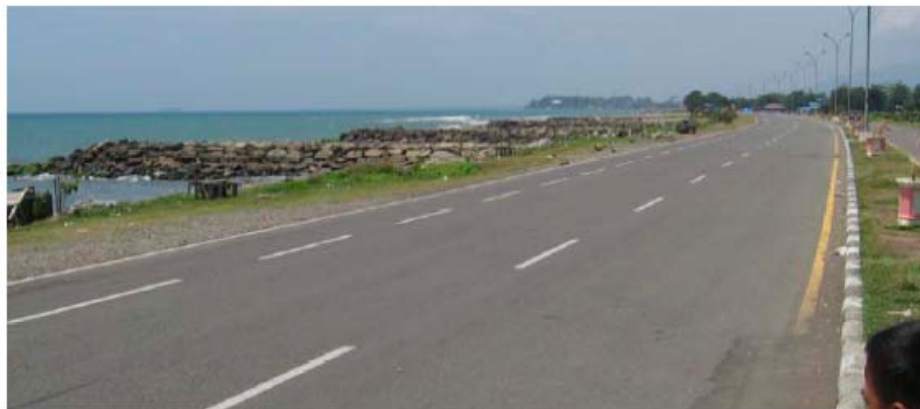
Fig.8.5 Sea dike with the height of 2-3 m at Padang, which prevent a small tsunami and stop the inundation.

Building dykes, elevated tsunami shelters, gates and water breaks and planting trees along the coast line can be also implemented as hardware measures against tsunami disasters (Figure 8.5).
