A RECONNAISSANCE REPORT
ON
THE BENGKULU EARTHQUAKE OF SEPTEMBER 12, 2007

2007 Bengkulu Earthquake Reconnaissance Team

Japan Society of Civil Engineers (JSCE)

October 2007

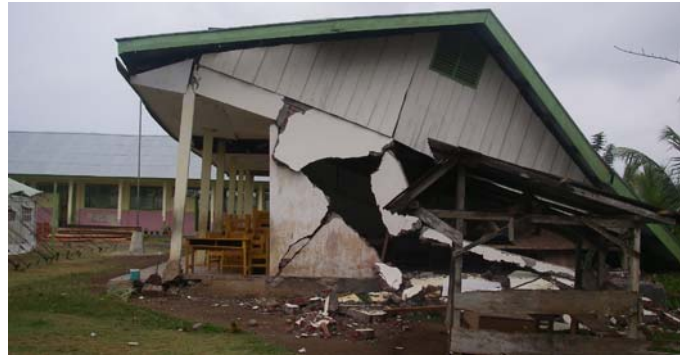
(a) Padang

RC buildings with two or three stories suffered heavily from the earthquakes. Many RC buildings either totally collapsed or heavily damaged in Padang City even though they were about 400km away from the epicenter. The reinforced concrete structures are framed structures with integrated or non-integrated in-fill walls. The reinforcing bars are generally smooth and infill walls are built with red-burned solid clay bricks using mortar. The floor height in the region ranges between 3 to 4m. The inspections of the reinforced concrete buildings indicated that they are mainly failed in the pancake mode. RC buildings are generally found in cities and large towns. The concrete buildings having 2 or more stories were either collapsed or heavily damaged. The causes of damage to RC buildings are similar to those observed in other recent earthquakes in Indonesia and elsewhere (Figures 5.4). They may be re-stated for this earthquake as follows:

Fig.5.4 Examples of damage to RC buildings

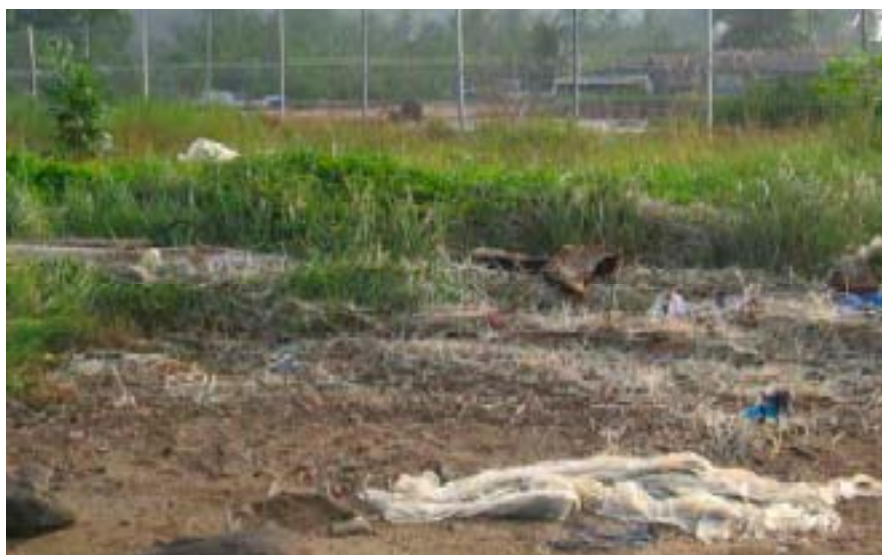
Fig.6.9 Example of the tsunami trace

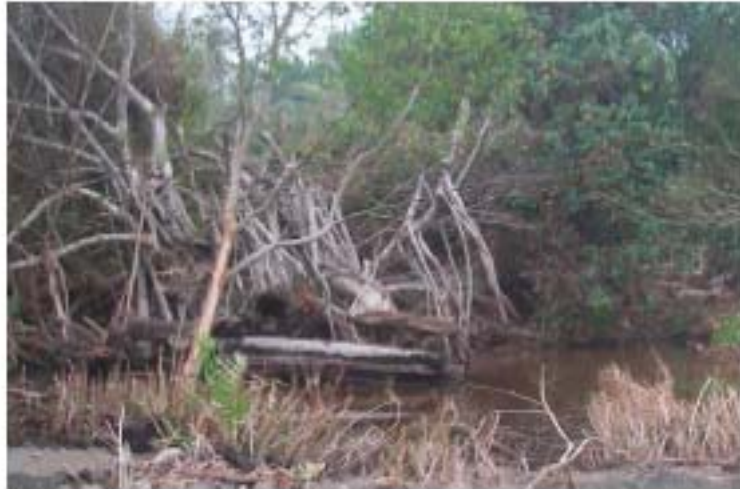
In this event, at Serangai there is green belt composed of the Mangrove along the coast, which could stop the floating material of timbers moved by the tsunami from

coast. However, the houses behind the green could not be survived and completely destroyed. Because there are so many timbers on the sea, which can be not trapped. And wave force of the tsunami should be so strong that the green rule is not enough to reduce them. The width of the green would be small at this area. This suggests the limitation of the green belt to reduce the tsunami impact force.

Fig.6.12 Floating timbers trapped by the Mangroves on the shore

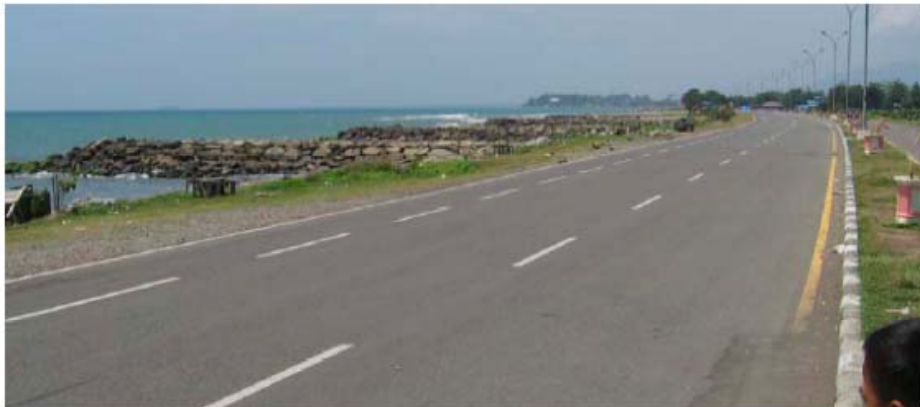
Fig.8.5 Sea dike with the height of 2-3 m at Padang, which prevent a small tsunami and stop the inundation.

Building dykes, elevated tsunami shelters, gates and water breaks and planting trees along the coast line can be also implemented as hardware measures against tsunami disasters (Figure 8.5).
