4. DAMAGE TO TRANSPORTATION FACILITIES

4.1 Overview

4.2 Highway Bridges

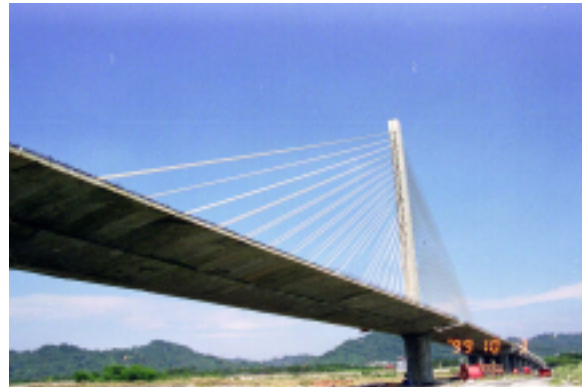
Photo 4.5 Overview of Ji-Ji Da Bridges

This bridge is located in the south in Ji-Ji Village, and crosses over Juo-Suei-Shi River. This bridge is under construction. It consists of one cable stayed bridge (Photo 4.5) of 4 traffic-lanes, two 8 span prestressed concrete simple-girder bridges and 3 span continuous rigid-frame bridge (Figure. 4.6).

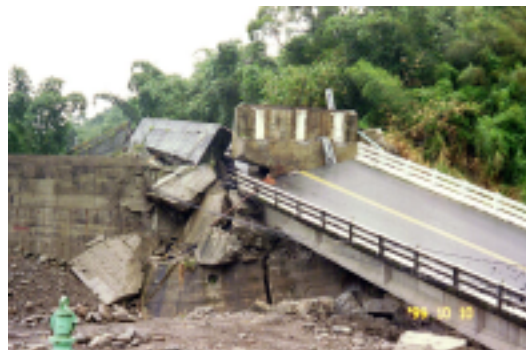
Photo 4.41 Collapse of Abutment

This bridge was completely collapsed (Photo 4.40). Two piers are failed in shear mode and one pier fall in the ground. All decks also fall in the ground. And the abutment suffered severe damage (Photo 4.41). Beside the abutment, a large-scale collapse of rock wall was observed. It is supposed that active faults exist around the bridge, because the piers, especially the abutment, were damaged severely.

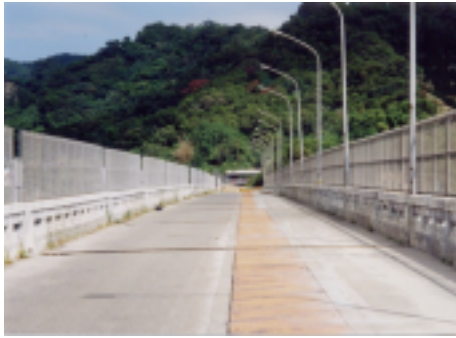
Photo 4.42 Highway on Shi-kan Dam

At the undamaged portion of bridges, several damages on secondary structures which affects the serviceability of highway are also observed. Photo 4.42 shows the highway on the Shi-Kan Dam. One of the lighting pole is overturned due to the failure of the anchor(photo 4.43).

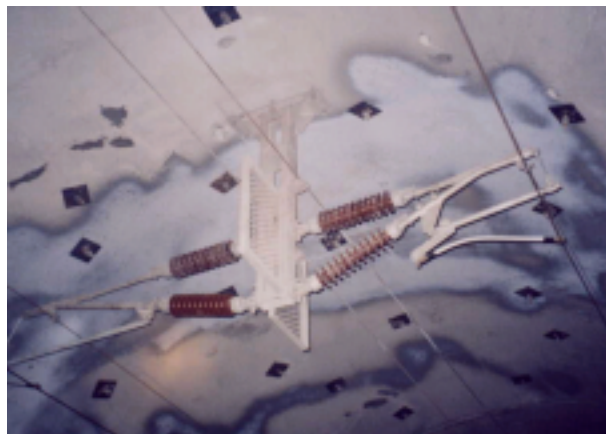
Photo 4.58 Reinforcement of tunnel

- Damage was found at three locations (vicinity of 161K, vicinity of 164K, and vicinity of 165K630m), 8 segments (Photo 4.58) in total.
- Spalling of the concrete block in the tunnel, fall of the trolley line, and the rail buckling.
- Horizontal displacement of the tunnel was about the maximum 2.0cm. The rail deformed at maximum 74.0cm horizontally due to buckling.

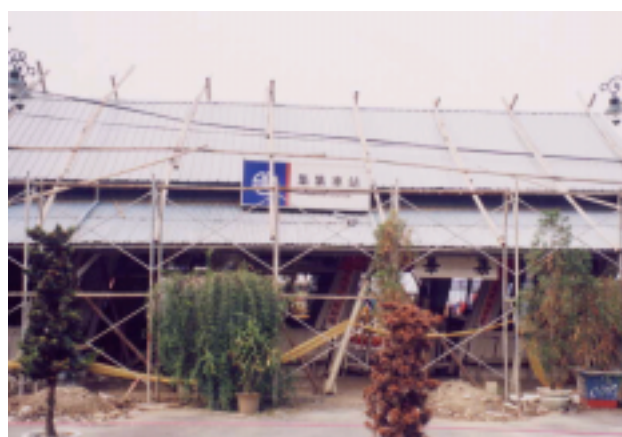
Photo 4.61 Chi-chi station

Ji-Ji station received severe damage close to collapse due to the earthquake. It is scheduled to repair and to be preserved, because it is the oldest historical wooden station in Taiwan constructed in 1930(Photo 4.61).

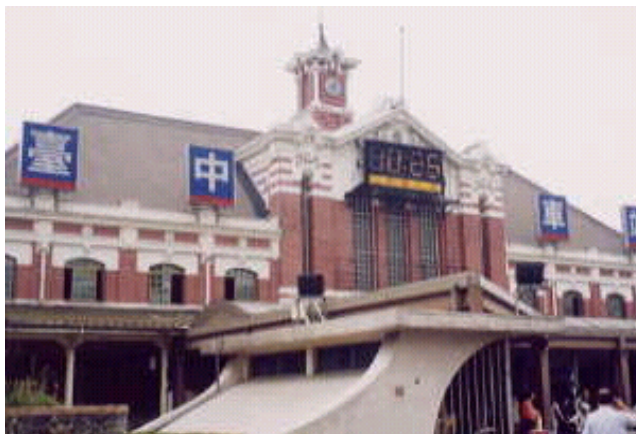
Photo 4.62 Taichung station

The Taichung station (cultural asset specification), is being repaired for the cracks in the column (Photos 4.62,63).
