5. DAMAGE TO PORT AND HARBOR FACILITIES

5.1 Introduction

5.3 Damaged to port and harbor facilities

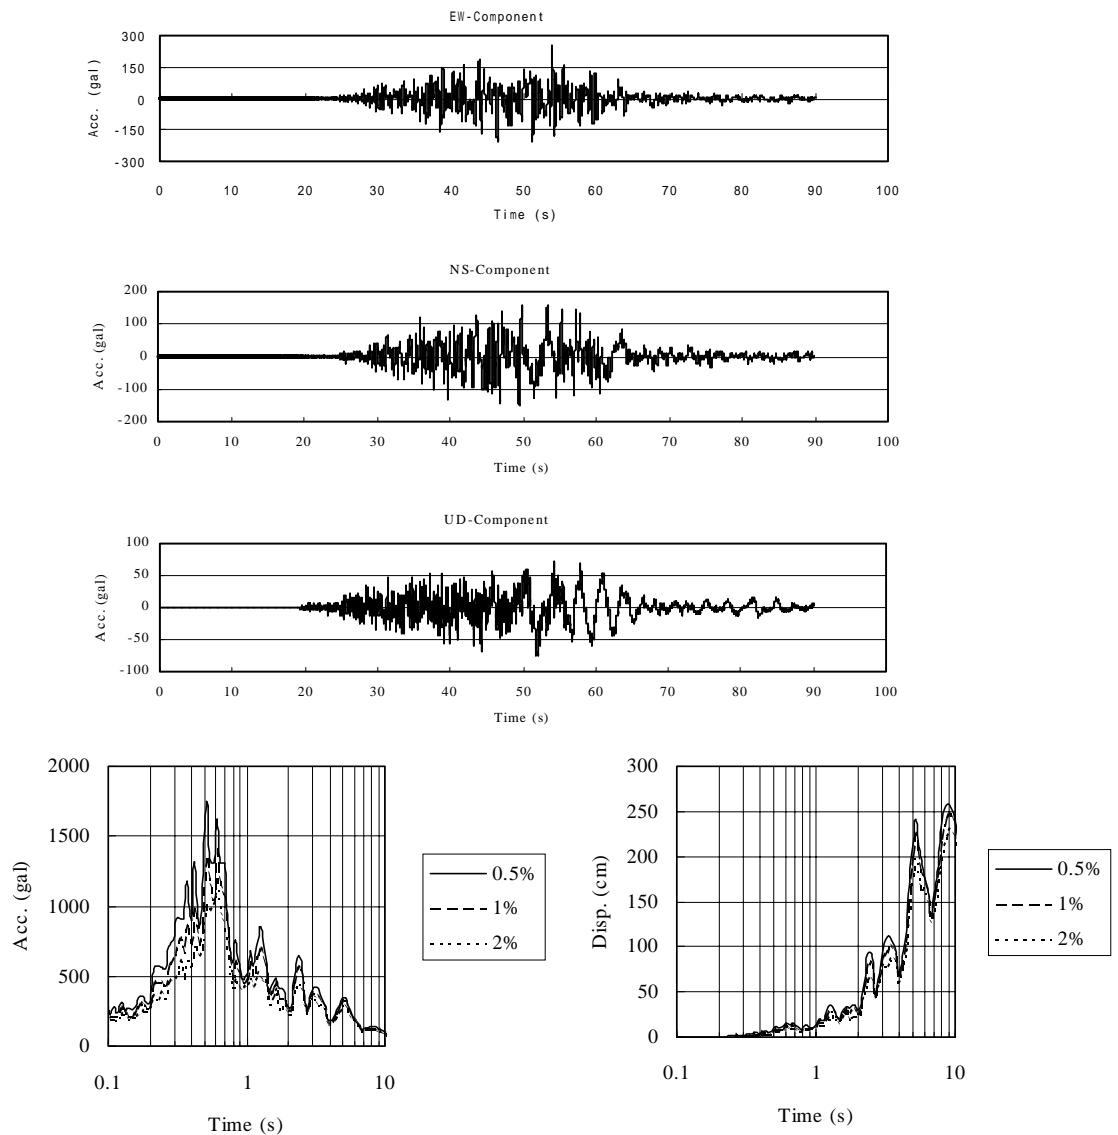
A major earthquake($M_L=7.3$) occurred near the town of Ji-Ji in Nantou, Taiwan, at 1:47 a.m., Sept. 21, 1999 local time. The estimated peak acceleration of Taichung port is 0.1g to 0.25g according to the PGA map reported by the Central Weather Bureau. The acceleration and response spectra at TCU070 are shown in Figure.5.1. The TCU070 station is located 1.6km east, 10.3km south from Taichung No4 berth.

Figure.5.1 TCU070 Time histories and Response spectra

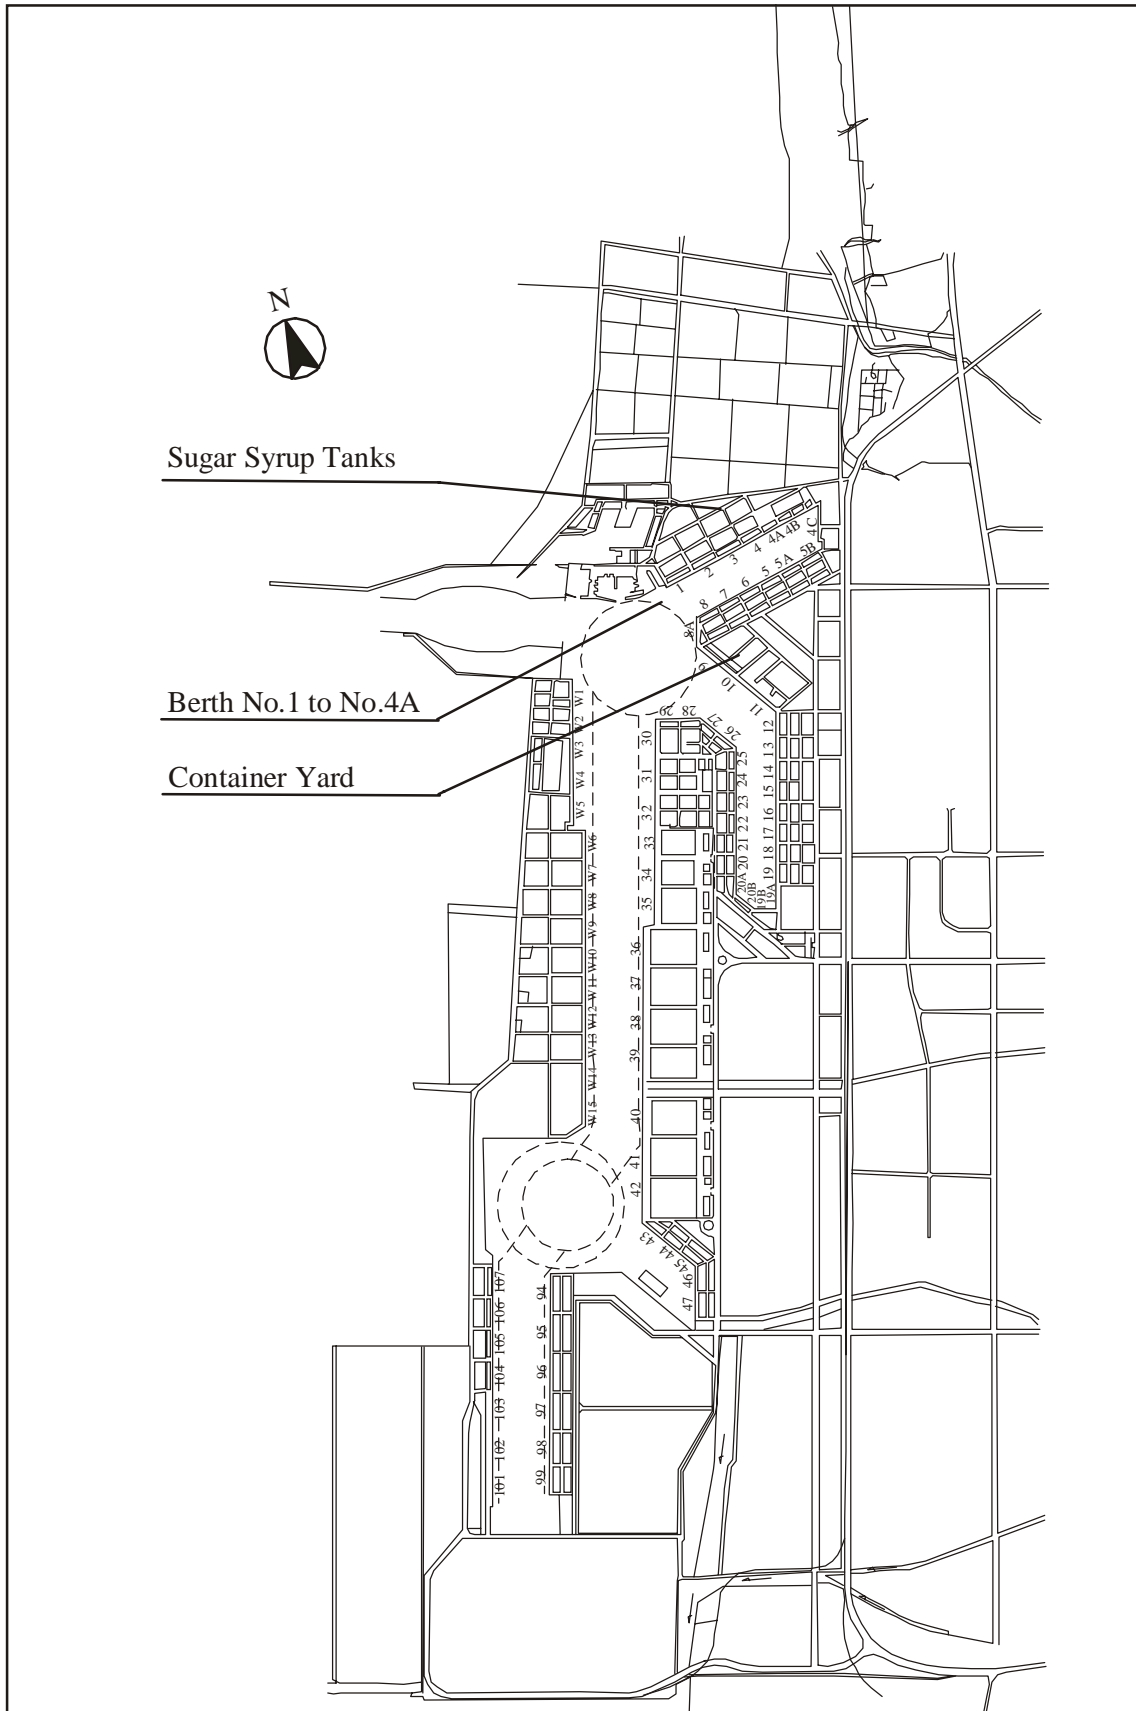
Figure 5.2 shows the plan of Taichung port. The largest damage to Taichung port occurred at the berths No.1, 2, 3, and 4 in the north terminal. The quay walls have the same type of RC caissons. The design specifications are listed in Table 5.1.

Figure.5.2 Plan of Taichung Port
