6. DAMAGE TO DAMS

6.1 Shih-Kang Dam

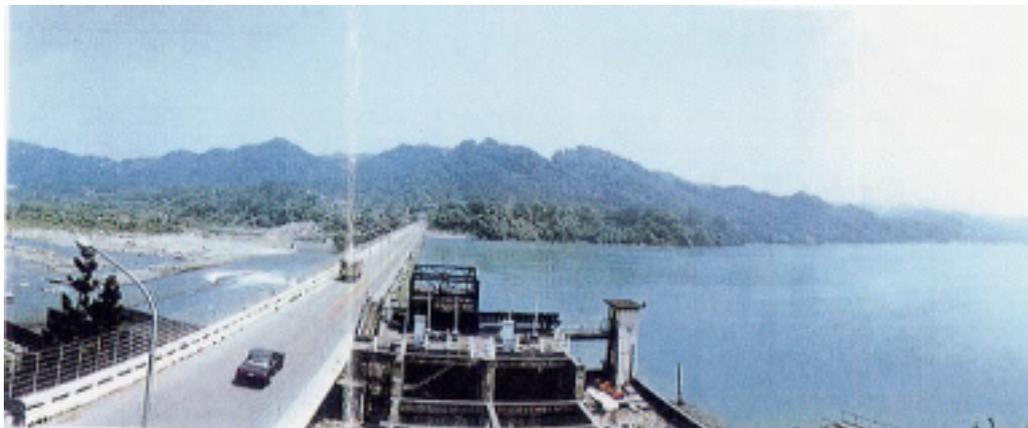
Figure 6.2 Shih-Kang Dam (before Earthquake)
 Broacher of Shih-Kang Dam: Committee for maintenance of Shih-Kang Dam, 1994

The Shih-Kang Dam, 25 m tall and 357 m long with 18 gates lined up, has a total concrete bulk of 141,300 m³ (Figures 6.2, 6.3 and 6.4). The reservoir with the capacity of 3.38 million m³ collects water from a catchment area of 1,061 km² in the Chung-Yang Mountains, and provides a steady supply of water for irrigation and etc. An intake tunnel on the left abutment of the dam leads the water through a diluvial terrace down to the Feng-Yuan water-treatment plant.

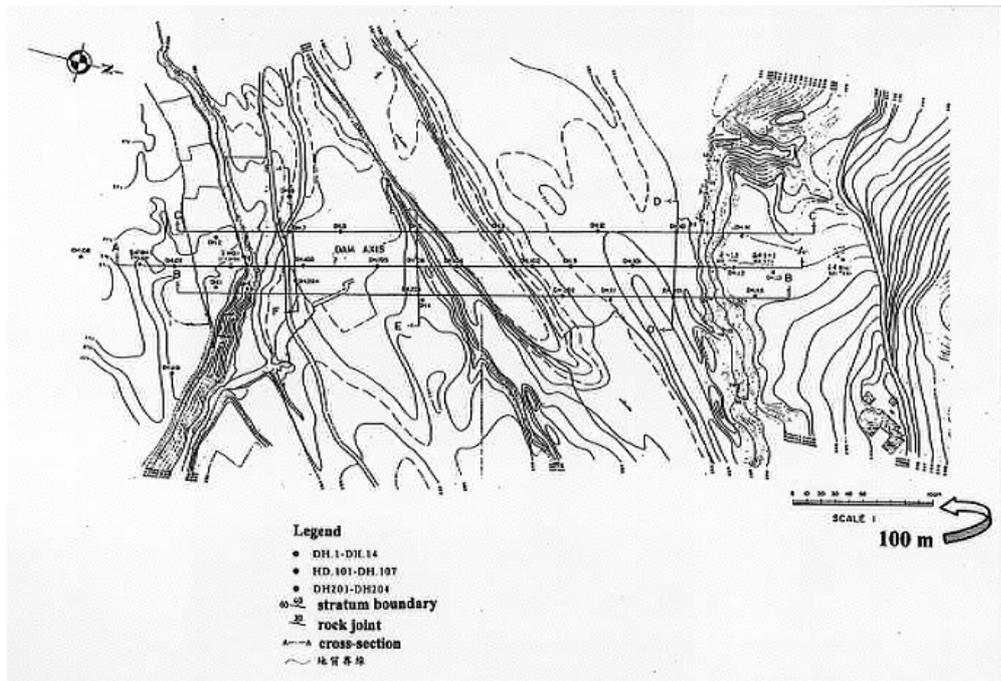
Figure 6.5 Arrangement of boreholes

The construction of the dam was preceded by some necessary geological investigations. The contours in Figure 6.5 describe the configuration of the base rock of the Tertiary period overlaid with sands, gravels and other suspended matters that the Da-Jia river has carried over centuries. Solid circles in the figure (DH. 1 – 14 on the line C-C, DH.101-107 on A-A and DH201-204 on BB) show the arrangement of the boreholes lined up along the dam axis. Figure. 6.6 shows the estimated soil and rock profiles across the river with the borehole data provided. Both two cross-sections AA and BB show that the base rock surface is quite shallow in the middle of the river bed, -3 to -4 m below the soil surface, and reaches -10 to -13 m depths on both sides. These sedimentary base rocks of the Tertiary period can be recognized with their stratified feature. The strata of these rocks run, in general, in about N40°E-40°S direction, and meet the dam axis at an

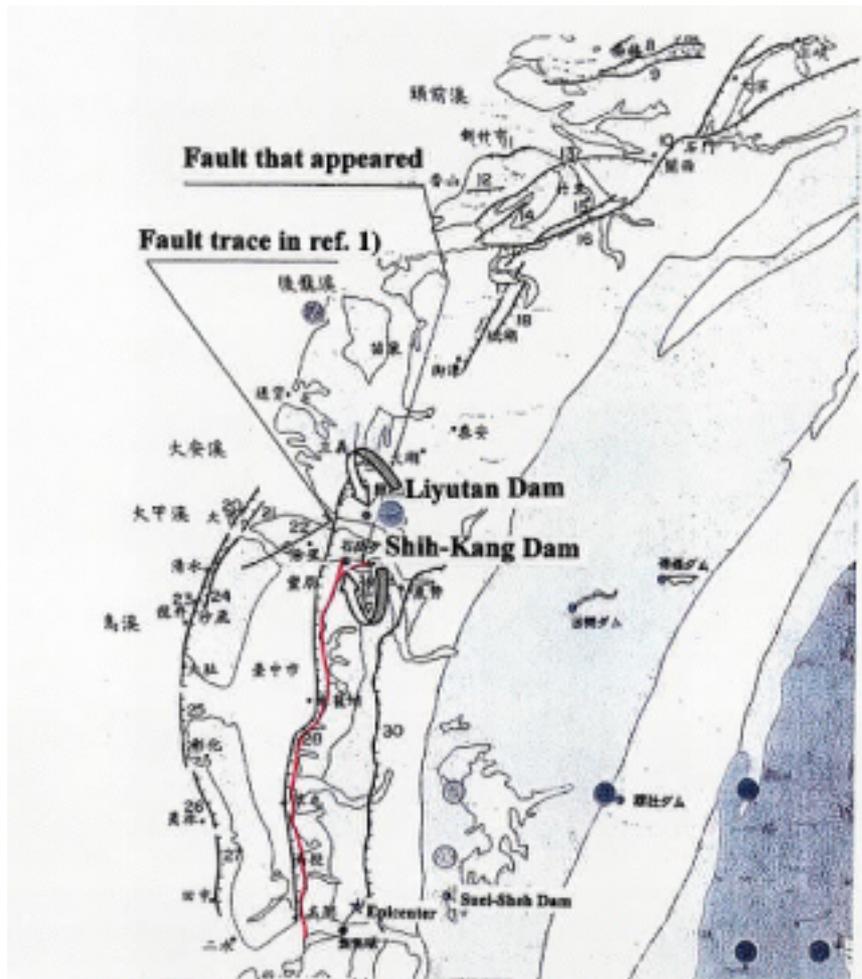
Figure 6.7 Chelungpu fault

Figure 6.7 is taken from “An Introduction to the Active Faults of Taiwan”, Central Geological Survey (CGS), Ministry of Economic Affairs, Taiwan. The CGS has confirmed that 51 active and/or suspicious faults longer than 5 km exist, and are classified as follows:

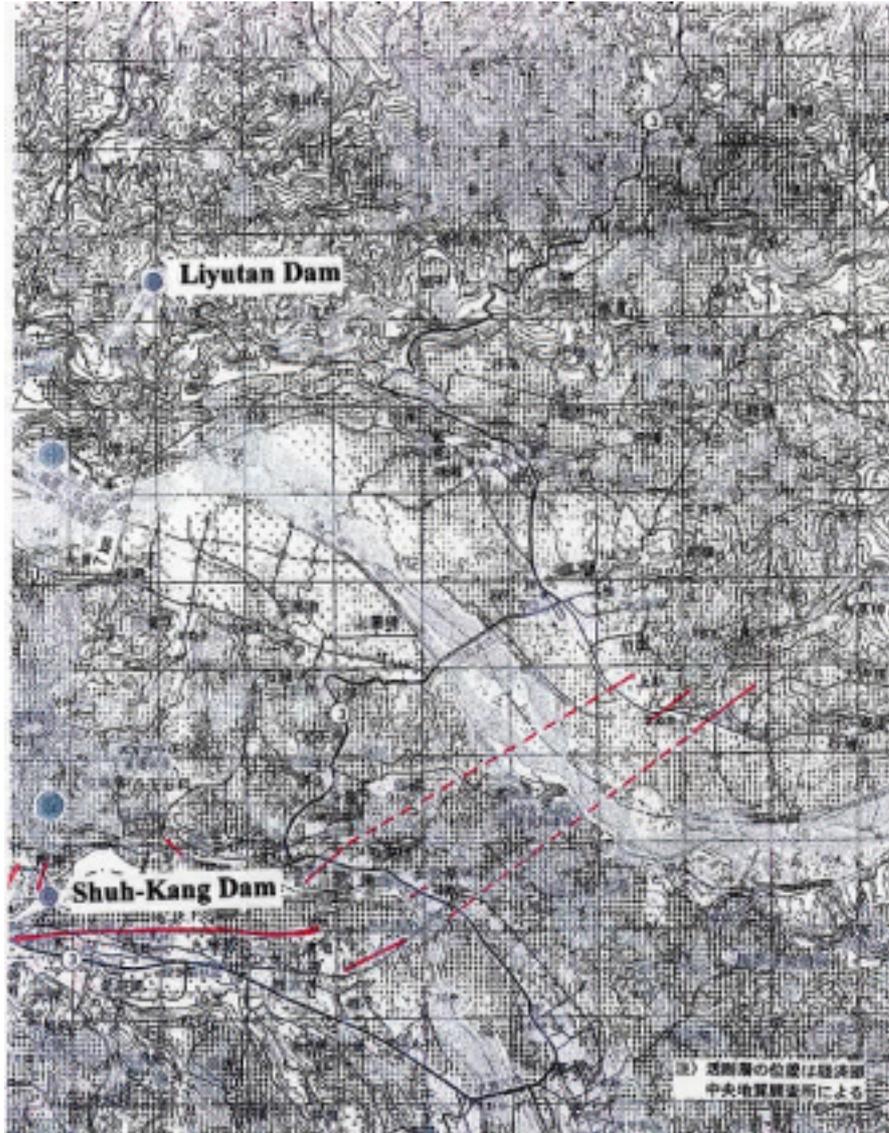
Figure 6.23 Liyutan Dam and Shih-Kang Dam

The Liyutan Dam, a center-cored rockfill dam of 96 m high and 235 m long, is located about 7 km north of the Shih-Kang Dam (Figure 6.23). The plan and the transverse

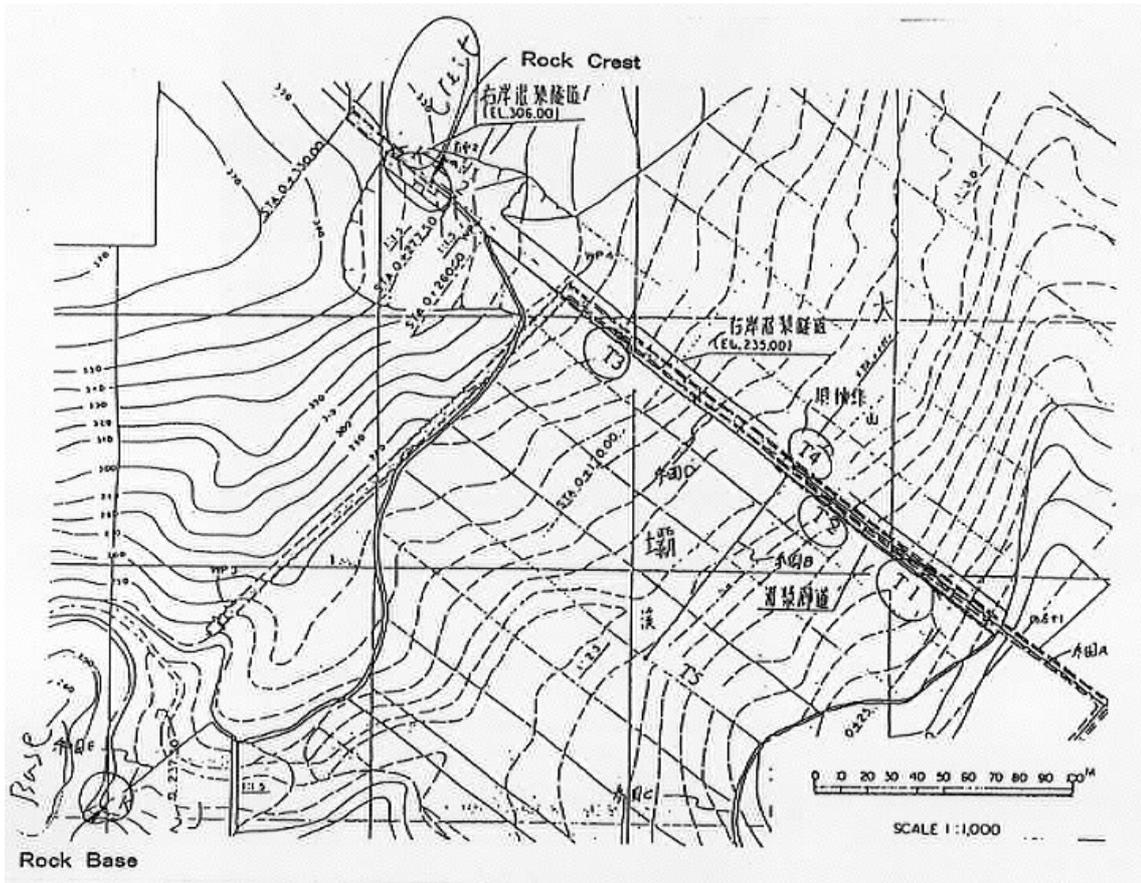
Figure 6.26 Arrangement of seismometers (Liyutan Dam)

cross-section of the dam are shown in Figures 6.24 and 6.25, respectively. The construction of the dam across the Jing - Shan Shi River, a small branch of the Da-An River was completed in 1992 with seismometers installed at five different points on the dam (T1-T4) and in its vicinity (on an outcrop of rock) as shown in Figure. 6.26. Table 6.3 shows the peak accelerations obtained from the seismometers on rocks.

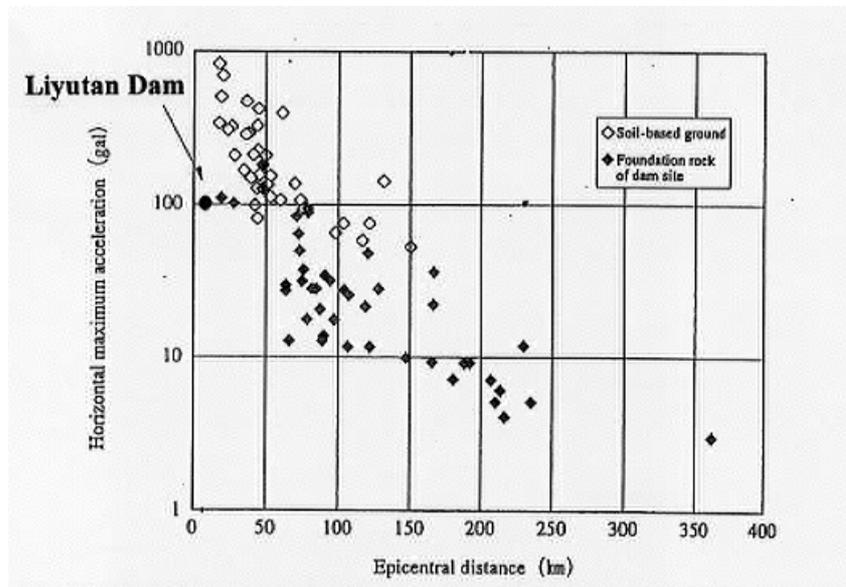
Figure 6.27 Peak horizontal accelerations on rock outcrops and soil deposits (Hyogoken-Nanbu Earthquake (Kobe Earthquake) of 1995)

Since no seismometer was installed in the Shih-Kang Dam, the obtained accelerations will be of some help for us to go on further detail discussions. Figure 6.27 shows the peak values of acceleration observed in the 1995 Kobe Earthquake on both rock outcrops and soil sediments; the accelerations are plotted with respect to the distance from the nearest fault rupture plane beneath Kobe City. The outcrop acceleration observed at Liyutan Dam site, when plotted on this figure, seems to fall in the possible range of scattering.

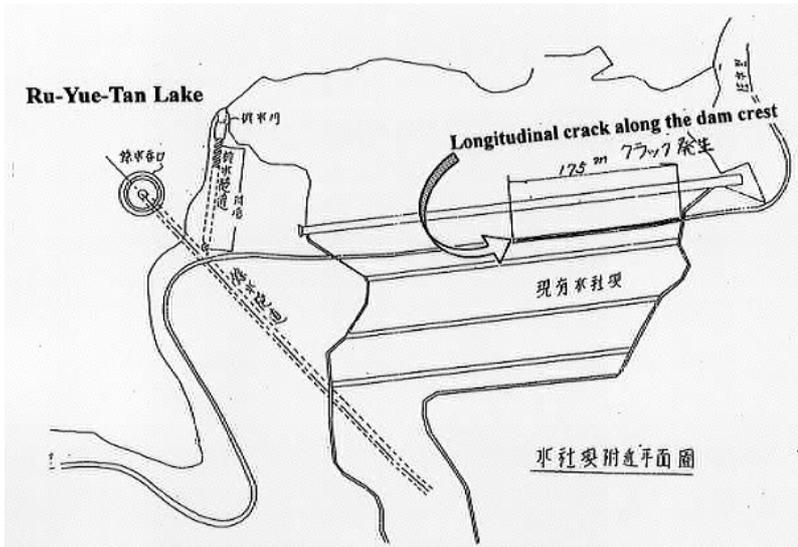
Figure 6.28 Plan of Suei-Sheh Dam

The Suei-Sheh Dam, a center-cored earthfill dam of 30.3 m tall and 363 m long, has a total soil volume of 694,000 m³ (Figures. 6.28 and 6.29). This dam, located about 13 kilometers east of the epicenter, and about 21 km east of the nearest rupture fault plane, was built across a depressed configuration along the Ru-Yue-Tan Lake, where the water of the lake flowed over into a small river leading to the Juo-Suei river. The construction of the dam began in 1918, and was completed in 1934, before the World War II.

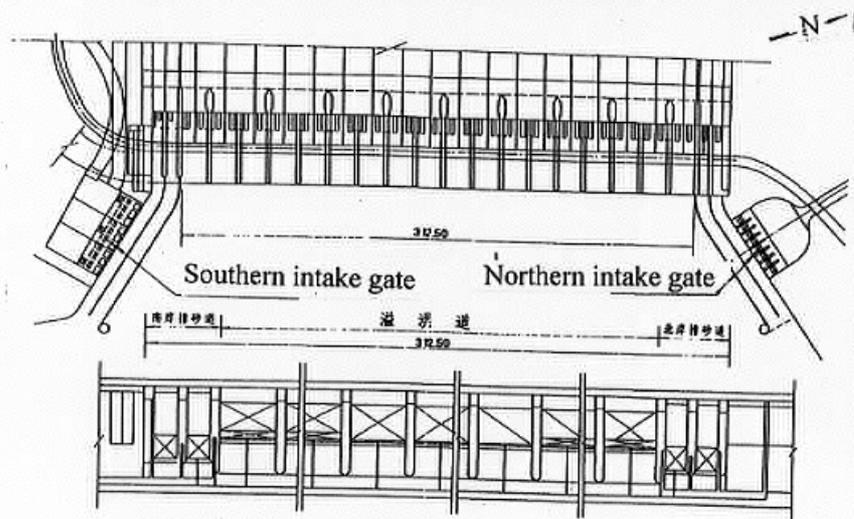
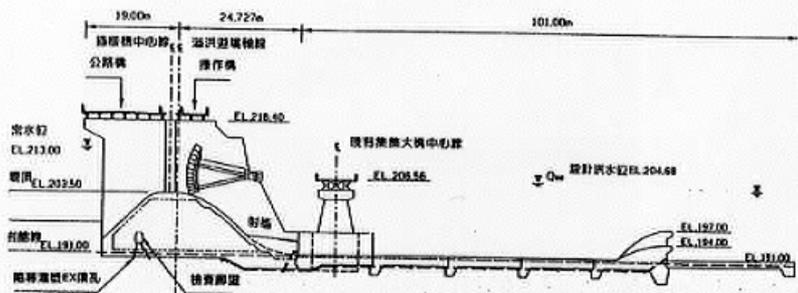
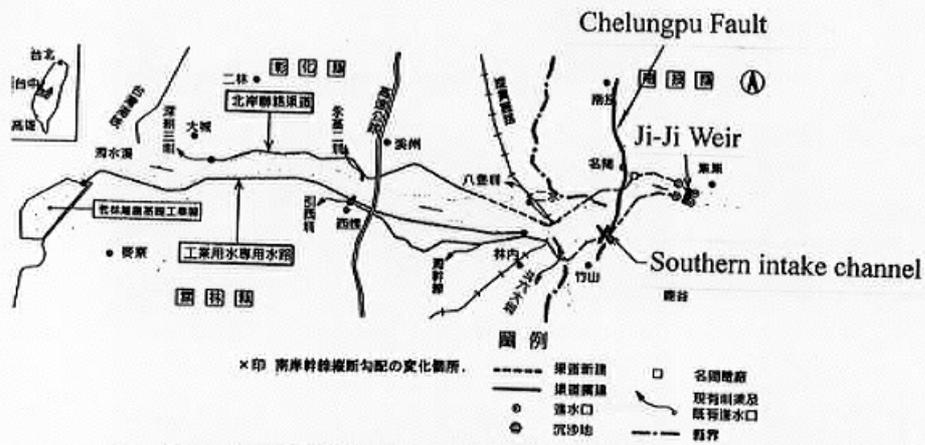
Figure 6.31 Ji-Ji Weir

Ji-Ji Weir, located about 50 kilometers south of Shih-Kang Dam, is being built across the Juo-Suei River where the river's low-lying plain begins to spread (Figure 6.31). The stream flow of the Juo-Suei River, carrying a heavy load of suspended matter, is quite different in wet and dry seasons. Most of the stream flows, about 71 to 87% of the annual amount, occur in the wet season, from mid-May to late October, and often wash away diversion facilities along the river. To minimize the damage and to provide a steady supply of water for public and industrial use, the project of constructing the Ji-Ji Weir was carried into effect in 1993. The weir, 30.3 m tall and 352.5 m long with 18 tainter gates and 4 sluice gates lined up, lies directly on a laminated mass of sand stone and slate of the Tertiary Period.
