7. DAMAGE TO LIFELINE FACILITIES

7.1 Electricity

7.2 Gas

7.3 Water Supply System

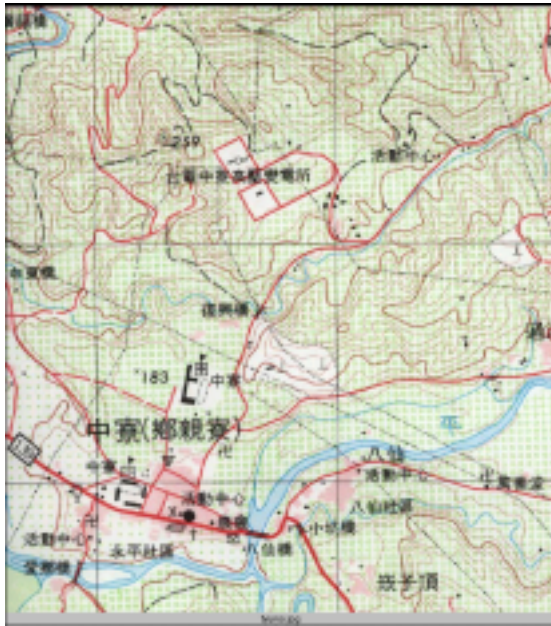
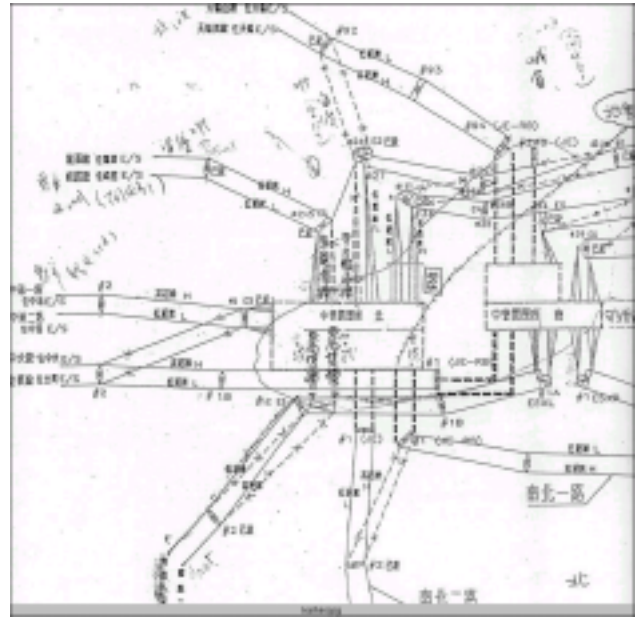
At the Chungliao switching yard (Figure 7.3, 7.4 and 7.5), insulators and bushings for the 345-kV extra-high voltage switching facilities were damaged. The probable causes of the damages are vibration and ground movement caused by collapse of the fault which diagonally crosses the switching station. The switching station consists of the northern and the southern parts (see the plan view for reference), with the former locating approximately 20 m higher than the latter. The whole area of the switching station also has a gentle north-south gradient of approximately 5 degrees and is provided with pile foundations because of its poor soil conditions. Therefore, there is a possibility that cracks observed in the ground of the site was caused by landslide of the lower southern part (Figure 7.6).

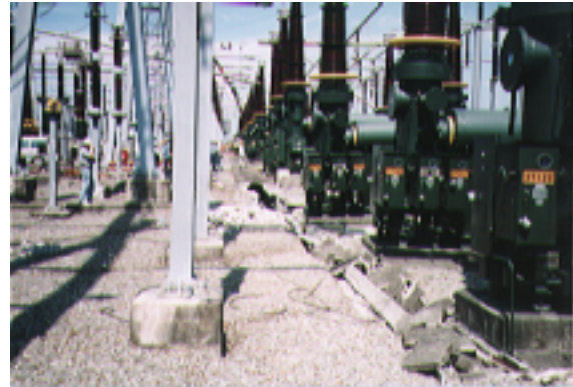
Figure 7.10 Ducts and GIS

Six outdoor pipes located at southern part of the switching yard escaped fracture, due to flexible joints provided at mid sections of them (Figure 7.9). However, they were slightly bent and it has not yet been confirmed whether they are in working order. The gas insulated switchgears (GIS) are products of Mitsubishi and Hitachi and started operation 12 to 13 years ago (Figure 7.10). The local engineer of Mitsubishi said that since they are obsolete, there is no engineer in Japan who is well aware of the details of their mechanism. Checking on the GIS operation system was underway and efforts had been made to partially resume their operation from 5th October. The TPC said that for the time being, bypassing electric lines without using the switching facilities would directly transmit power. The Chungliiao switching yard is base of two north-south power transmission routes, so unless it is not rehabilitated, electric power cannot be transmitted from south to north; hence electric power failure in Taipei is not dissolved. Although some foundations for transmission towers were heaved, it seemed that it would not disrupt power transmission for the time being.

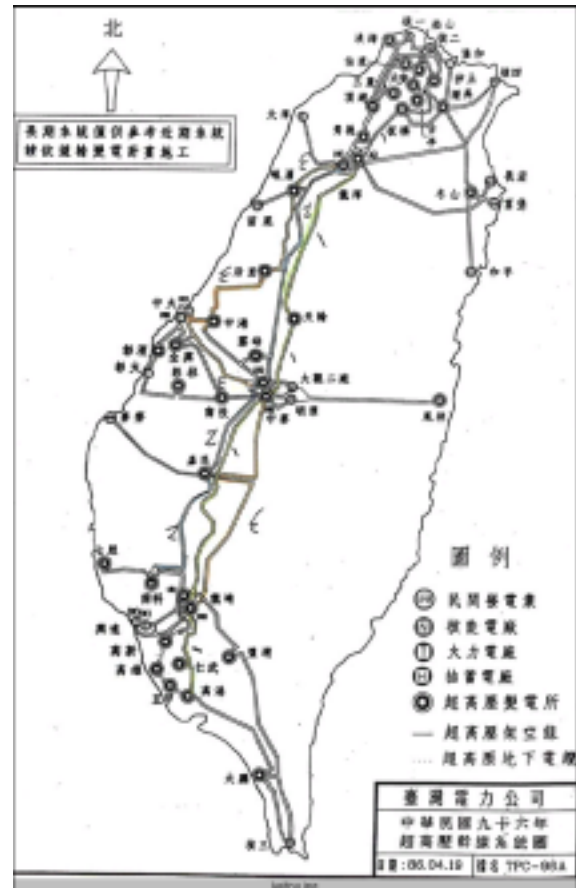
Figure 7.16 Distribution Diagram of Extra-high Voltage Trunk Line in Taiwan

The 345-kV extra-high voltage transmission facility was covering the first north-south route, which starts from Chungliao, runs through Tienlun and leads to Long Tan; and the second north-south route connecting Chungliao and Er-Mei, when hit by the earthquake. The third route, which starts from Chungliao, runs through Chung-Gang and Ho-Ri, and leads to Er-Mei, is under construction (Figure 7.16).

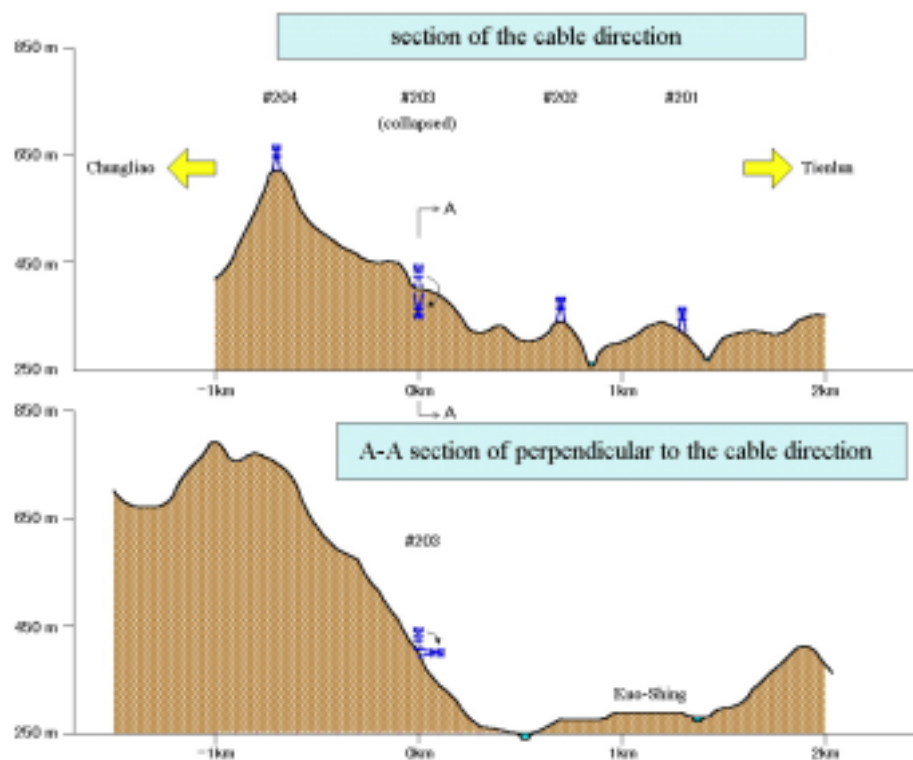
Figure 7.19 the detail location of collapsed tower # 203

relatively close to the town of Kuo-Shing, about 20 minutes' by a 4WD vehicle, and located on the mountain slope. The suspended type tower collapsed at the bottom toward the valley side, perpendicular to the cable direction (Figure 7.19). The foundation level on the valley side was lower than the mountainside by approximately 10-m from the beginning (Figure 7.20). Electric cables were not disconnected and no visual damage was observed on the foundation concrete.

All four tower legs were bent inward at the bottom, which indicates that the two legs on the valley side had buckled. No major fissure, other than the one which runs through the center of the four legs in the mountain-valley orientation, i.e. perpendicular to the cables, was observed around the tower. Four foundations have a pyramid-shaped profile; about 2 m from the ground surface of one foundation on the mountainside was exposed, but other three showed no serious visual damage. While ground falls at the tower location were minor, prominent falls were observed everywhere near the tower.

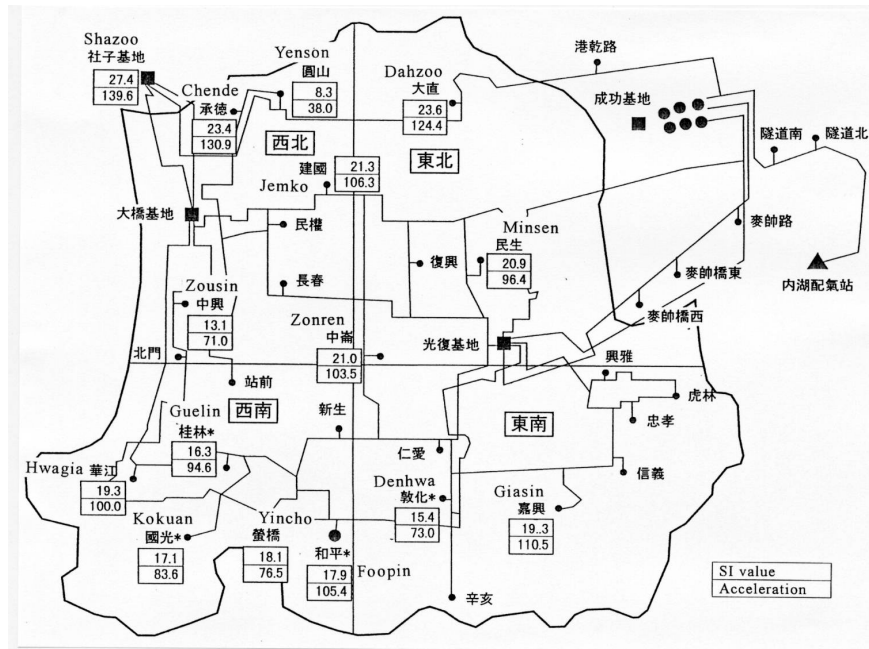
Figure 7.31 The SI value and the maximum acceleration measured in Taipei

Figure 7.31 shows the SI value (Shimizu and Yamazaki, 1997) and the maximum acceleration measured in TAIPEI. The automatic shut off function of the 5,000 intelligent gas meters installed in the area did not work.

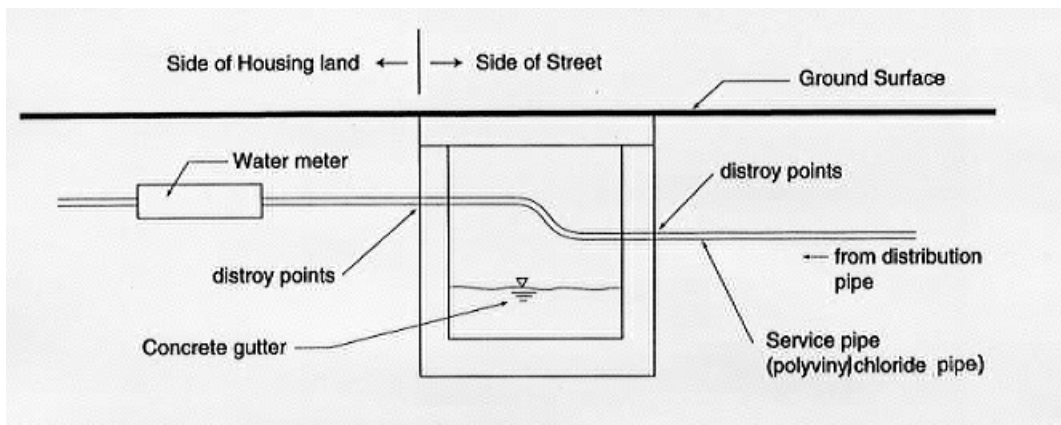
Figure 7.42 Water service installation

Damage to water service installation was investigated at Chunglia and Jong shing shin Tsuen. Service pipe is made up of polyvinyl chloride pipe and the pipe is installed as shown in Figure 7.42. Since the service pipe passes a concrete gutter shown in Figure 7.43, it was easy for the pipe close to the gutter to break during the earthquake. It was difficult to find the water leak because the water from the breakage permeated to gravelly ground.
