8. LANDSLIDE, SLOPE FAILURE AND LIQUEFACTION

8.1 Landslide and slope failure

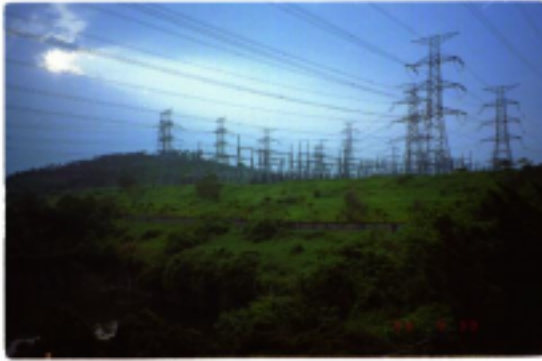
Photo. 8.12 General view

Chungliao switching yard of Taiwan Electric Power Company as shown in Photo.8.12 locates in the north from the epicenter. The switching yard was constructed on the top of a hill by cutting of the soil. Some fissures were observed around the filled area in the yard as shown in Photo.8.13. These fissures were supposed to be caused by the liquefaction, because a lot of sand volcanos were observed as shown in Photo.8.14. The erupted soils around sand volcano contains an amount of fine contents.
