6 DAMAGE TO PORT FACILITIES

6.1 Damage State at Port Facilities around Eastern Marmara Sea

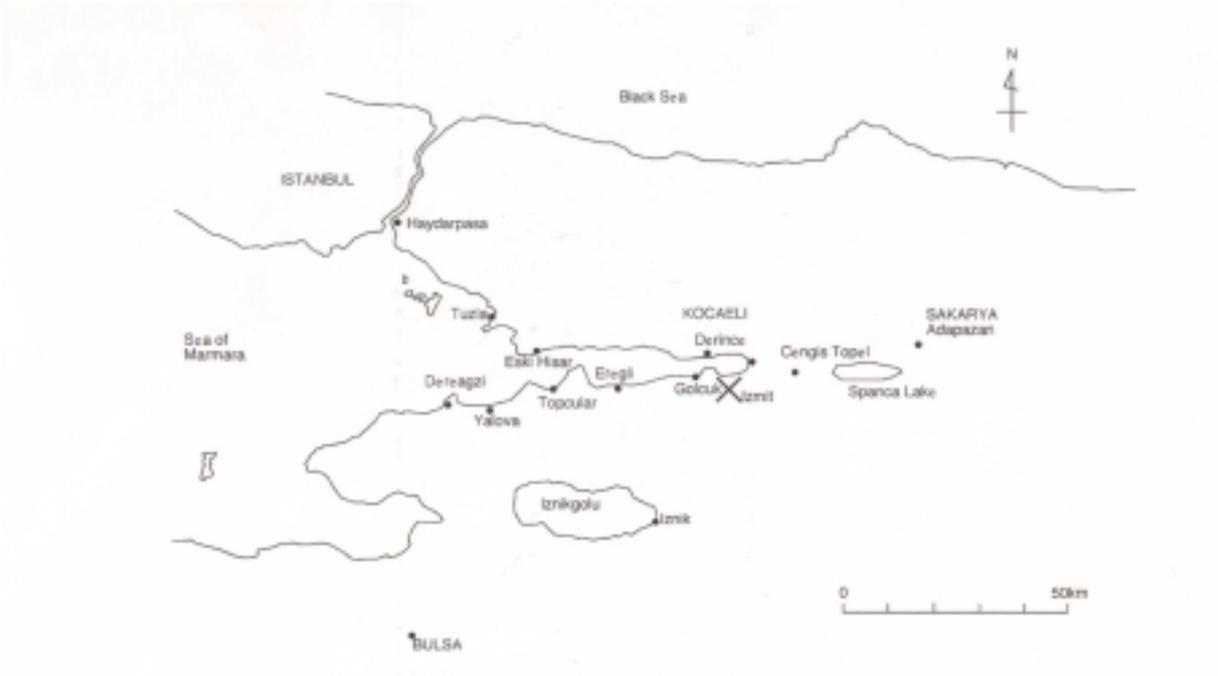
Figure 6.1 Epicenter and location of the surveyed ports

This is a preliminary report. It compiles earthquake, structural and geotechnical data, including preliminary discussions, but does not contain detailed analysis. Location of epicenter is shown in Figure .1 with the locations of several ports investigated.

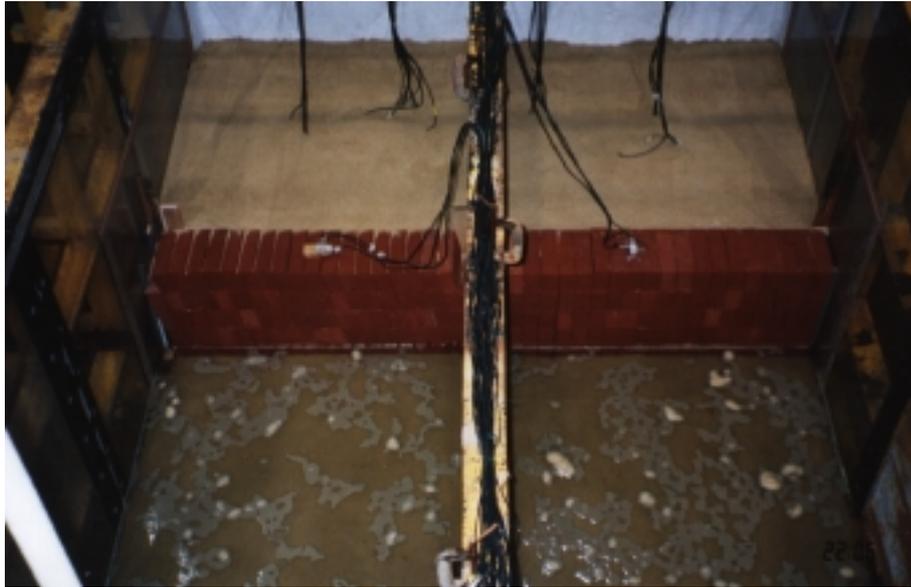
Figure 6.10 Underwater shake table test models

To investigate the performance of the cellular block type quay wall, we conducted underwater shake table test as shown in Figure 6.10. The blocks stacked vertical (right hand side) is modeled as Yokohama Shinko No.5 quay (Uwabe, 1986). At the No.7 quay wall of Derince port, blocks are stacked with around 16 degrees slant. The backfill ground was constructed as a loose fine sand layer. The input motion was used YPT records with 3 axes. The test results(Figure 6.11a and b) show that the horizontal displacements of No.7 quay wall are smaller than those of the blocks vertical stacked quay wall. The underwater shake table test result expressing the constaint effect of the blocks with 16 degree slant stacking.

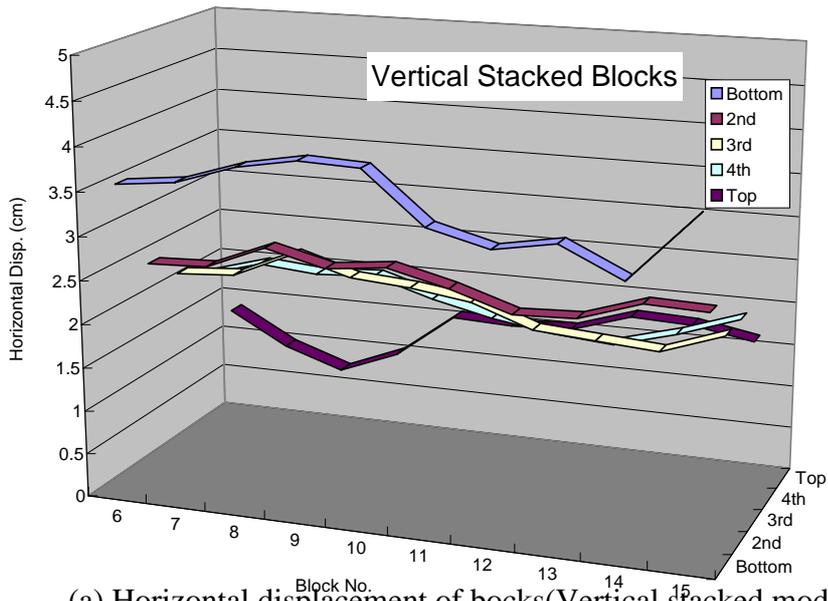
(a) Horizontal displacement of blocks (Vertical stacked model)

Figure 6.11 Shake table test result of cellular block type quay wall

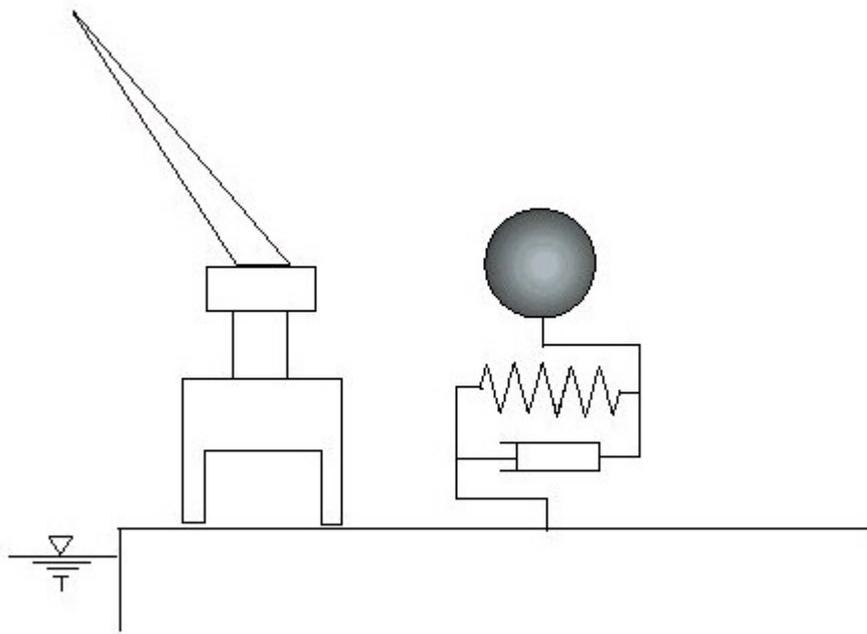
Figure 6.12 Mass-spring model of the crane

The functions of port facilities are mooring the ship, unload/load freights and transport the freights to/from land side, it is important to consider the seismic performances of whole port facilities during earthquake. To investigate the performance of general purpose crane located on the No.7 quay wall which was fall down, simple analyses(Yamamoto et al.1999) were conducted. The prototype crane was reduced in the mass-spring model as shown in Figure 6.12 .We assumed the crane weight of 100t, height of gravitational center is 7m, natural frequency of 2Hz and damping is 0.025 from the rough estimation by Japanese cranes. The rail span was measured as 5.5m. The input motion is chosen NS component of YPT record with maximum acceleration of 313.85 Gal. The response time histories of acceleration and displacement are shown in Figure 6.13 a and b. The next cane (7.5 m rail span, 7t capacity, weight of 150t, height of gravitational center is 9m) was not overturned during the earthquake. Simple static analyses were conducted to calculate the condition of overturning occurrence. The origin of coordinate is set at the land side leg, then calculate the sum of momentum as listed in below with condition of 0.5 m land side leg settled, and finally we can obtain the overturning threshold level of pseudo static acceleration A in horizontal direction as shown in Figure 6.14.

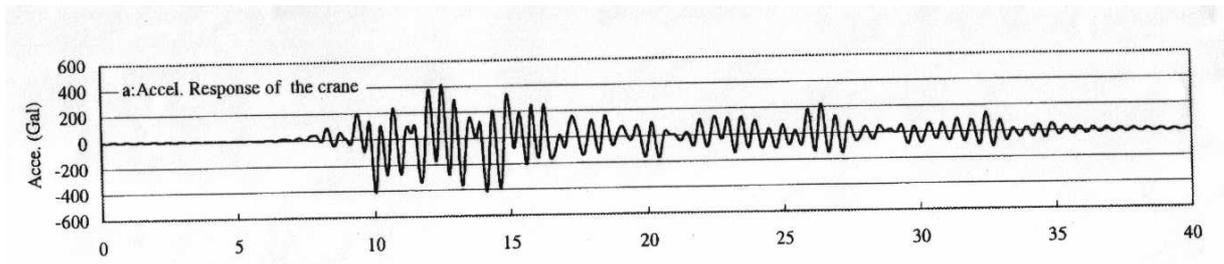
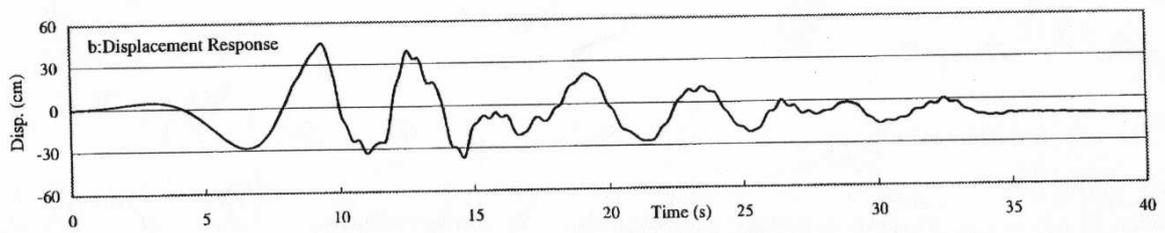
Fig.15 Acceleration Response(Top), Input motion(Middle), Displacement Response(Bottom)

(a) Acceleration response

(b) Displacement response
