# THE BEHAVIOUR OF STRUCTURES BUILT ON ACTIVE FAULT ZONES : EXAMPLES FROM THE RECENT EARTHQUAKES OF TURKEY

Reşat ULUSAY<sup>1</sup>, Ömer AYDAN<sup>2</sup> and Masanori HAMADA<sup>3</sup>

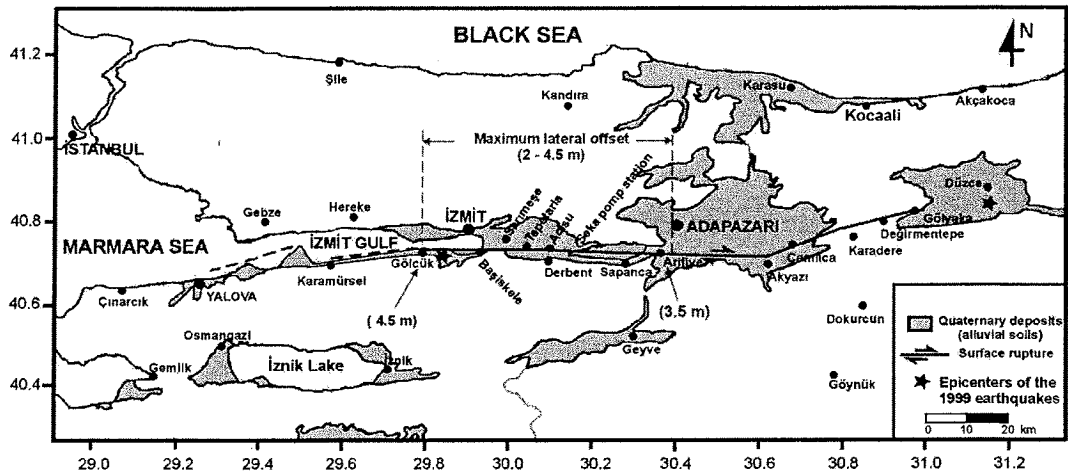
Fig.2 Rupture path of the fault during 1999 Kocaeli earthquake.

produced a surface rupture over a distance of 120 km between Gölyaka in the east and Hersek in the west as shown in Fig.2. Between Gölük and Degirmendere the surface rupture disappeared and extended towards west (Hersek delta) as a near-shore strike-slip fault.

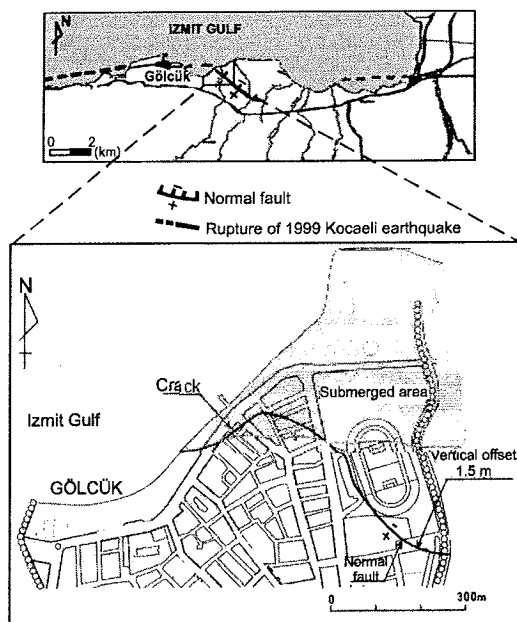
In the western part of the earthquake-affected region, between Kavaklı (Gölük) and Hisareyn, a normal fault striking N45-60W/75-80NE with a significant vertical offset was observed. It produced a scarp of 3.5 km in total length and a vertical movement or a drop up to 2 m and some lateral movement (Fig.5). The fault initiates somewhere at the sea shore in Kavaklı and terminates near the D-80 highway in Hisareyn village without apparent connection

**Fig.5** (a) Location and orientation of the normal fault at the east of Gölcük, and (b) a part of submerged land in Gölcük town (rearranged from Ishihara et al. 2000<sup>b</sup>).

northeastern part of Gölcük town (see Fig.5). Several models are suggested for explaining the cause of the normal faulting. These models may be broadly divided into the pull-apart model and the fracture zone model as illustrated in Fig.7. To validate the pull-apart model one need to find one more lateral strike-slip fault segment at the Hisareyn terminus of the normal fault. Since such a fault could not be found during both aerial and land surveying of this normal fault, this model must be declined.

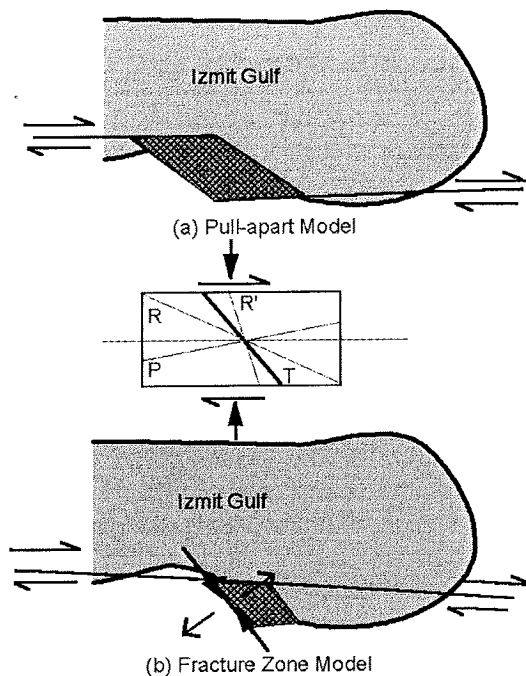
**Fig.7** Models for explaining the cause of normal faulting between Kavaklı and Hisareyn (P : P' - fractures, T : T' fractures, R-R' : Reidel fractures).

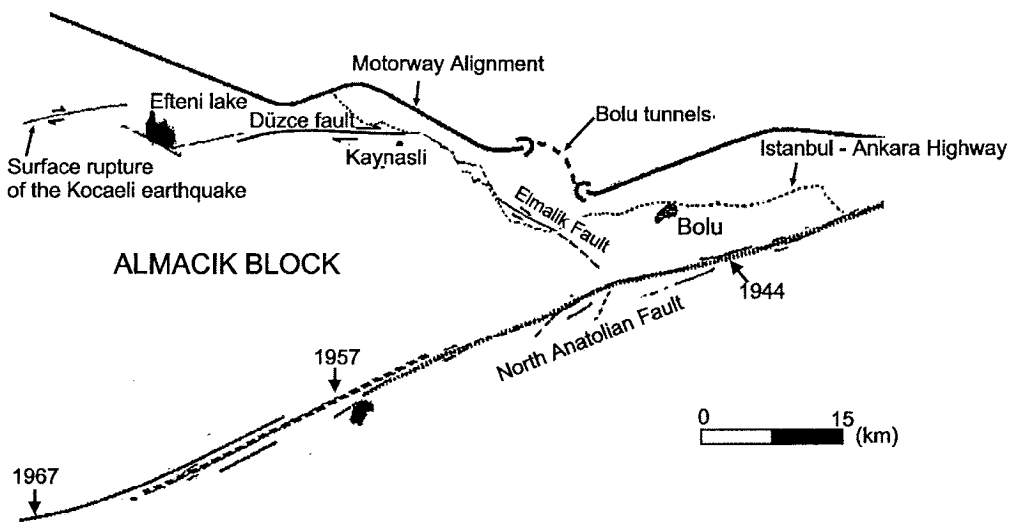
Fig.8 Active faults and previous earthquakes between Bolu and Düzce, and the position of the Ankara-Istanbul motorway project.

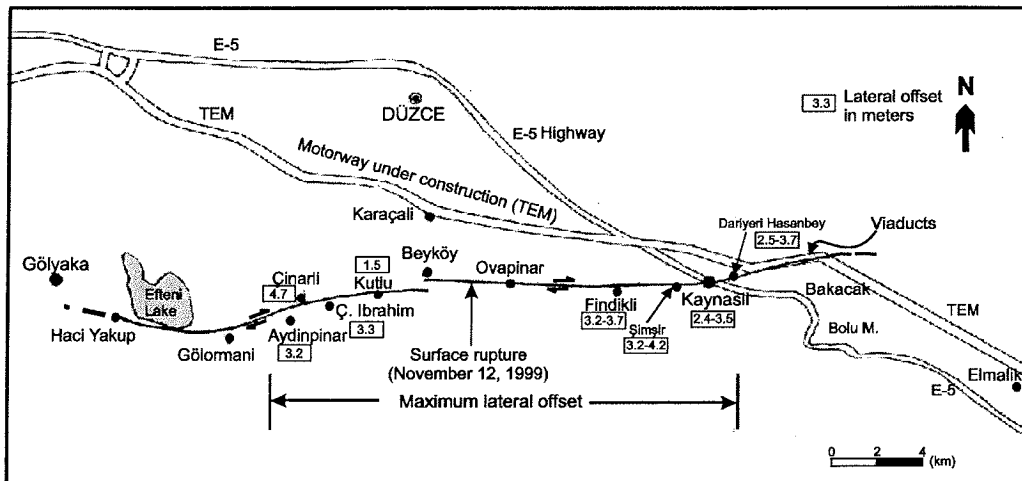
Fig.9 Rupture path of the fault during Düzce earthquake and amount of lateral offsets measured at certain locations.

wards Bolu (Fig.8). The southern strand goes into the Mudurnu valley and the Düzce-Hendek fault in the north surrounding a crustal block called Almacik block. The Düzce earthquake originated at a depth of 14 kilometers and caused a right-lateral strike slip movement on the Düzce fault with a slight normal faulting component. The surface rupture was 40 km long. There is an approximately 5 km step over at the eastern tip of the surface rupture resulted from the Kocaeli earthquake near Efteni Lake. The surface rupture, with a general trend of E-W, appeared at the south of Gölyaka town and terminated at a location about 2 km far from the west portal of the Bolu Tunnels (Fig.9).

The maximum lateral offset is about 5 m. As seen from Fig.9, the amount of right-lateral offsets, clearly observed on roads, fences and tree lines (Fig.10), in-

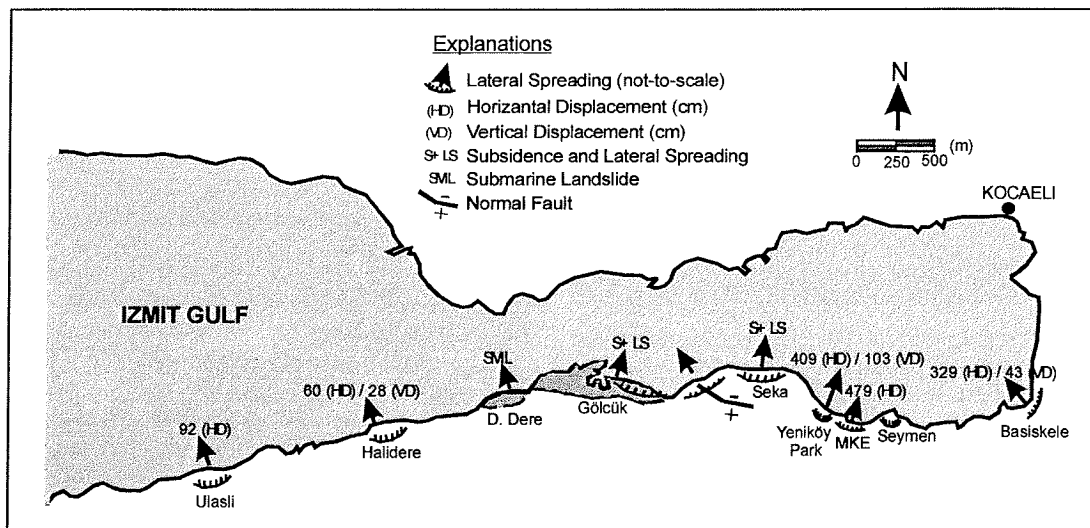
In addition to liquefaction-induced lateral spreading with a large extent (**Fig.22**), a huge scale subsidence occurred along the southeastern shore of

**Fig.22** Locations of lateral spreading, subsidence and submarine landslides along the southern shore of Izmit Gulf<sup>(10)</sup>.

Submarine and seashore slides during the 1999 Kocaeli earthquake (see Fig.22) were mostly associated with reclaimed lands along the shore. It seems that in addition to ground disturbance near faulting, soil

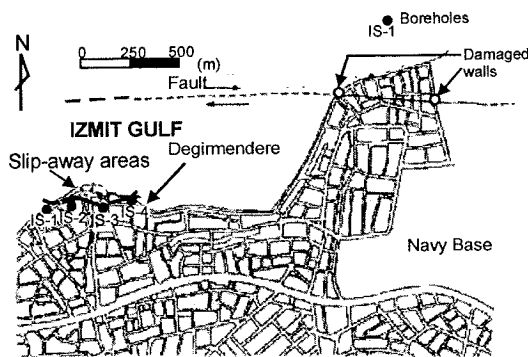
**Fig.25** Locations of fault break, land submerged and geotechnical boreholes drilled after the Kocaeli earthquake (rearranged from Ishihara et al. 2000<sup>4)</sup>, and Kiper and Arel 2000<sup>11)</sup>).

liquefaction has also some roles in submarine slides. The most publicised submarine slide took place at Degirmendere where a 5-story hotel slid into the sea together with two adjacent buildings (Fig.24). The site investigations showed that there were tension cracks extending into the land at a distance of 75–80 m from the post failure seashore. The spacing of these tension cracks was quite consistent. The coastal land about 250 m long was chopped away into the sea (Fig.25).

(see **Fig.3a**), and the fault break disappears near the shore between Gölcük and Değirmendere. Based on the general trend of the fault break at this locality, it is possible to consider that the fault break passes very close to Degirmendere coastline under the sea as illustrated in **Fig.25**. As previously stated in the previous investigations<sup>4),11)</sup>, it seems that the most important factor contributed to this ground failure occurred in the form of submarine landslide is the disturbance effect in the fault zone.

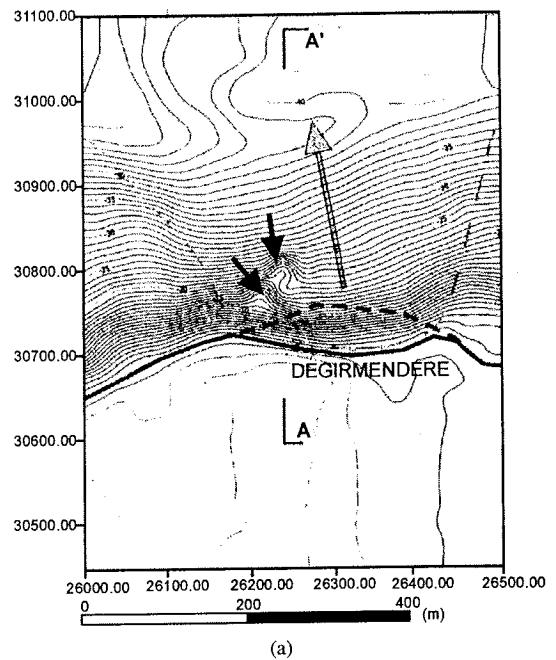
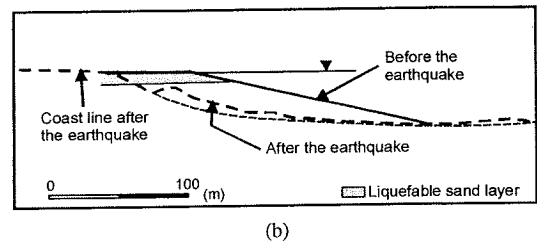
**Fig.26** (a) Bathymetry of Degirmendere coast and vicinity, and (b) configuration of the seabed before and after the Kocaeli earthquake (rearranged from Kiper and Arel 2000<sup>11)</sup>, and Ishihara et al. 2000<sup>4)</sup>).

After the Kocaeli earthquake, depth of water was measured<sup>4)</sup> and the bathymetry map of the seabed in the vicinity of Degirmendere was prepared<sup>11)</sup>. From Fig.26 it is evident that the seabed topography considerably changed after the earthquake. Abrupt changes in the configurations of contour lines at northwest of the sliding land (shown by dashed arrows in Fig.26a) and heaves at the bottom of the sea (Fig.26b) probably suggest that the sliding material spreaded about 300–350 m from the shoreline. The right-lateral offset reaches to a maximum value (4.5 m) in this area

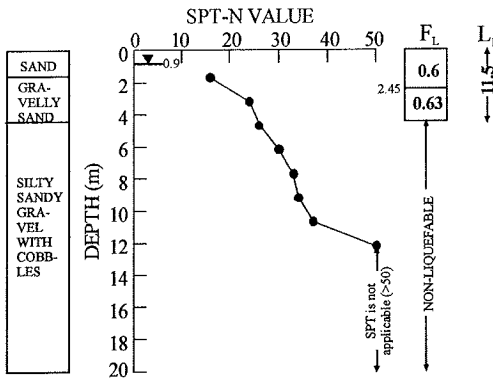
BOREHOLE: IS-1

**Fig.27** Simplified borehole logs illustrating ground conditions, variation of SPT-N values with depth and liquefiable layers at Degirmendere coast line ( $F_L$ : Factor of safety against liquefaction,  $L_I$ : Liquefaction potential index, N.L.: Non-liquefiable).

An attempt was made by the authors to assess the effect of liquefaction on this failure as a supplementary work to the previous observations. For the purpose, data (**Fig.27**) from four geotechnical boreholes of 20 m deep drilled after the earthquake near the slip-away coast line of Degirmendere by a private firm (see **Fig.25**) were employed. **Fig.27** suggests a very shallow groundwater table and fully saturated soils. At the top, except fill materials 1 to 1.5 m thick, there are generally silty sand (SM) layers of 3 to 7 m thick above moderately dense silty sandy gravels (GW-GM). The method based on the
