DAMAGE OF BRIDGES RESULTING FROM FAULT RUPTURE IN THE 1999 KOCAELI AND DUZCE, TURKEY EARTHQUAKES AND THE 1999 CHI-CHI, TAIWAN EARTHQUAKE

Kazuhiko KAWASHIMA¹

This paper describes the damage of bridges resulting from the fault movements in the 1999 Kocaeli and Duzce, Turkey, Earthquakes and the 1999 Chi-Chi, Taiwan, Earthquake. Effect of the fault displacement on the seismic performance of bridges is presented with an emphasis on the mechanism of failure.

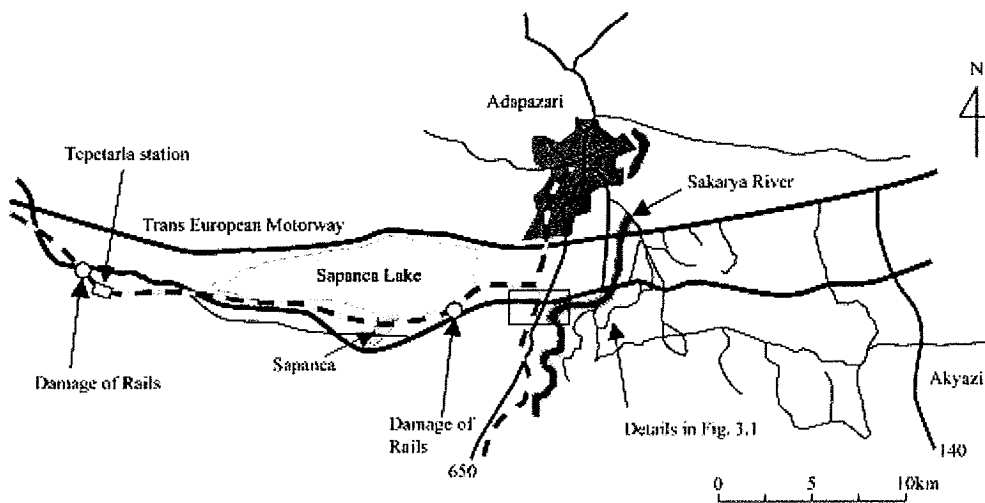
Fig.2 Damaged Area near Sapanca Lake

Near Tepetarla Station (refer to **Fig. 2**) where a large offset of railways occurred, an offset of the poplar trees of about 2.5m occurred as shown in **Photo 5**. As well as the right lateral slip, a vertical offset occurred (south tip of the fault was about 1 m lower than the north tip).

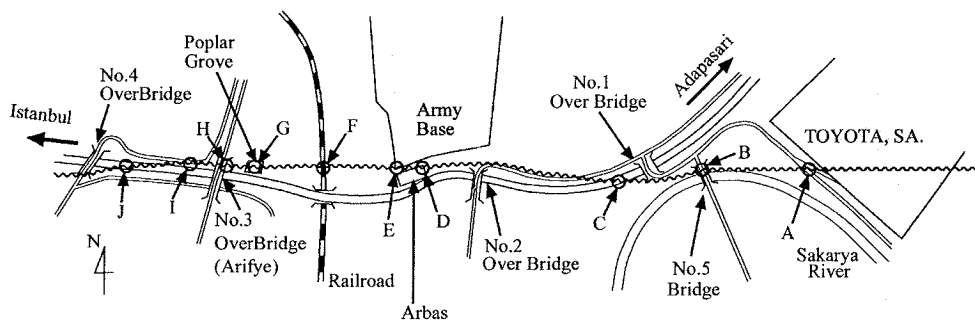
Fig.3 Damaged Transportation Facilities and Fault-Induced Ground Movement, Kocaeli Earthquake

In the Kocaeli earthquake, the transportation facilities suffered extensive damage in the Sakarya region. A part of the right-lateral strike slip Anatolian fault ruptured in east-west direction for about 100km from Golcuk to Duzce. As shown in **Fig. 1**, since the Trans-European Motorway was almost parallel to the fault, the fault crossed the Motorway at several locations. Extensive damage occurred at these intersections. Damage of the road facilities was extensive around the city of Arifiye as shown in **Figs. 2** and **3**. Arifiye Overpass (No. 3, refer to **Fig. 3**) and Sakarya Center Bridge (No. 5, refer to **Fig. 3**) collapsed. Overpasses near Ariyiye Overpass (No. 1, 2, 4 and 5, refer to **Fig. 3**) suffered limited damage. Since **Fig. 3** was produced based on

the author's memo during the survey, it may not be geometrically exact.

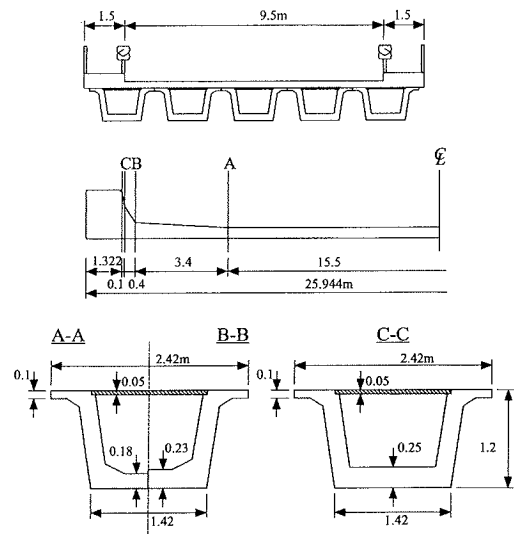
Fig. 6 Cross Section of Arifiye Bridge
(Courtesy of F.Inal and H. Hoashi)

The decks consisted of 5 precast concrete U-beams as shown in Fig. 6. Five elastomeric bearings with a size of 300mm x 300mm and 100mm high supported the deck per substructure. As shown in Fig. 7, the piers were 1m thick and 14m wide in the longitudinal and the transverse directions, respectively. The design strength of concrete was 30 MPa. The reinforced concrete footing that supported P1 was 5.3m long and 14m wide in the longitudinal and the transverse directions, respectively. Eight one m-diameter cast-in-

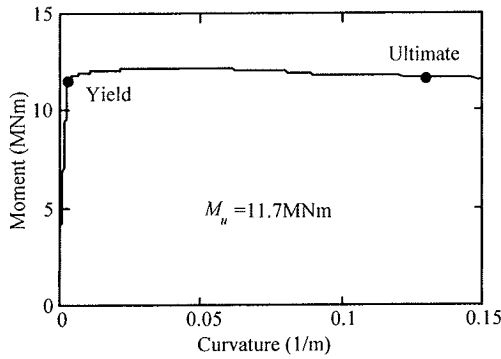
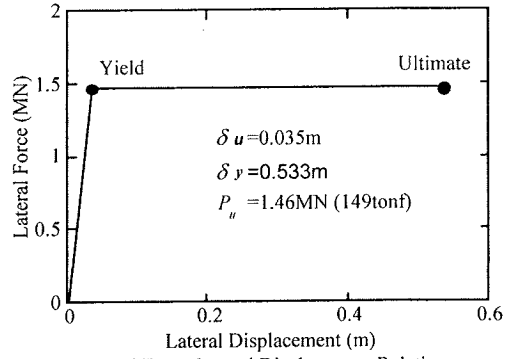
Fig.9 Lateral Force vs. Lateral Displacement of a Wall Pier, Arifiye Overpass

mass of a pier was 5800 kN, the response acceleration that resulted in the yielding of a pier is approximately 0.3 g. This is the yielding level of bridge piers designed in accordance with the Japanese design codes using a 0.25 seismic coefficient.

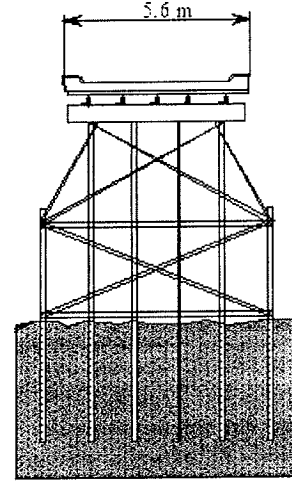
Fig.10 Sakarya Central Bridge (Courtesy of K. Kosa)

Sakarya Center Bridge, crossing Sakarya river, on a regional road (No. 5 bridge, refer to **Fig. 3**) collapsed as shown in **Photo 8**. The bridge consisted of eight span simply supported girders with two internal hinges (Gerber hinges) at the center. It was 92m long (10m+6x12m+10m). Steel bent piles as shown in Fig. 10 supported them. It was constructed 30-35 years ago. The fault crossed the north abutment.

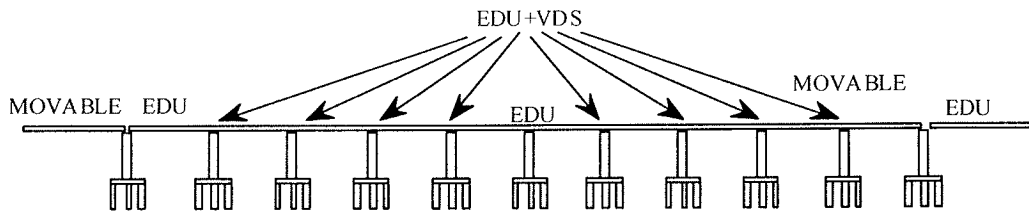
Fig.12 Supporting Condition of Typical 10-Span Continuous Deck (EDU: Energy Dissipating Unit, VDS: Viscous Damper Stopper, Movable: Sliding Pot Bearings)

stopper (VDS in **Fig. 12**) was provided. It was connected to the energy-dissipating unit in series.

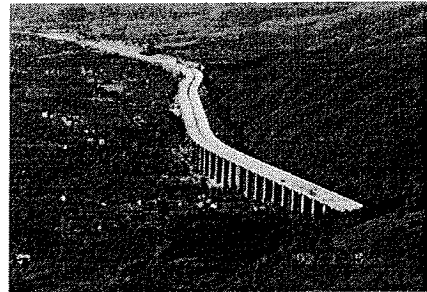
Photo 9 Bolu Viaduct

superstructure consisted of seven prestressed concrete U-beams placed in the transverse direction, and they were connected together by reinforced concrete decks. Although the U-beams were simply supported, the concrete decks were continuous over 10 spans. Hence, the Viaduct behaved as 10 span continuous bridges.

Reinforced concrete piers with heights from 10m to 49m supported them. Most piers were taller than 40m. Pile foundations supported the piers. A pile foundation consisted of 12 1.8m diameter piles and a 3m thick 18.7m wide and 16m long footing. Pile depths varied from 15m to 40m depending on the soil condition.

When the Duzce Earthquake occurred, the Viaduct was almost completed, i.e., the foundations, the piers, and the decks were completed, and only the pavement was not ready.

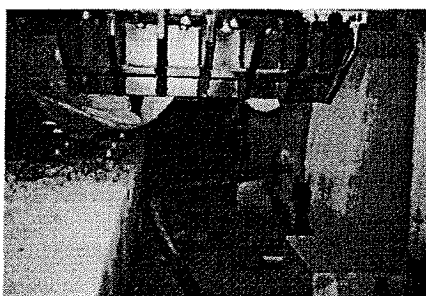
Photo 14 Cable Restrainers

Photo 12 shows a damage of the energy-dissipating unit and the viscous damper stopper at Pier 48R. The C-shaped energy dissipating elements suffered damage, as shown in **Photo 13**, due to an excessive movement of the deck. 30mm diameter bolts that connected the elements to the frame ruptured. **Photo 14** shows a set of cable restrainers at a deck end. It seemed that the cable restrainers were effective to prevent collapse of the Viaduct

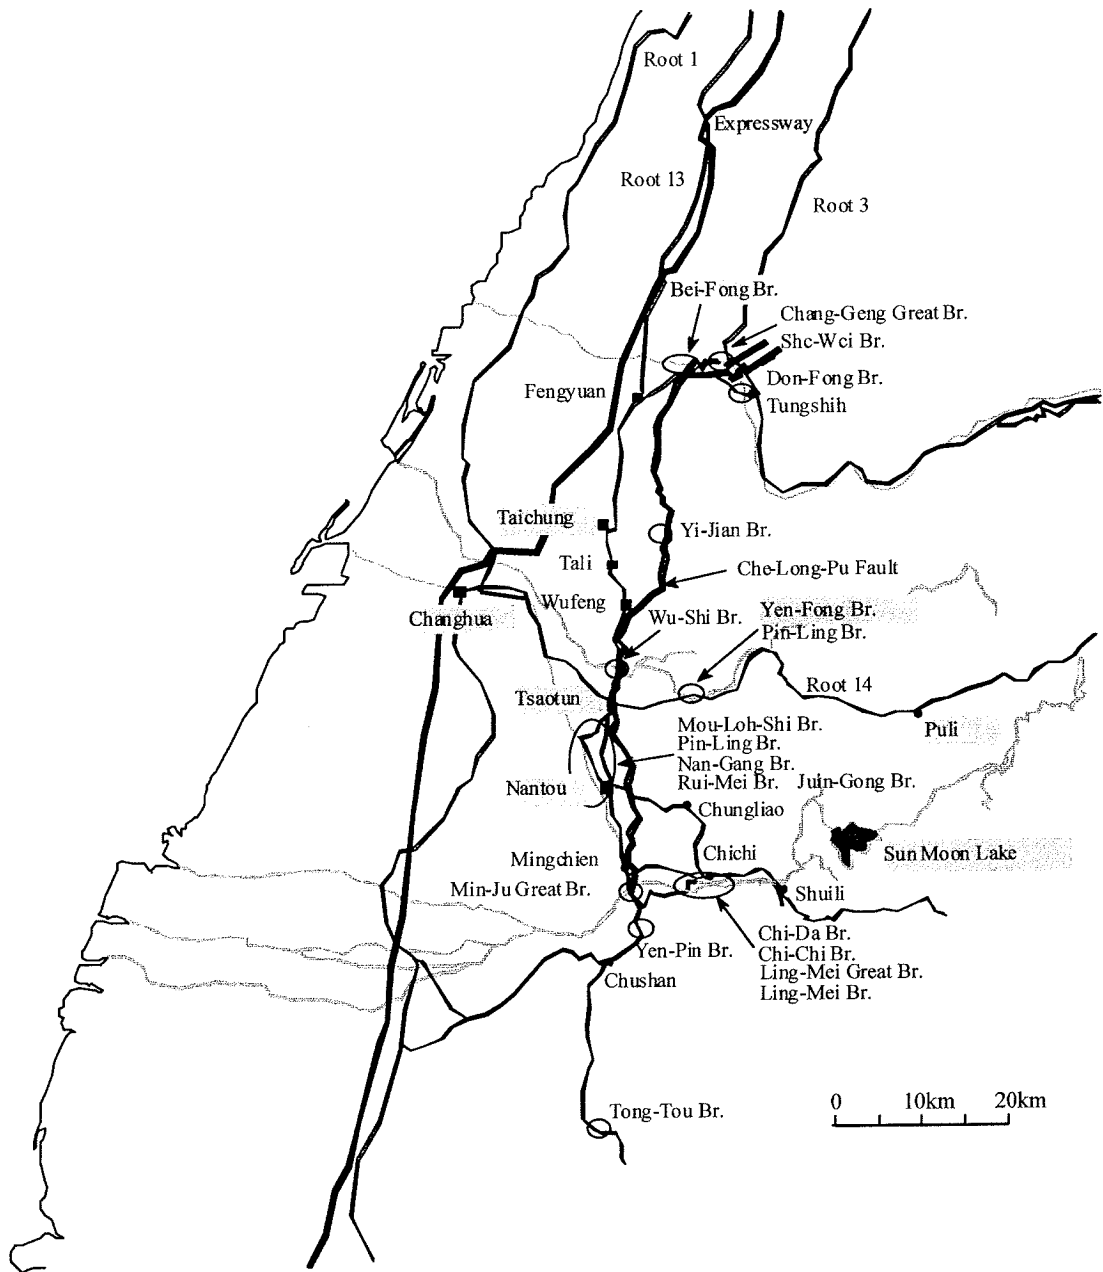
Fig.13 Damaged Bridges, Chi-Chi Earthquake

The Che-Long-Pu Fault induced the earthquake. It was a thrust fault, and surface ruptures occurred over 70km between Min-Ju and Tungshih. Eastern Taiwan is a tongue of the Philippine Sea tectonic plate that is over-thrusting the Eurasia plate. As shown in **Fig. 13**, damage occurred in Shihkang region, Tungshih region, Taiping, Wufeng and

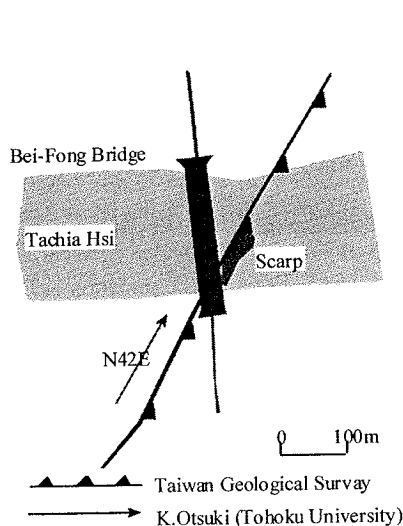
Fig.18 Fault around Bei-Fong Bridge

Fig. 18 shows the location of fault investigated by the Taiwan Geological Survey and Otsuki, K., Tohoku University. It seems that the fault crossed the bridge between A2 and P12 at an angle of about 42-degree. From the fact that P12 was laterally displaced in west, and that D11 and D12 clockwise rotated (20-40-degree), it appeared that the fault rupture crossed the bridge between A2 and P11 as shown in **Fig. 19**.

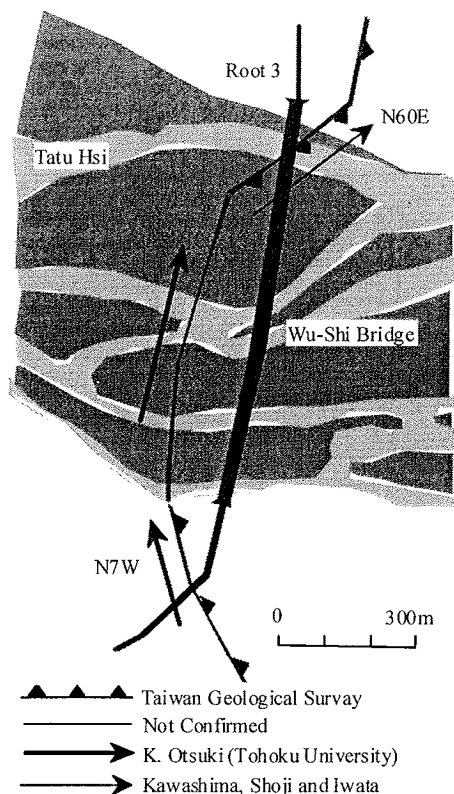
Fig.24 Fault around Wu-Shi Bridge

A 2m high scarp was observed at about 100 m east (upstream) of the bridge. The fault crossed the bridge between P2 (P2E & P2W) and P3 (P3E & P3W) at an angle of about 40-degree (N60E) as shown in Fig. 24. Photo 19 shows the eastward (transverse direction) displacement of P1W relative to other piers in the south of P3. The displacement was as large as 2m. However based on Fig. 24, it seems that the ground at the south tip of the fault moved in the west direction, and that this resulted in the shear failure from the east to the west in P1W and P2W.
