**A PRELIMINARY REPORT ON SULTANDAĞI-AFYON  
EARTHQUAKE OF FEBRUARY 3, 2002\***

**Ömer Aydan**

**Tokai University  
Department of Marine Civil Engineering  
Shimizu, Japan**

**February 7, 2002**

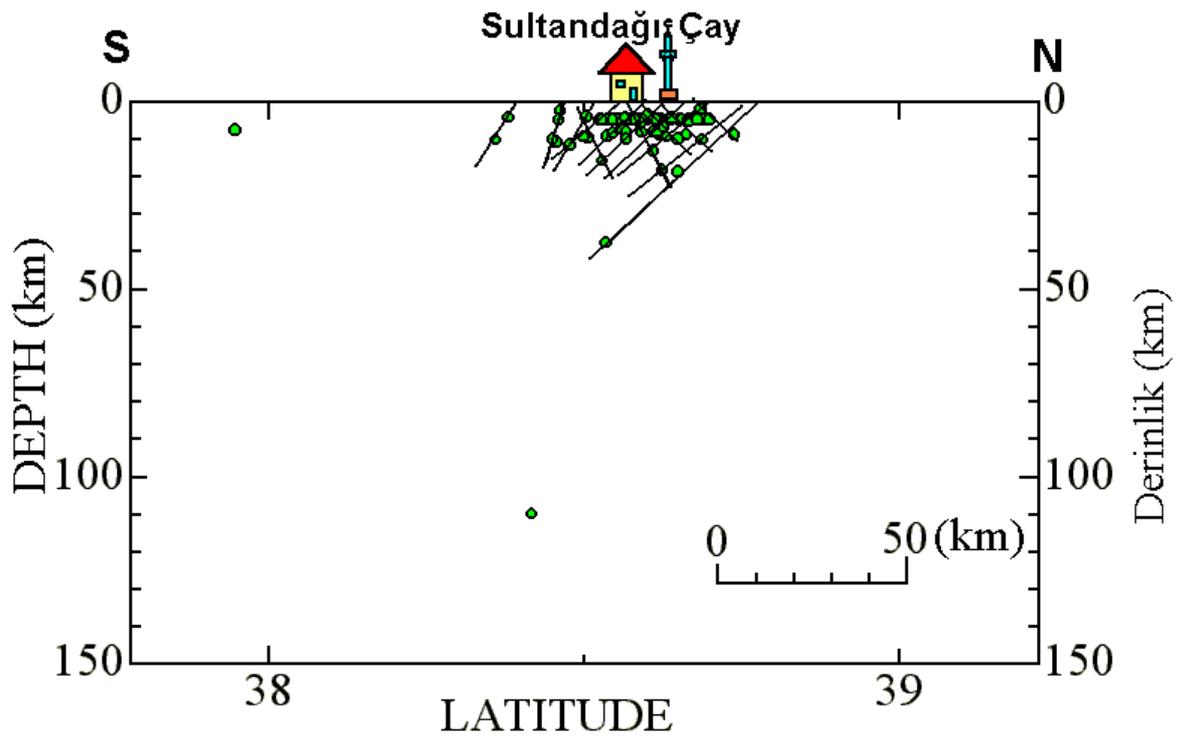
Figure 12 and Figure 13 show the plots of latitude-depth and longitude-depth plot of aftershocks together with the main shock. It seems that the epicenters of the aftershocks are distributed over an area of 38km (NS) by 50km (EW). Except one aftershock having a depth of 110km, the depth of aftershocks is generally less than 20km and they took place beneath Sultandağı and Çay. Figure 12 shows also inferred fault breaks on the basis of the distribution of the hypocenters of aftershocks. The inferred inclinations are generally less than 45° for faults dipping south while those dipping to north are much steeper.

Figure 12 Plot of hypocenters of aftershocks on the space of latitude and depth

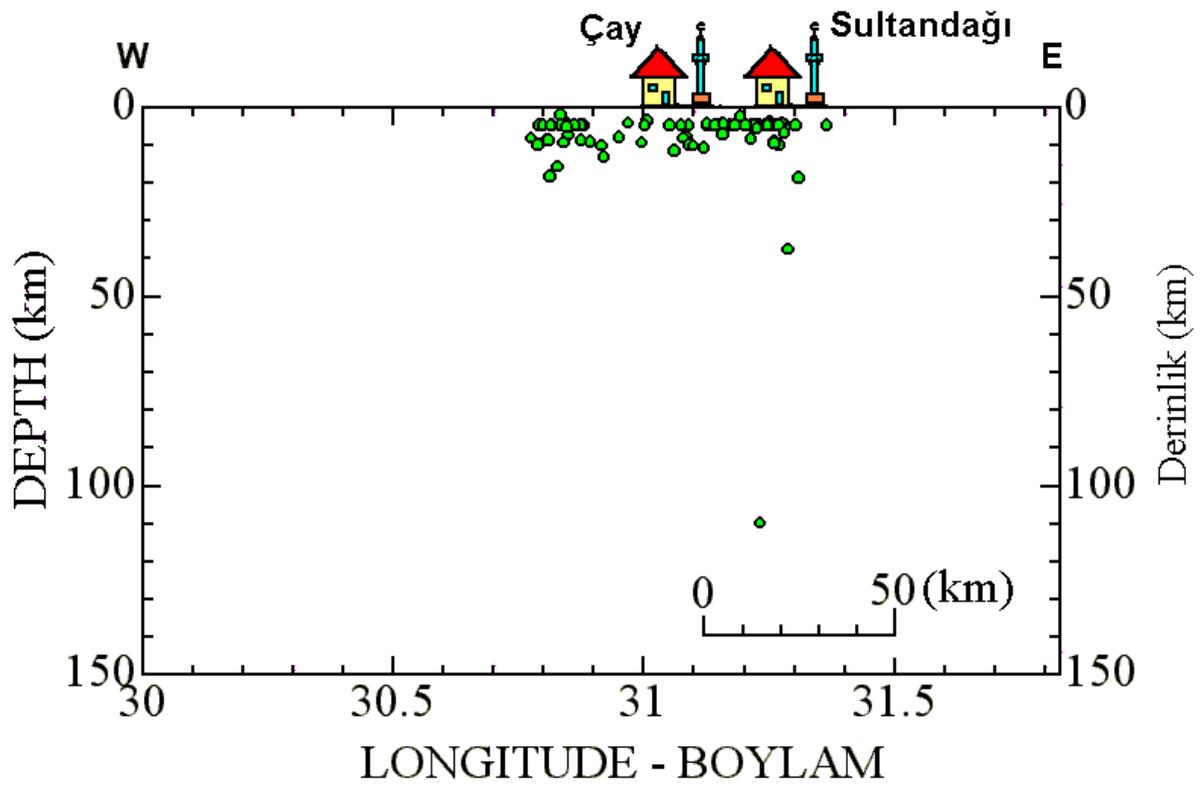
Figure 13 Plot of hypocenters of aftershocks on the space of longitude and depth

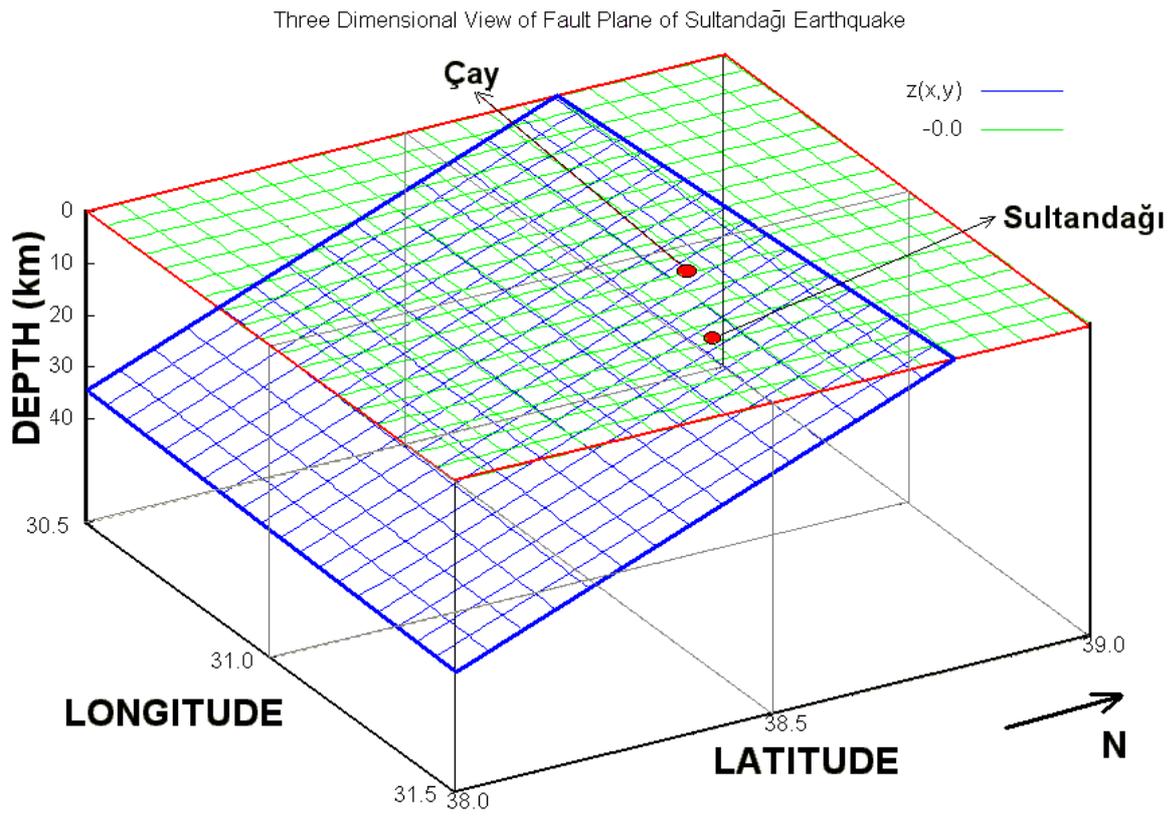
Using the least square technique, parameters  $a$ ,  $b$ ,  $c$  of the above equation was found to be 1737, 2.067 and  $-46.46$ , respectively by taking into account aftershock data within a region bounded by 30.6-31.4 N and 31.1-31.9E. The three dimensional view of the fault plane is shown in Figure 14. The results indicate that the fault plane should dip towards south with an inclination of 18° and its surface trace should appear at the north of Çay and Sultandağı and along the northern shore of Eber Lake and its strike is almost EW (dip direction is about 177°). It is of great interest that this prediction almost coincides with the focal plane solution obtained by the Swiss Seismological Institute. There are some reports that fault breaks occurred at Kırca, Dörtköy, Yakasenek and Gedil villages and also in Maltepe. Since the author does not have a detailed map of the area, he is unable to verify whether the expected ground surface breaks correspond to the reported fault breaks. However, the author believes that the northern segment of Karadilli faults (see Figure 11 for location) has been activated in this earthquake. The sinistral sense of deformation at the northern shore of Eber Lake confirm the reasoning of the author.

Figure 14 A three dimensional view of the inferred causative fault plane

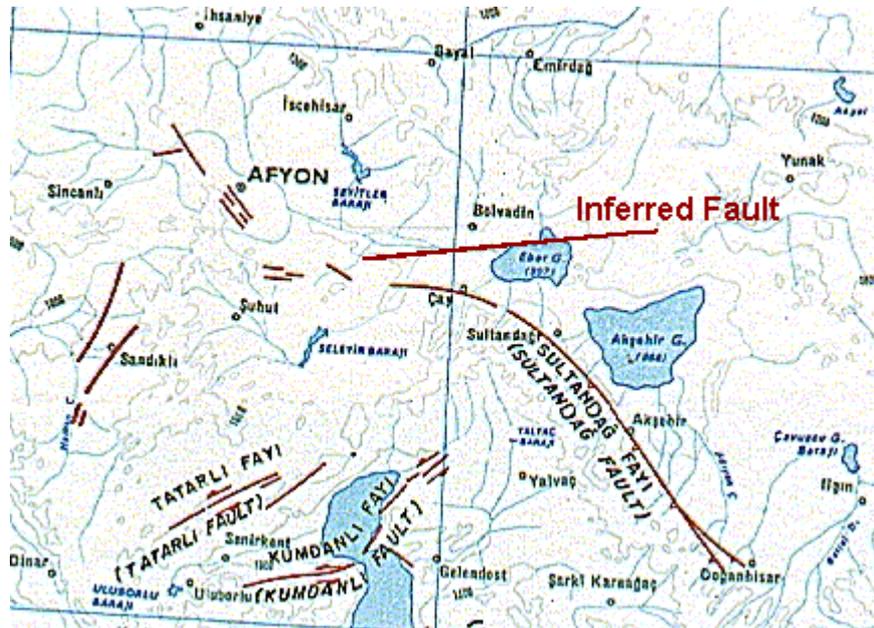
Figure 15 compares the inferred fault trace together with the known active faults. Figure 16 re-shows the LANDSAT view of the area together with the inferred fault break. In the satellite picture, a lineament appears the north of Çay and Sultandağı and runs along the northern shore of Eber Lake as shown in Figure 3 and Figure 16. This may be the possible surface projection of the inferred fault plane. Figure 17 shows a model test by Cloos (1953) on a clay layer undergoing stretching deformation, which may be relevant to the mechanism of the Sultandağı earthquake of February 3, 2002.

Figure 15 Comparison of newly inferred fault plane together with known active faults

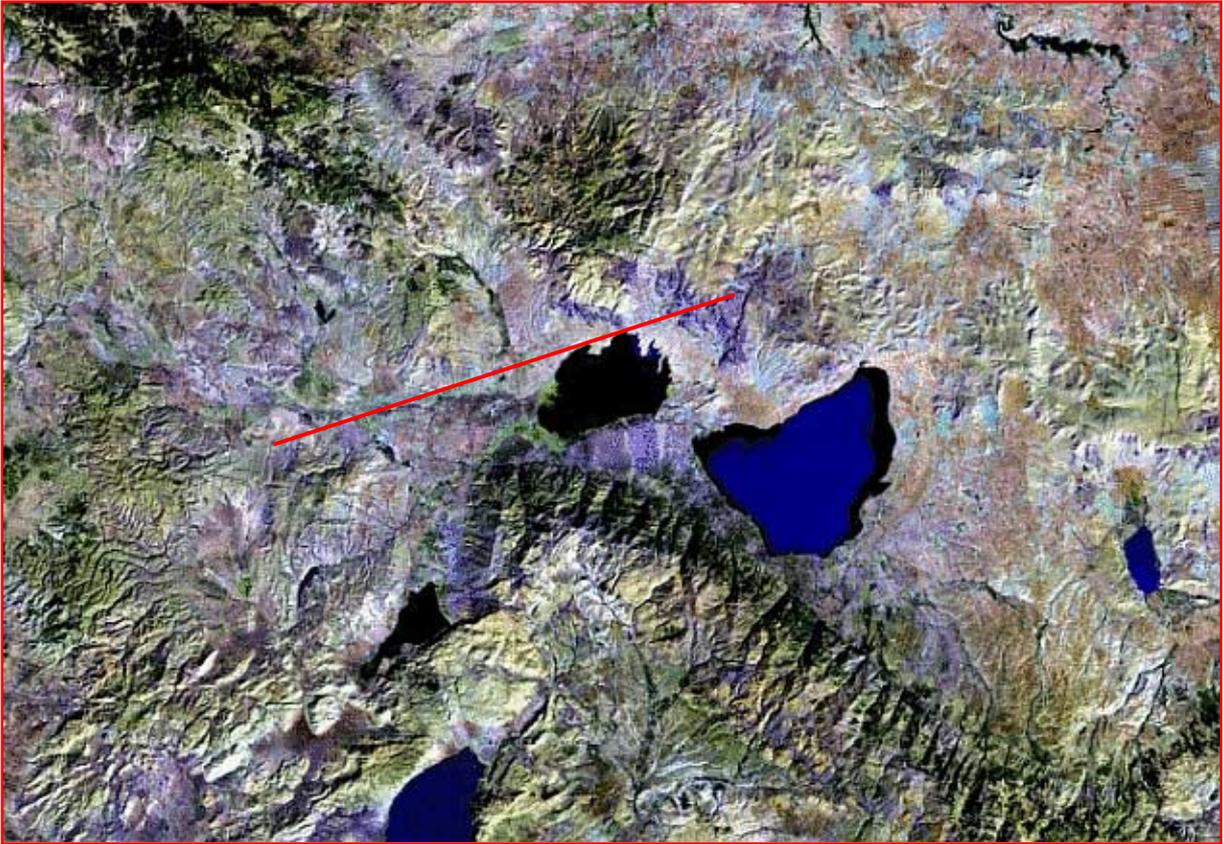
Figure 16 A LANDSAT view of the earthquake area and projection of the inferred fault trace
