THE 1999 QUINDIO EARTHQUAKE, COLOMBIA

- Investigation into Damage to Civil Engineering Structures -

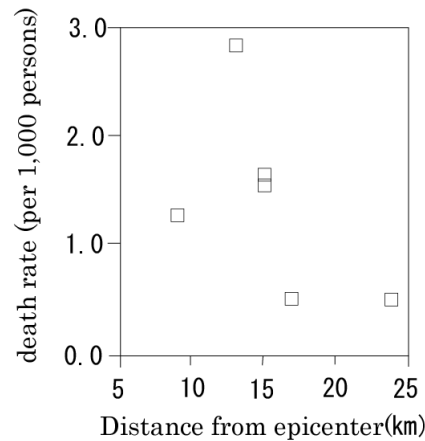
Fig.2.Relation between death rate (per 1,000 persons) and the distance from the epicenter

Table 2 lists the damage statistics for human lives and structures in the affected provinces. Table 3 summarizes the damage statistics in major cities. Fig.2 shows the relation between death rate per 1,000 persons and the distance from the epicenter. Armenia City with the severest damage has the highest value of 2.8 persons per 1,000 persons. This value is much less than the values for Higashi Nada, Nada, and Nagata wards in the 1995 Hyogoken-Nambu (Kobe) Earthquake (more than 5.0 persons per 1,000 persons), but is almost equal to that of Hyogo ward (3.0 persons per 1,000 persons). The overall scenario indicated that the further the city is from the epicenter of earthquake, the smaller the death rate is.

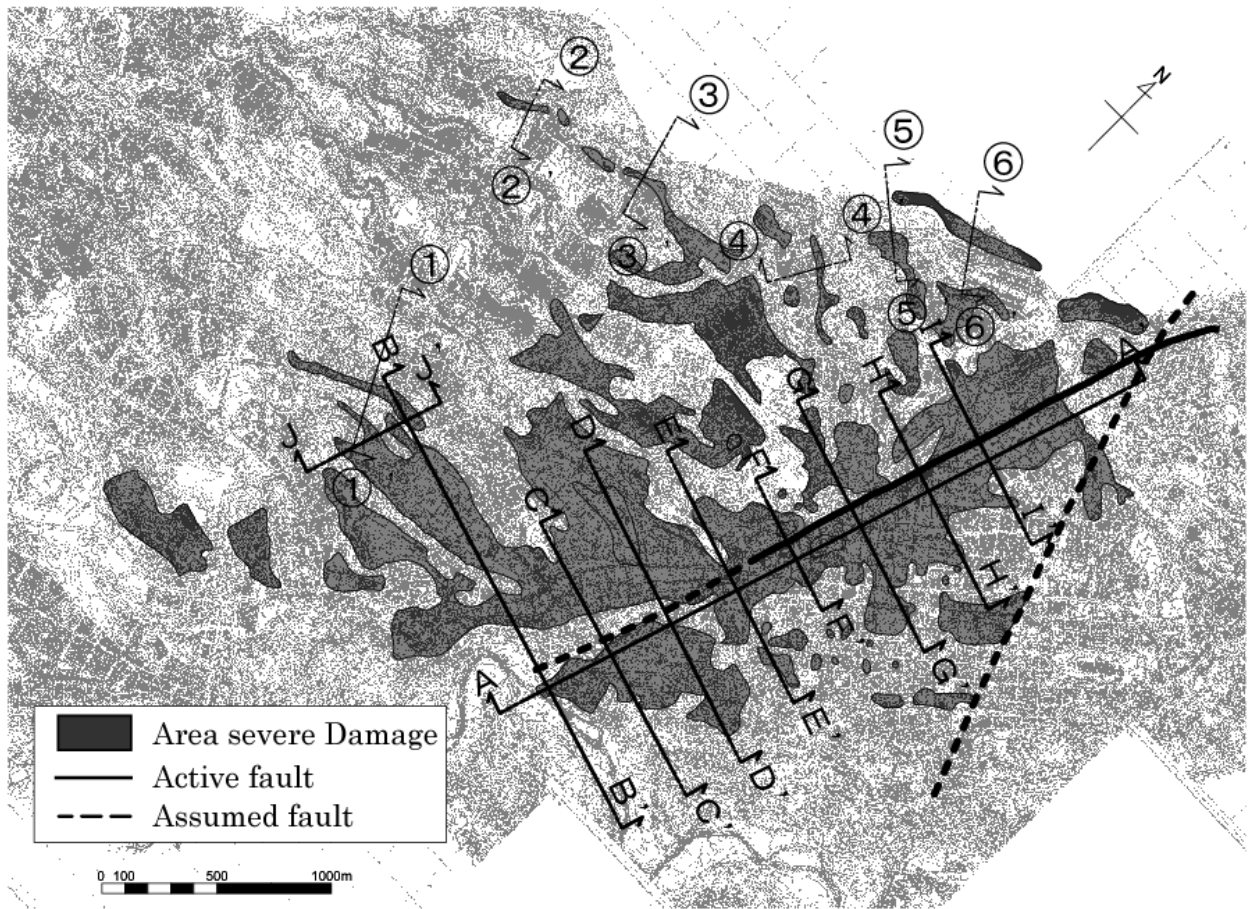
Fig.6. Area of severe damage and fault locations

To analyze the damage in the worst affected areas, the effects of topography (①~⑥) and foundation soils (A to J) were investigated. Lines of cross-sections considered are shown in Fig.6 In areas where severe damage occurred slope failure and tension cracks etc. were observed due to topography of slopes (see photo 2). In Fig.7, cross-sections at slope failure locations are shown. These locations were affected severely by the topographical conditions. Fig.8 shows relation between width of damage area and height of cliff. Damage area is defined as the places where severe damage to houses and buildings was caused in this paper. According to distribution map of damage level presented by INGEOMINAS [1999b], all areas of the Armenia City are classified into severe and moderate damage levels. The severe damage level area is adopted here as the maximum damage area. Therefore, there was no big difference in the damage level in the area. It was possible to observe that an upper boundary of L is 1.0 to $1.5H$, where L and H are width of maximum damage area and height of cliff respectively. In locations like cross-section ⑤ where it is surrounded by a valley, the damage was observed to be $L > 1.5H$. Fig.9 indicates relation between slope and L/H . L/H increases in an increase of slope and the upper boundary of L/H is 1.5 . There is almost no study that investigates width of damage area during earthquake with respect to the height and/or angle of cliff. Hirai et al. investigated the damage to building foundation in relation to an angle, height (H) and distance from the edge of cliff (D) in the 1995 Kobe Earthquake. They clarified that the number of damaged buildings increased when the slope exceeded 30% and no building damage occurred in the areas of $D > 1.5H$ (Hirai et al. 1996). These show good agreement with our observation in Colombia. Since the soil type is, however, different in each site, further study is needed.
