Chapter 1

Purpose, Members and Itinerary of the Reconnaissance

The purpose of the reconnaissance was to investigate damage to civil engineering structures caused by the earthquake shaking as well as by tsunami, for the progress of disaster mitigation and earthquake as well as tsunami resistant design and construction.

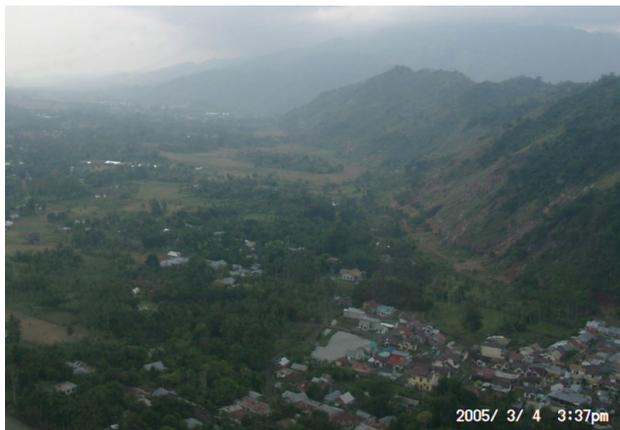
Figure 3.5 shows a view of Sumatran Fault in the western side of Banda Aceh city. The hills are made of heavily folded limestone and shale. The strike of folds has the trend of NW-SE. Figure 3.6 shows a view of bedding plane in limestone nearby Lhonga port, on which striations for two different episodes of relative motion are identified. The earlier event has a sense of dextral slip with a thrust component while the most recent one has a sense of dextral slip with a normal component, implying the trans-tensional deformation of Banda Aceh basin.

Figure 3.5 A view of Sumatran fault nearby Banda Aceh city(from NW to SE)

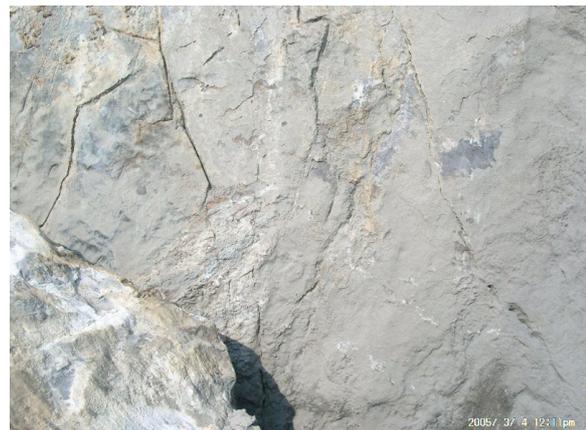
Figure 3.6 Striations on bedding plane in Lhonga
(Old and new striations associated with the motion of Sumatra fault)

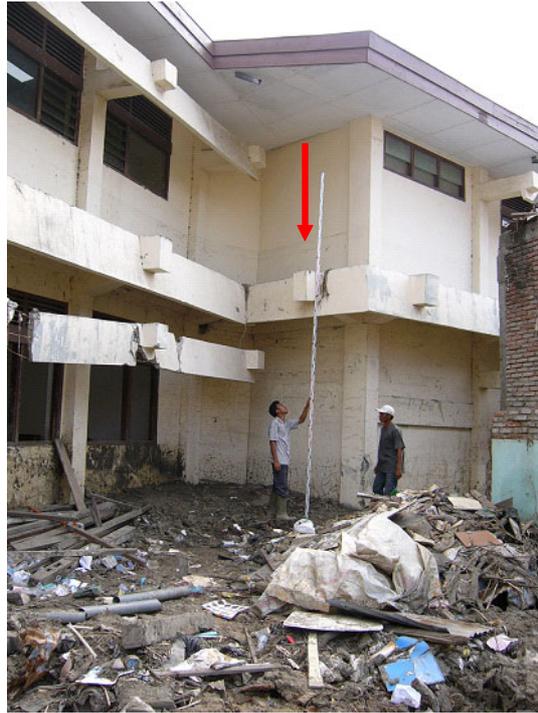
Photo 5.3 shows the water mark on the north side wall of the first high school as an example of the tsunami traces. The numbers with * indicate the height of the watermarks just under the ceiling of the first floor of house. It seems that the watermarks with * were left while the seawater retreated, because the hole made is likely to be by collision of a drifting body remained on the side wall of the second floor (Photo 5.4).

Photo 5.3 Watermark on the first high school in Banda Aceh

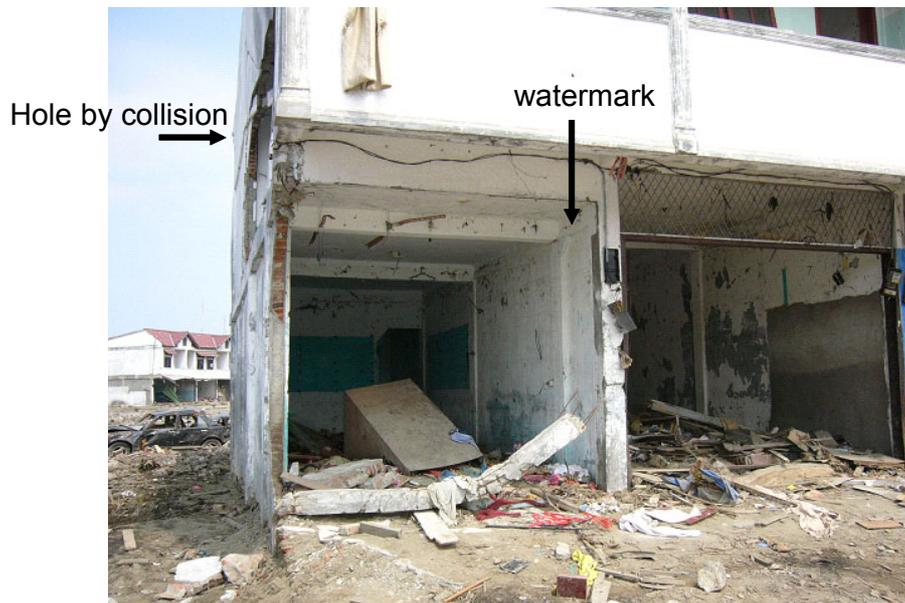
Photo 5.4 A hole by collision of an obstacle and watermark

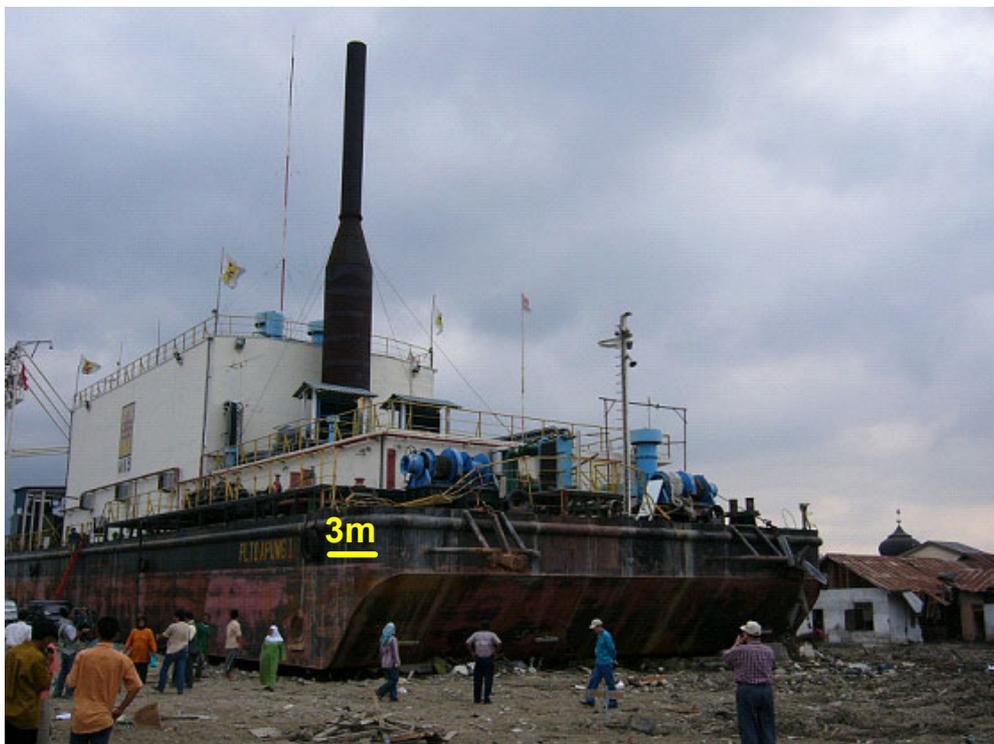
The tsunami swept away large bodies like a power plant barge and oil tanks. The power plant which generated 7,500 KW (Photo 5.5) was moored in a new ferry port of Banda Aceh, and was washed away by the tsunami action. Finally it reached the inland town 3km away from its original site. The watermark left in the inland town was 3m above the ground. The barge can easily drift if the water depth is greater than 3m.

Photo 5.5 Power plant barge (1,700 weight ton) removed in to inland area

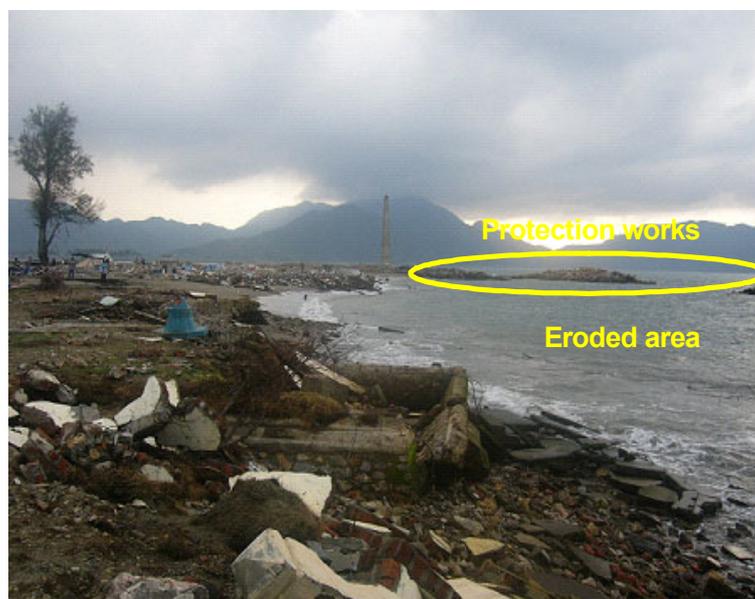
The tsunami eroded severely the north coast of Banda Aceh (Photo 5.2). Although there were protection measures by stones in this area before the tsunami, the protection works were completely destroyed and the reclaimed areas behind the protection works were eroded more than 1.5m in height (Photo 5.6), and then the topography was changed. The topographic change is also seen in the Thailand where a sandbar was eroded by the tsunami.

Photo 5.6 Eroded sandbar in the north coast of Banda Aceh

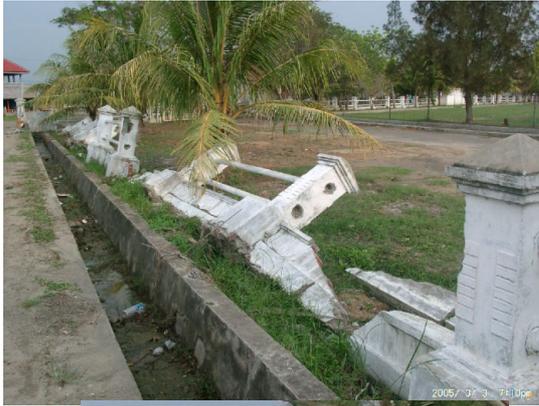
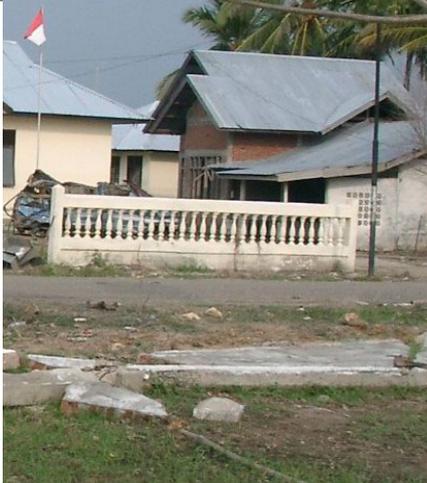
The some of garden walls were toppled during the ground shaking as shown in Photo 6.1. From these observations, the maximum ground acceleration should had been acted almost NS direction, perpendicular to the faulting direction. For NS direction, it should be greater than 200 gals and less than 350gal. As for EW direction, it should be greater than 110 gals and less than 170gal.

Photo 6.1 Earthquake induced wall failure

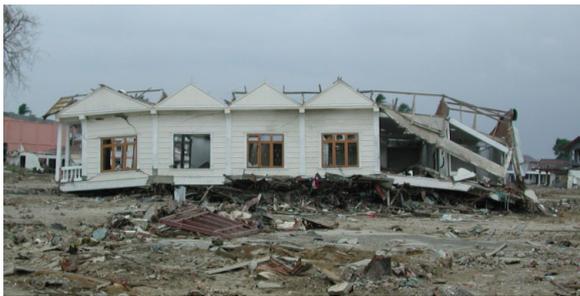
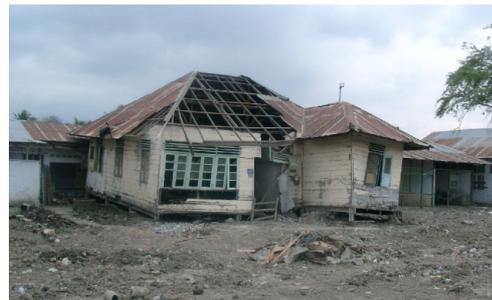
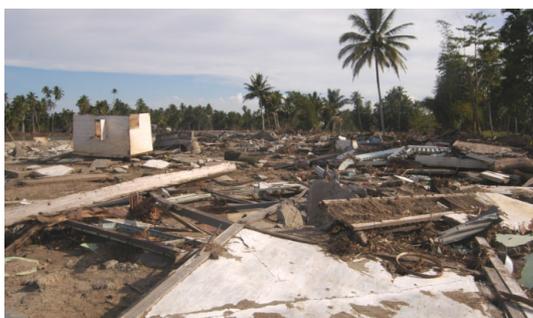
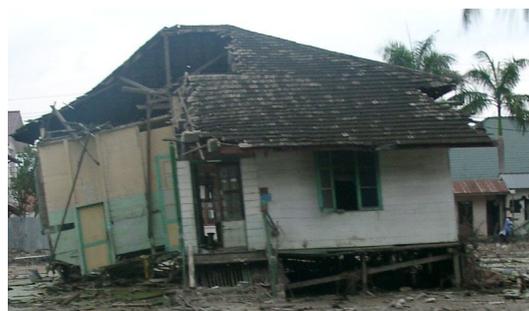
Wooden houses are generally single story or two story buildings. These buildings were almost non-damaged in the regions, which were not affected by the tsunami. Therefore the main cause of the damage was tsunami. The tsunami may impose at least four types of loading, namely, impact force, drag force, hydrostatic water loading and buoyancy (uplift) force on wooden buildings. While impact and drag forces directly related to the velocity of tsunami, the hydrostatic and buoyancy forces depend upon the tsunami height and relative density differences between the building material and tsunami waves. Photo 7.1 shows some examples of damage to wooden houses.

Photo 7.1 Damage to wooden houses

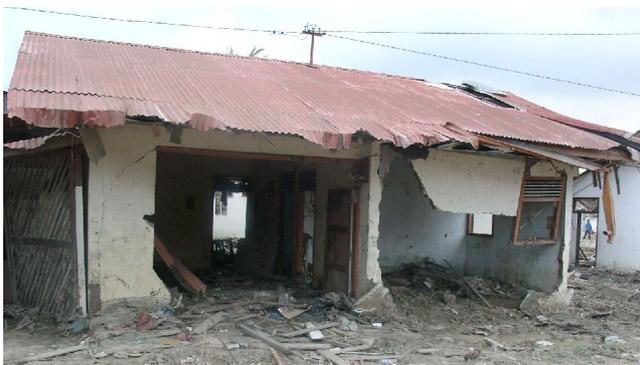
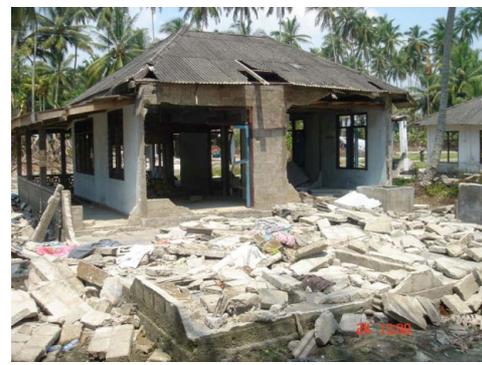
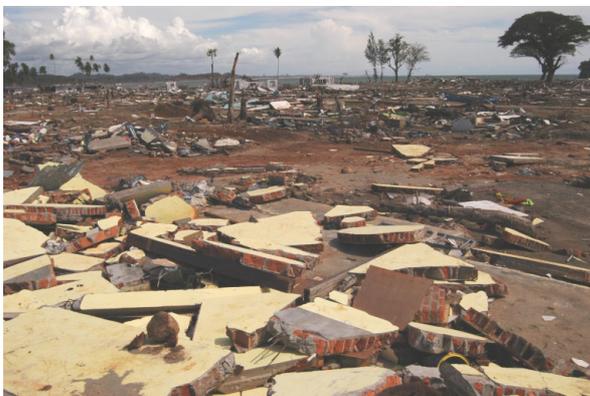
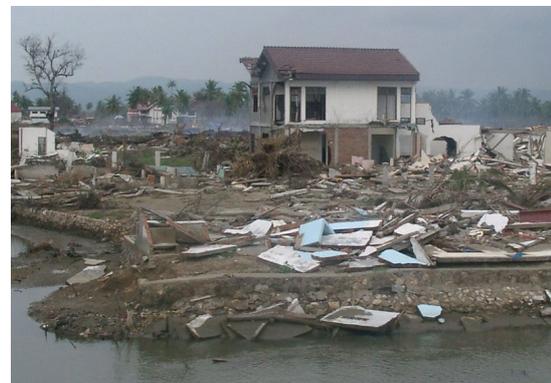
Masonry (brick) houses are generally single story buildings and some of them could be 2 story buildings. Solid red clay bricks or hollow concrete blocks were used for constructing the adobe houses. Although concrete column and slabs are utilized during the construction, they are merely used for achieving structural integrity. These buildings were not damaged in non-tsunami affected area. However, they were completely destroyed when the tsunami waves hit these structures. It seems that the impact force of the tsunami waves were quite high from the state of debris and the fallen tree trunks. The other force components of the tsunami waves could be drag forces and hydrostatic water loads. When the masonry (brick) houses are still standing, their walls were punched out. Photo 7.2 shows some example of damage to masonry (brick) houses.

Photo 7.2 Damage to masonry (brick) buildings

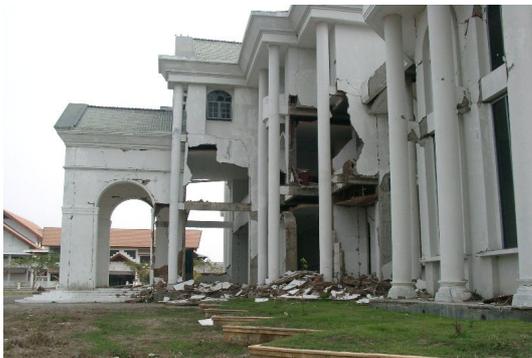
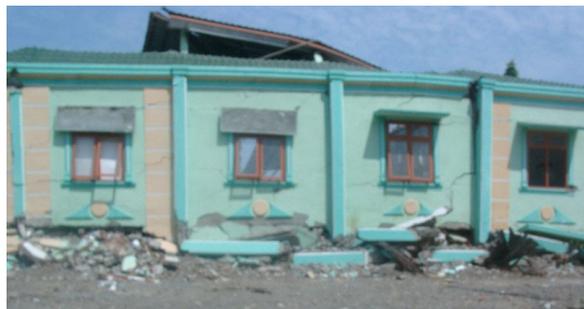
Most of RC buildings have 2 to 3 stories. Nevertheless, new buildings for governmental offices and shopping malls have more than 3 stories. Commonly their story number is 5. The common construction procedure for RC buildings is to construct the walls first and then cast the concrete columns and finally the slab concrete for a typical story and repeat the same procedure for the rest of stories. However, the new buildings are constructed as a frame structure by casting concrete columns and then slab concrete first and finally filling the space with solid brick in-fill walls. The floor height ranges between 3 and 4m. There was no structural damage to RC buildings having stories 3 or less than that in non-tsunami affected area. However, almost all new buildings having heavy weight on upper stories collapsed or heavily damaged in non-tsunami affected area (Photo 7.3). The collapses were mainly due to plastic hinging at column-beam connections due to the lack of required column size and stir-ups, hooking and confinement. Furthermore, the quality of concrete and workmanship were quite poor and the diameter of reinforcement bars was insufficient. The in-fill walls were too slender and they were easily separated from the concrete frame and came down by out-of plane failure mode. Besides the structural and constructional problems of RC buildings, the soft ground conditions may also play some roles on the collapses or heavy damage. The collapsed or heavily damaged RC buildings were constructed nearby rivers or swampy areas.

Photo 7.3(a) Collapsed or heavily damaged RC buildings

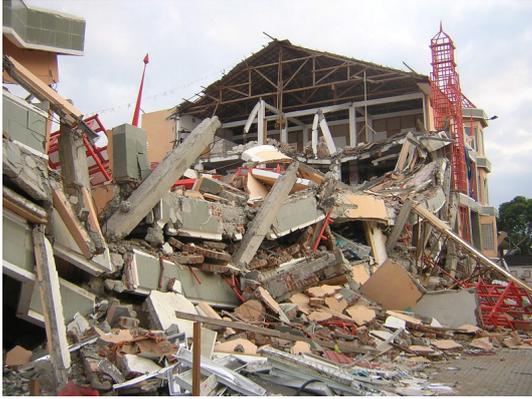
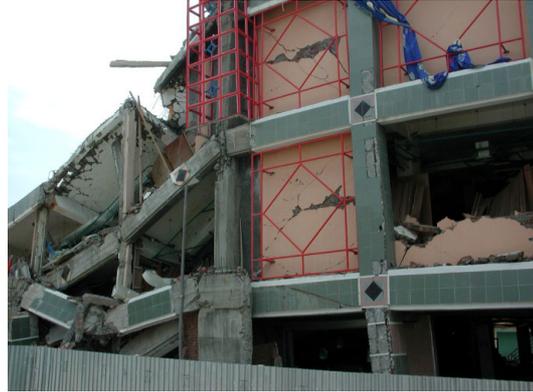
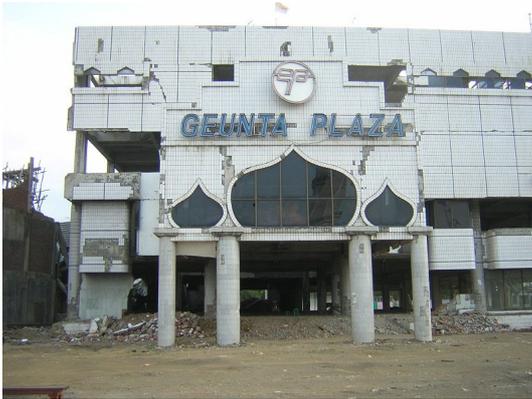
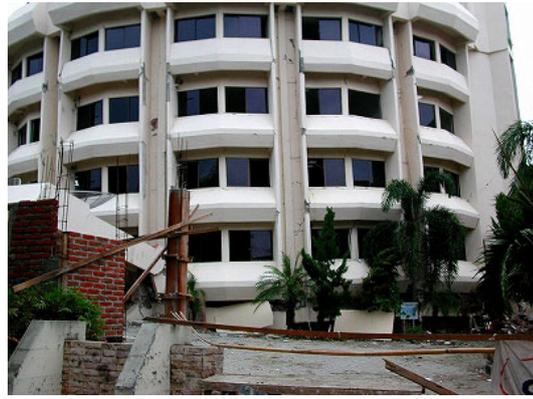
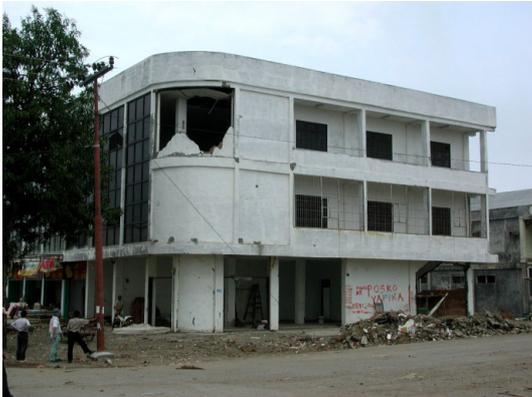
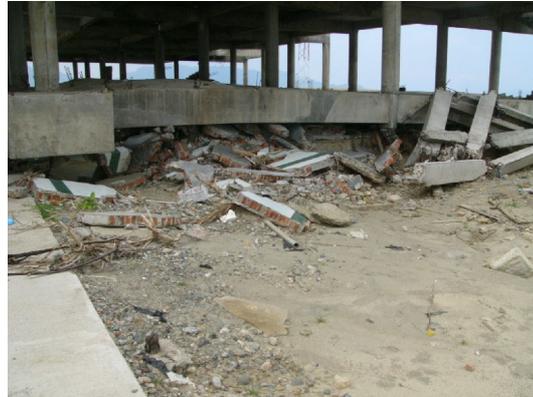
Photo 7.3(b) Collapsed or heavily damaged RC buildings

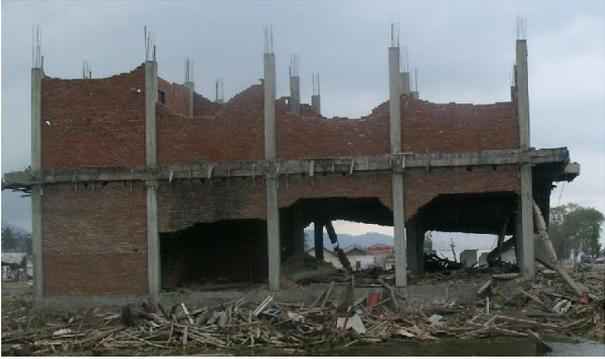
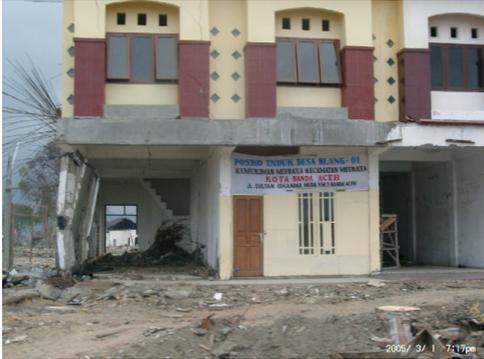
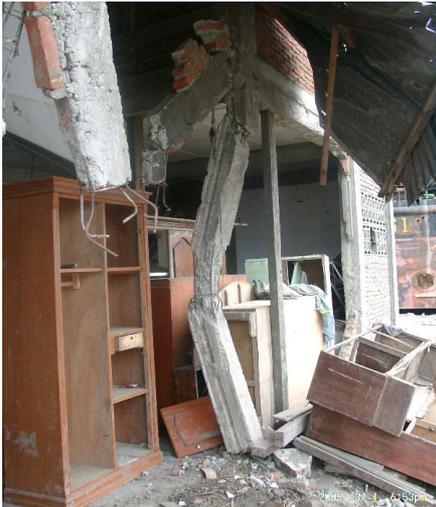
The RC structures in tsunami-affected areas have stories ranging between 2 and 3. Some of columns were broken and in-fill walls were punched out by the impact forces of tsunami waves and tsunami-dragged objects (Photo 7.4). Nevertheless, some of them survived against the ground shaking and also the forces resulting from tsunami waves. The columns were generally ruptured or fractured at their mid-height, which implies that there were subjected to high bending forces. Furthermore, the broken columns and punched-out walls were facing the direction of the in-coming tsunami waves.

Photo 7.4 Damage to RC buildings in tsunami-affected area

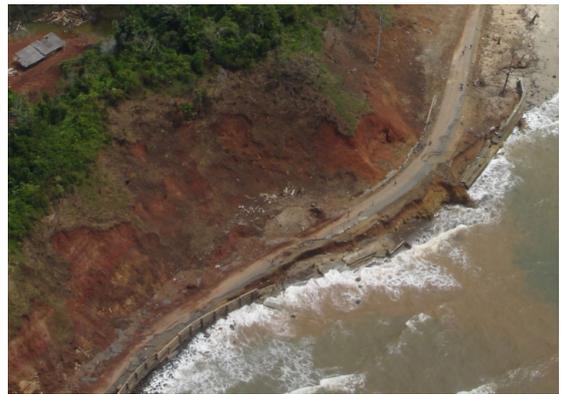
Slope failures were mainly observed in the areas of stone quarries, along roadways and seashores. The seashore between Banda Aceh and Lamno is particularly mountainous and slopes are steeply inclined. Furthermore, the rock layers are folded and are inclined towards the sea. The failure of rock slopes was mainly due to sliding on bedding planes of hard sedimentary rocks and the slopes facing the causative fault plane (Photo 8.1). It is therefore thought that the ground shaking was the main cause of rock slope failures. The weathered material on the rock slopes along the seashore was stripped away for a height of 10-20m by the tsunami waves as seen in Photo 8.2. Rock falls were observed in stone quarries in Lhonga area nearby the cement factory.

Photo 8.1 Rock slope failures and erosion by tsunami

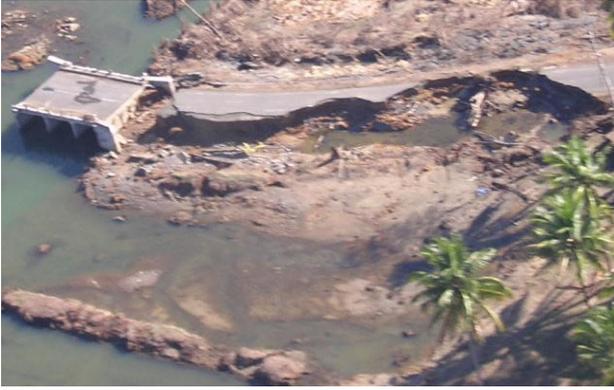
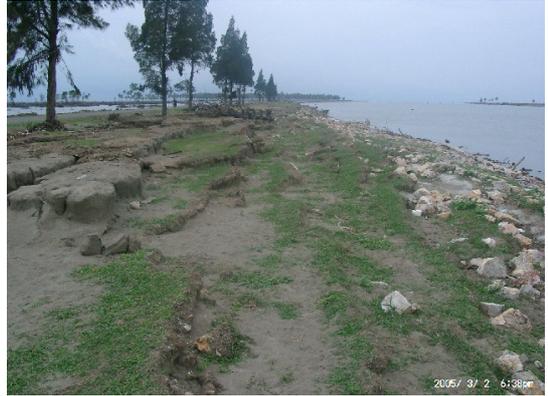
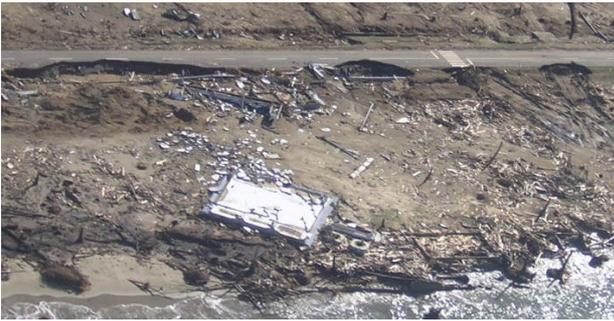
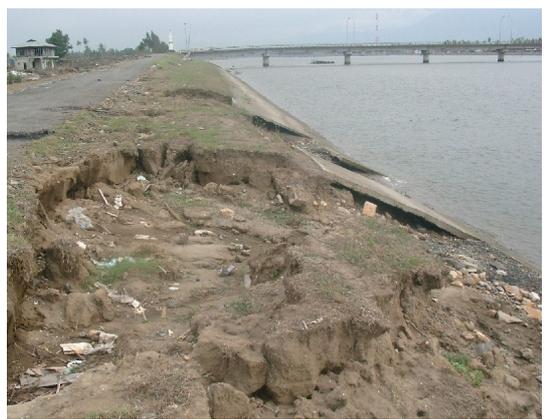
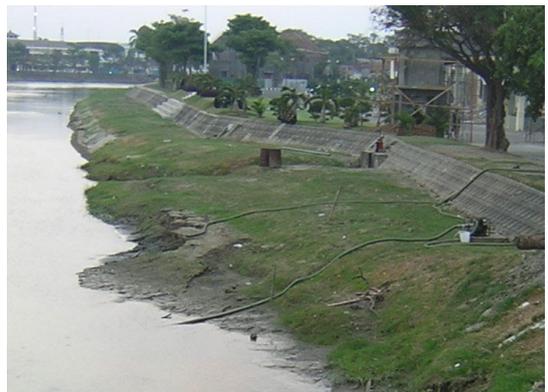
Embankment failures were observed along seashores, rivers and canals and roadways. Some of failures were in the form of typical circular sliding, erosion and liquefaction associated lateral spreading. Photo 8.3 shows some examples of embankment failures.

Photo 8.3 Embankment failures

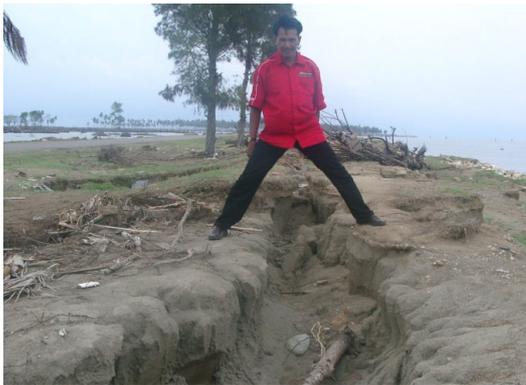
Ground along the western coast of Sumatra Island is mostly sandy soil. Liquefaction can be induced by ground shaking as well as by tsunami. The effects of liquefaction would be ground settlement, lateral spreading and erosion by retreating tsunami waves. The coastal area seems to be settled down and or topsoil is eroded. Photo 8.4 shows some examples of failures induced by liquefaction.

Photo 8.4 Effects of ground liquefaction and erosion

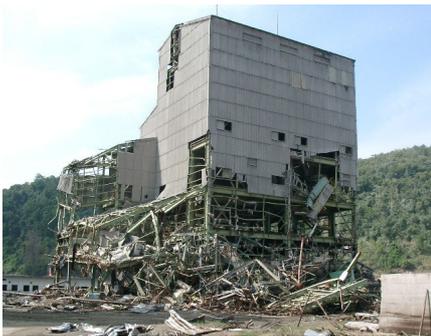
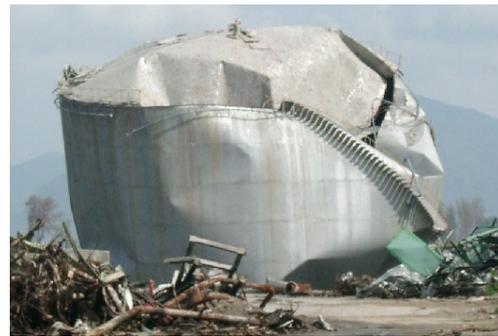
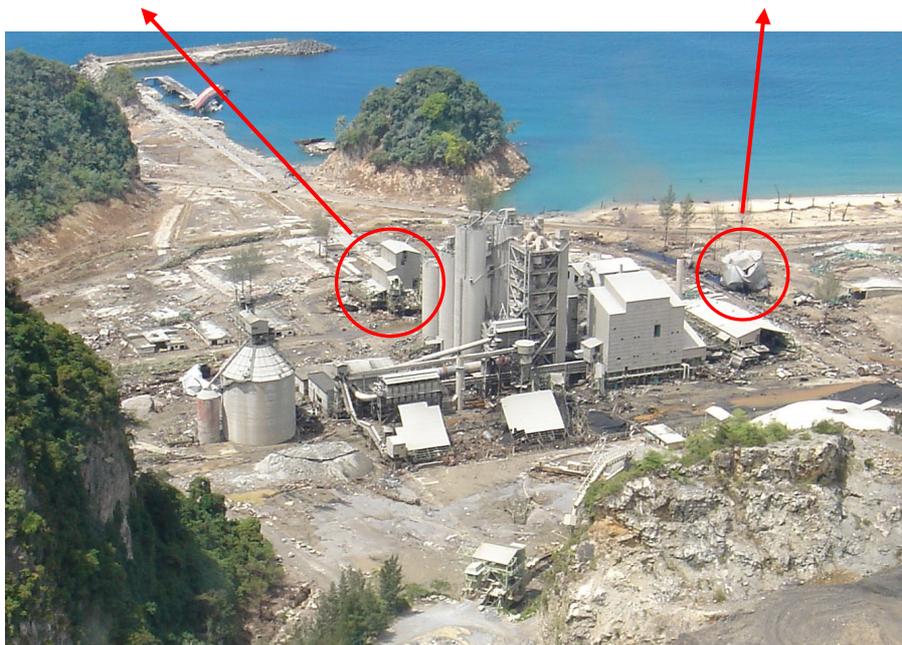
Aceh Province is one of the major oil and natural gas producing region in Indonesia. These facilities are on the east coast of province. None of these facilities were damaged either by ground shaking or induced tsunami. However, the cement plant at Lhonga was heavily damaged by tsunami waves. A French company originally built the plant and the subsidiary in Indonesian now operates it. The steel structure, kiln and fuel storage tanks were heavily damaged by tsunami while RC silos remained intact (Photo 9.1). It seems that tsunami waves reached a height of 15-20m in some sections and the steel beams and columns were either bended or buckled by the impact of tsunami waves and dragged objects. There were three cylindrical fuel tanks in the plant. Two of them were completely destroyed while the other one was buckled. All of them were offset from its original location.

Photo 9.1 An aerial view of the cement plant

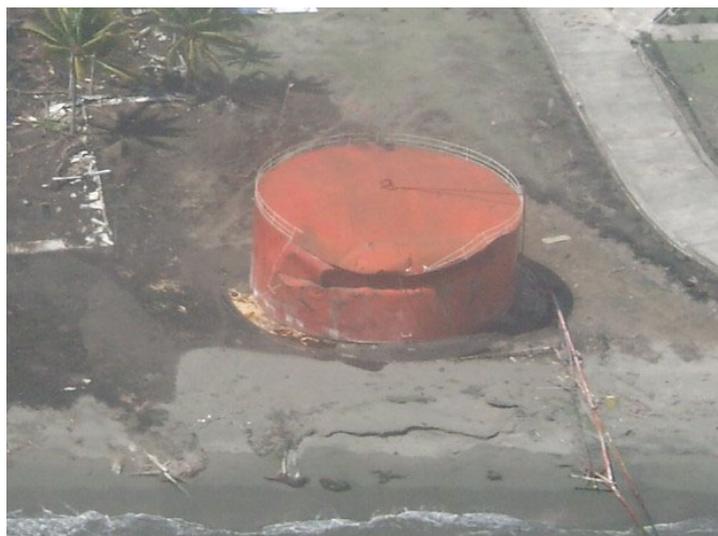
Storage tanks from an oil tank farm in the eastern part of Banda Aceh city (Krueng Raya, about 22km east of Banda Aceh) were displaced by the tsunami waves for a considerable distance from their original position as seen in Figure 9.2. The tanks were not fixed to the ground and some damage to piping did occur. Figure 9.3 shows a buckled tank along the seashore in Meulaboh. The tank was hit by tsunami waves and that side of the tank was buckled. Furthermore, some settlement of the tank occurred probably due to the liquefaction of foundation ground.

Photo 9.3 Buckled and settled tank at Meulaboh

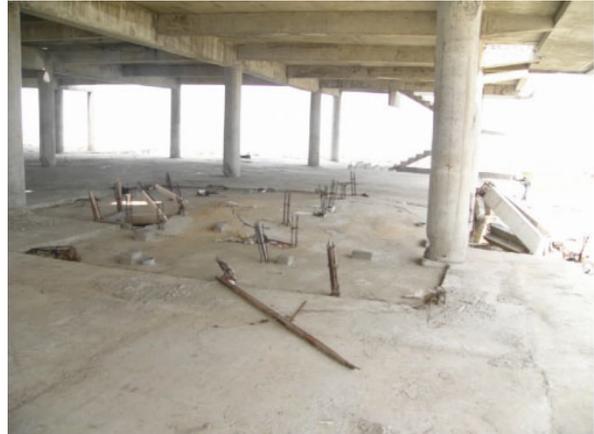
The RC building of the port facility collapsed at the ground floor as seen in Photo 10.4. However, the main cause of collapse was ground shaking rather than the tsunami waves because of the second floor with slightly damaged columns was survived during the tsunami waves (Photo 10.5). The ferry terminal building, which is a RC pile-deck structure without shear walls, collapsed at ground floor and the ground floor columns acted as a base isolation system. The second and top floors survived the earthquake and the tsunami.

Photo 10.5 Ferry terminal (2nd Floor)

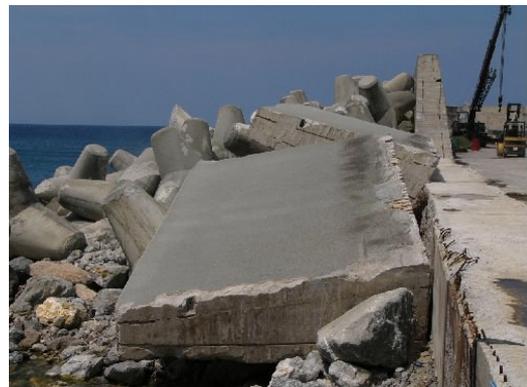
The port facility for the cement factory was also damaged by the tsunami. The 5m high gravity type parapet with a trapezoidal cross section was overturned as shown in Photo 10.6. Totally, three blocks were overturned, two blocks of the parapet were overturned outside direction of the port and other one was overturned opposite direction. To investigate the overturned scenario, detail consideration of the layout of the parapet and tsunami wave action should be needed.

Photo 10.6 Damaged seawall at cement factory

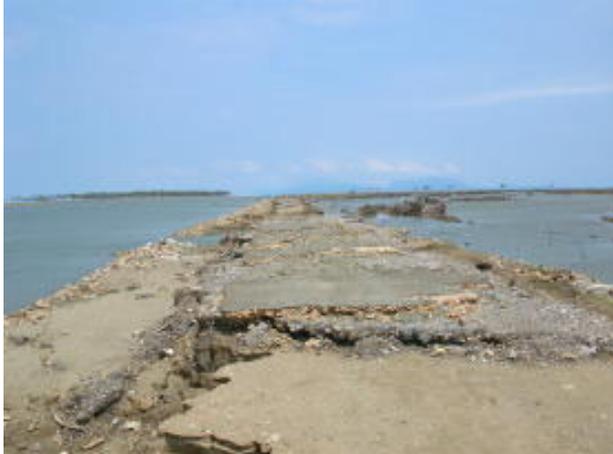
Photo 11.18 Washout of Pavement and Soils

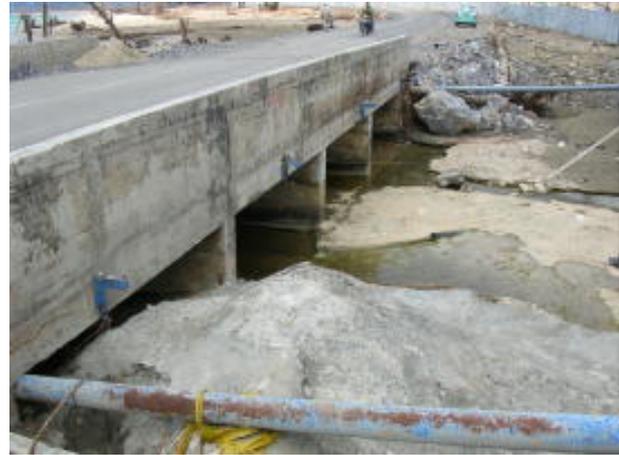
Photo 11.22 and 11.23 show the behavior of the reinforced concrete box culvert bridge. The bridge is located in the cement factory, which was significantly damaged by the tsunami. Some damage was found at the sidewall but there was almost no damage on the main body of the bridge.

Photo 11.23 Concrete Box Culvert Bridge

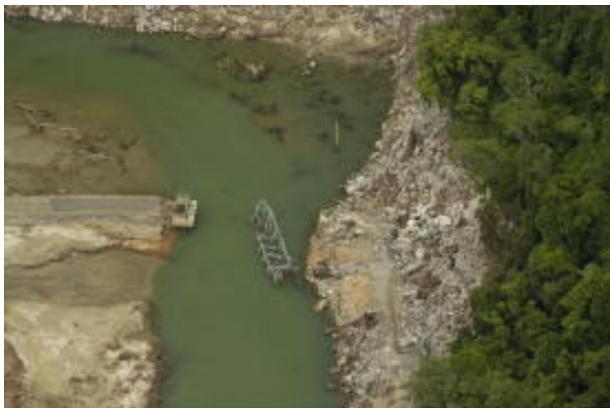
Photo 11.26 Washout of Truss Bridge (3)
(courtesy of Aceh Provincial Government)

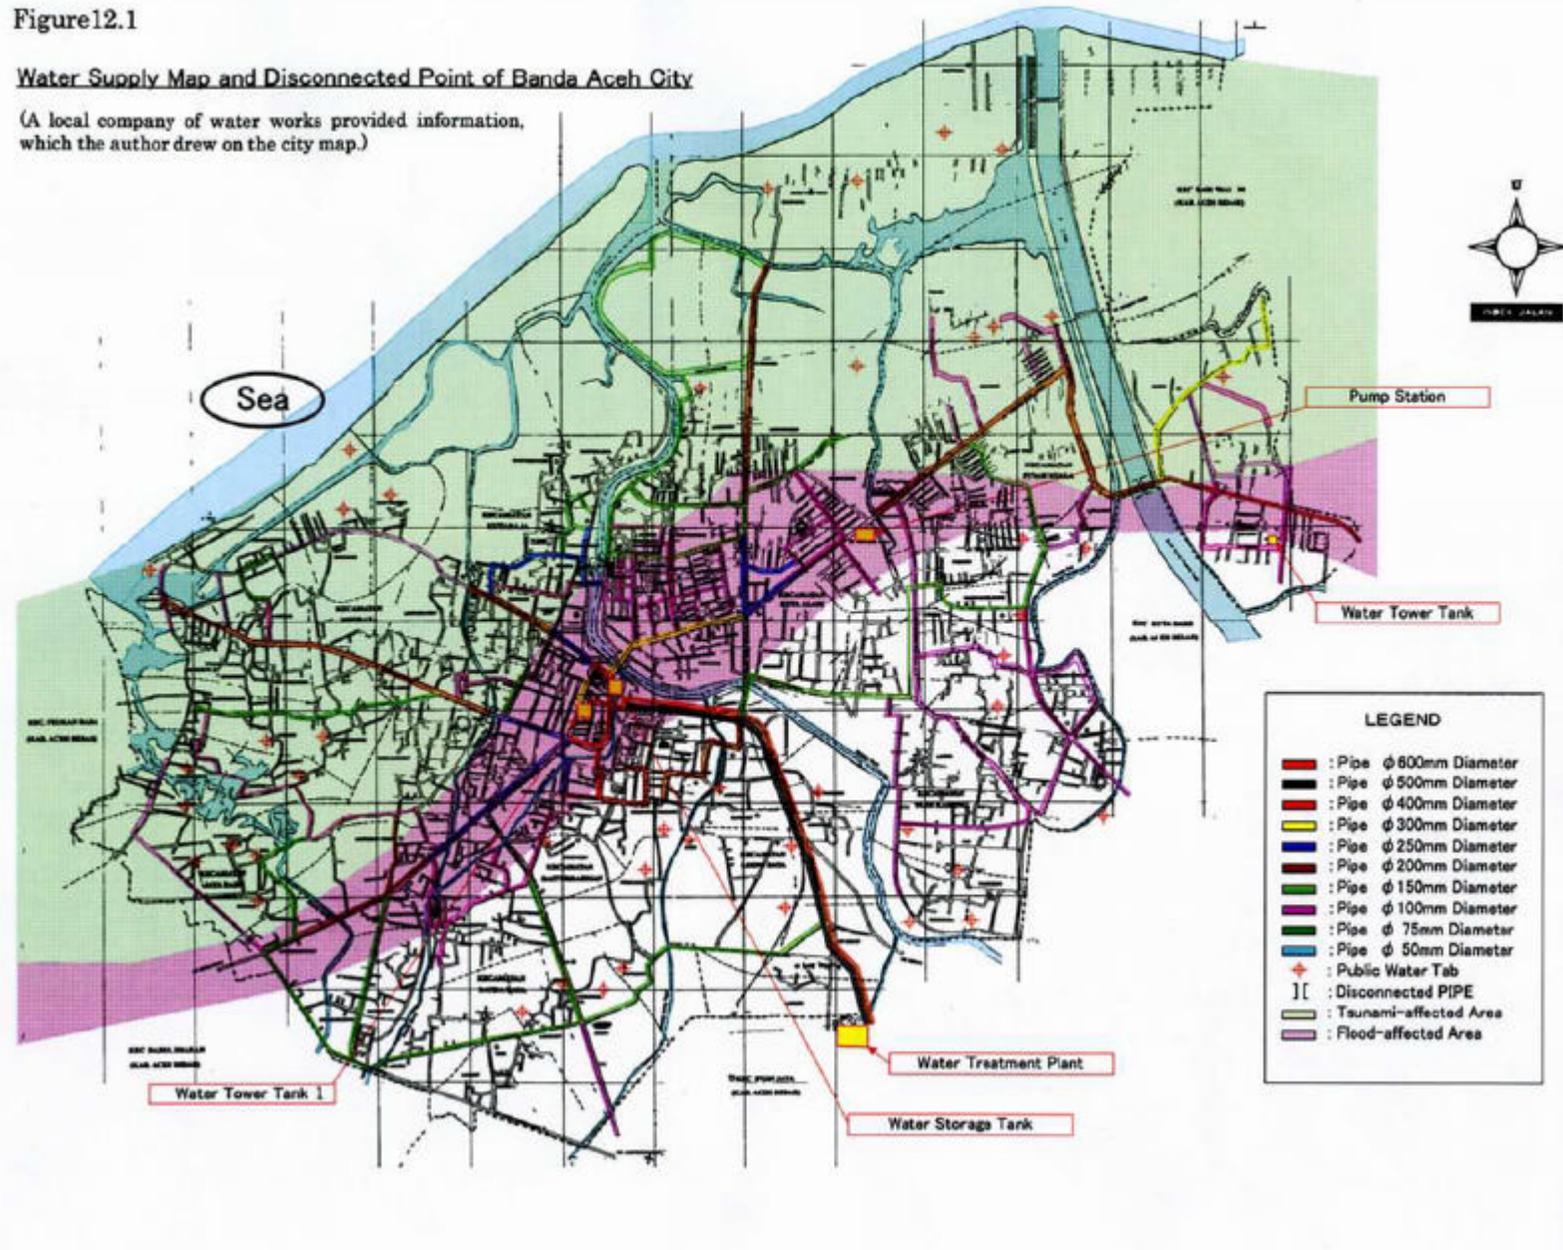
Figure12.1

The general plan of water distribution facilities for Banda Aceh city is shown in Figure 12.1. Major break places of the distribution network by the tsunami disaster are shown in the figure. Also in the figure, the tsunami-affected area and its run-up area are distinguished by different colors.

Water Supply Map and Disconnected Point of Banda Aceh City

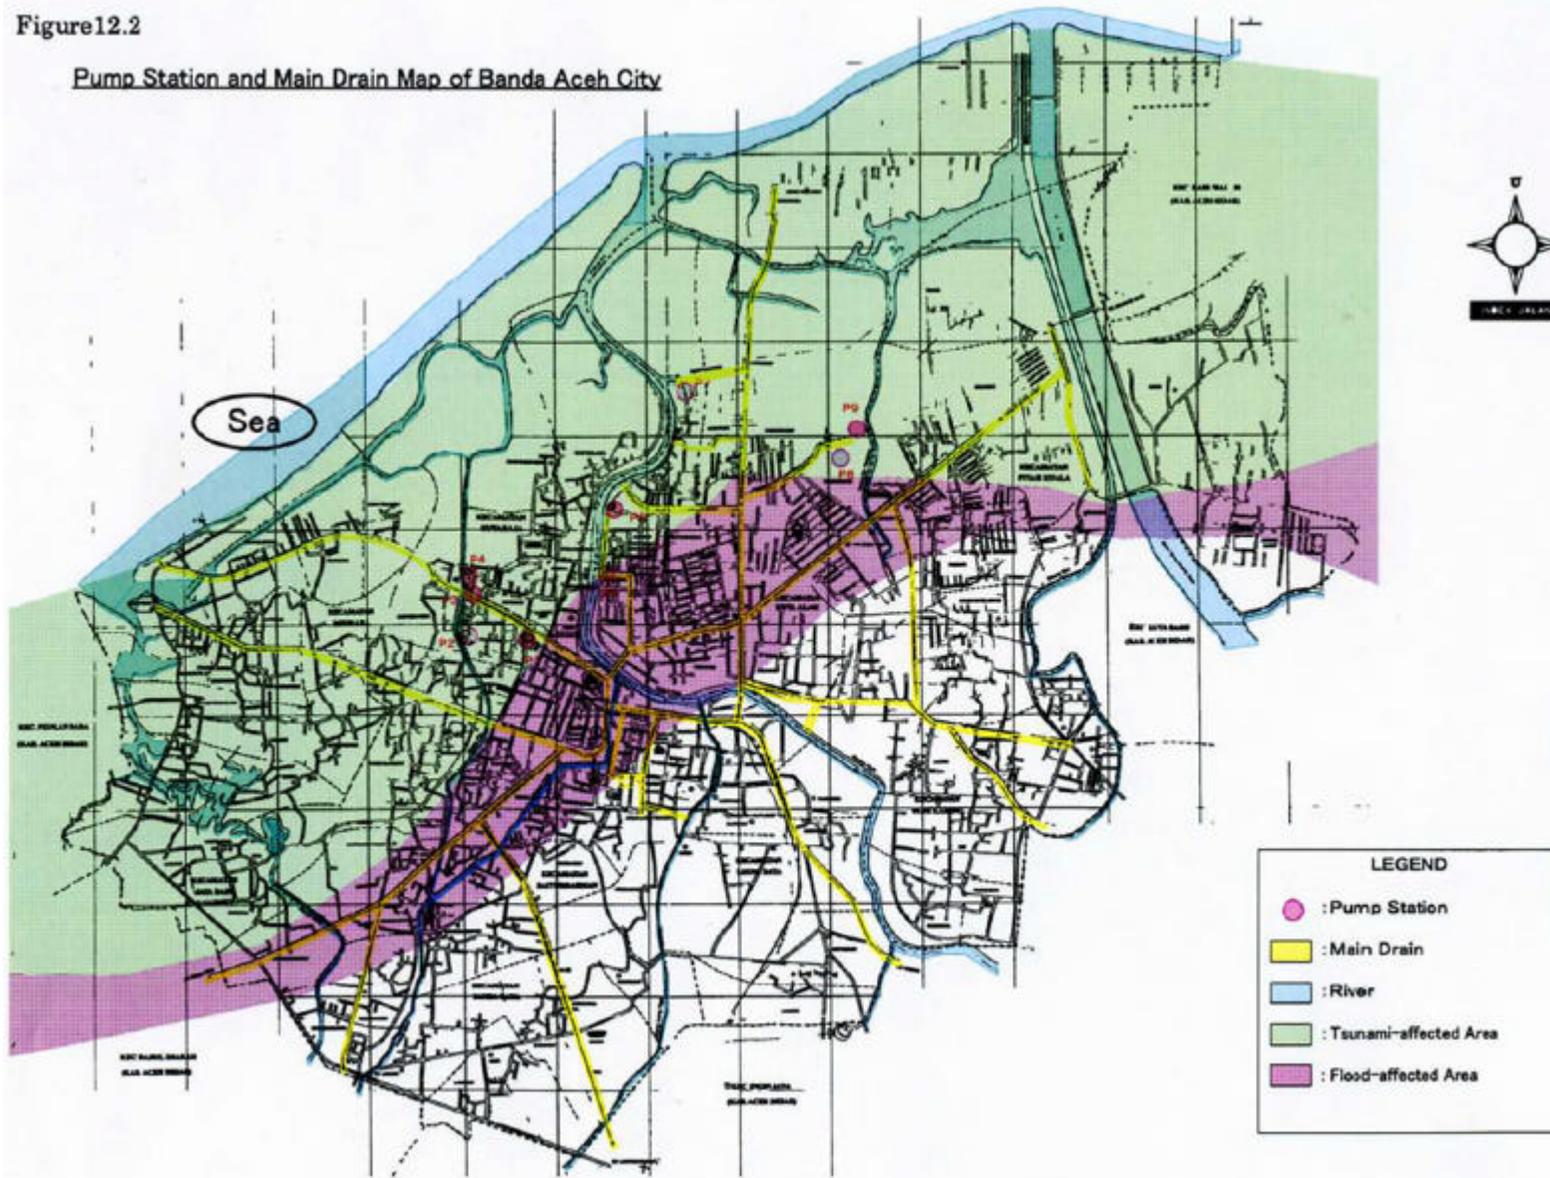
Figure12.2

Figure 12.2 shows the location of drainage pump stations and main drains in Banda Aceh City. The area, where the pump stations are located, is a low-lying urban area. The tsunami affected zone are back shaded in the same figure. All the pump stations from P2 to P9 except P1 were washed away by the tsunami and the drainage system is almost out of order. The drain ditch in the low-lying area has been clogged by debris, mud and sand carried by the tsunami, as shown in Photo 12.6. The backhoe during the cleaning work of debris is seen behind. The stocked water supply pipe has been scattered in mud at a water supply pump station as shown in Photo 12.7.

Pump Station and Main Drain Map of Banda Aceh City

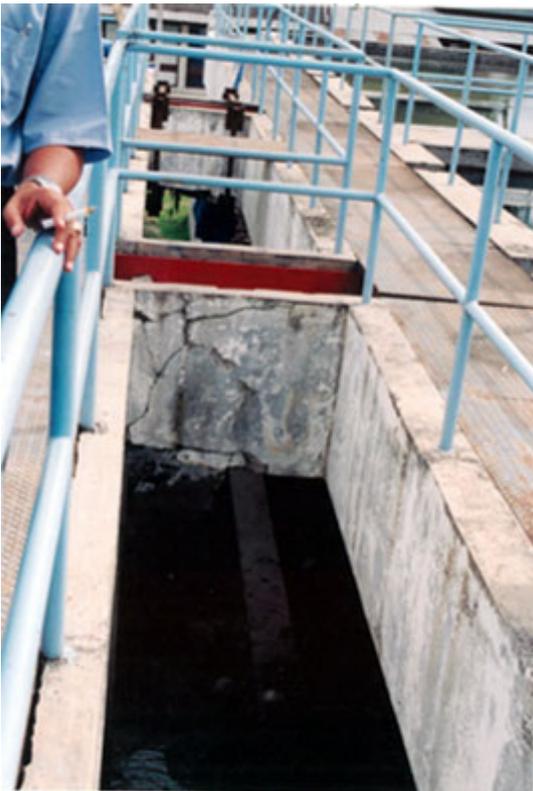
Photo 12.2 Emergency measure
at the treatment plant

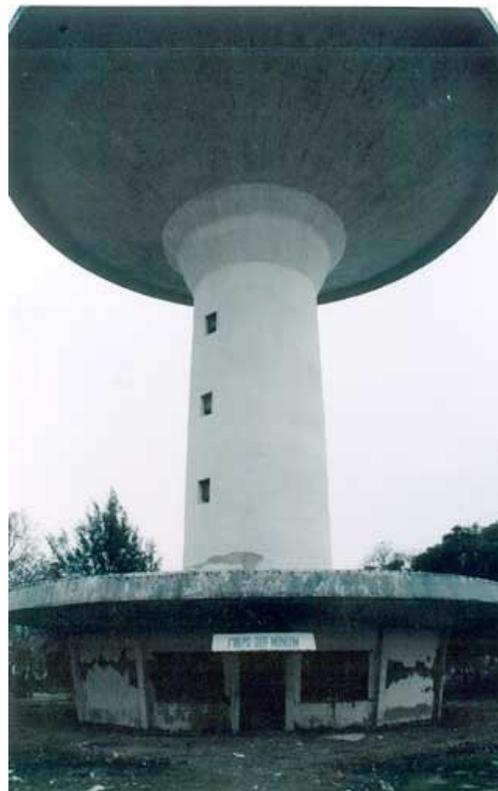
The elevated tank 1(2,000m³) of Photo 12.3 had not been functioning before the earthquake. However, the foundation of the tank was seriously damaged by the bending stresses caused by the earthquake. The tank should be demolished as soon as possible for safety reasons. The pipe next to the bridge nearby the Great Mosque crossing the Aceh River was washed away by the tsunami. As seen in the left picture of Photo 12.4, a rubber hose is temporarily installed on the river bed for water transmission to the other side of the river. The elevated Tank 2 of Photo 12.5 was also damaged with some minor cracks by bending stress in its foundation. Now the tank is used for emergency raw water supply from the nearby river. The water supply in the city is still critical now.

Photo 12.3 Water tower tank 1

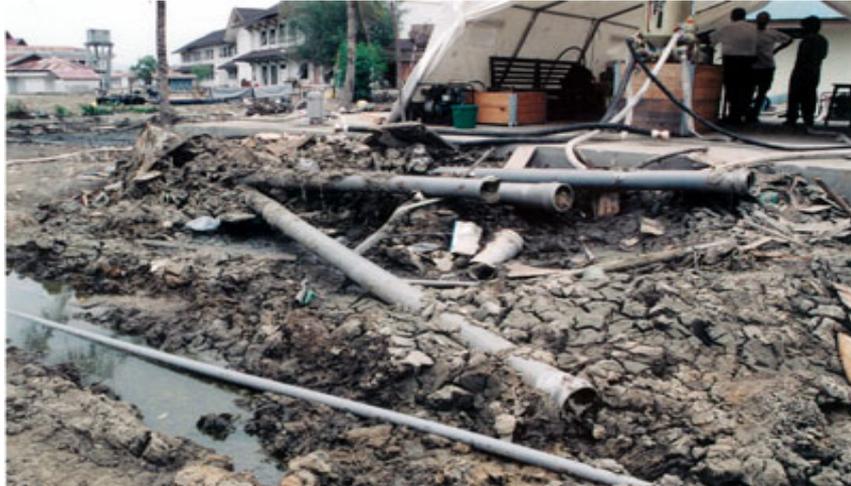
Photo 12.7 Scattered transmission pipe around pump station

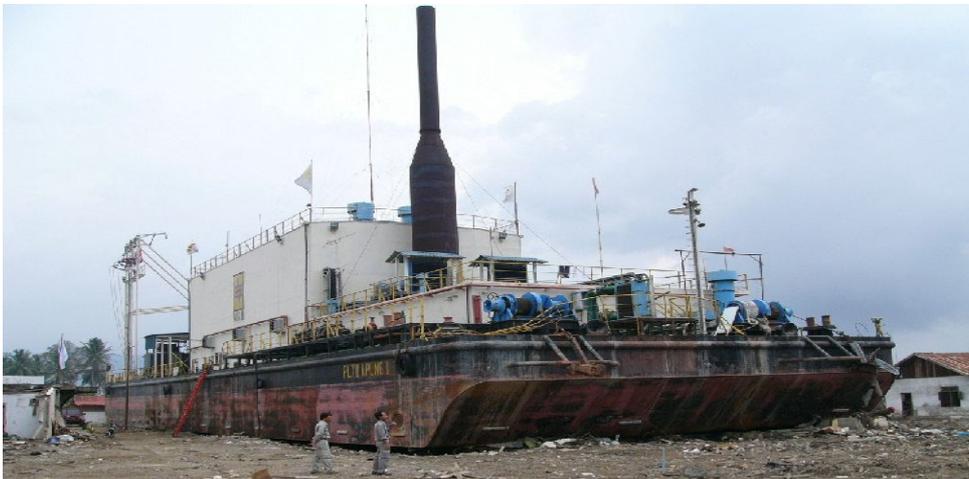
Although the dolphin for a barge with a power generator was not damaged by the tsunami as seen in Photo 10.2, the barge (Photo 10.3) was displaced from the dolphin to a distance of 3km inland.

Photo 12.8 Displaced barge with a thermo-electric power generator

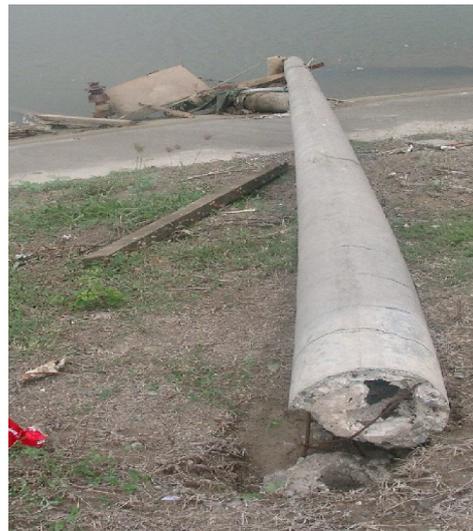
Many RC electric poles were broken in the area affected by the tsunami (Photo 12.9). However, either ground shaking or the tsunami did not damage transmission facilities from Medan (10MW).

Photo 12.9 Broken electric distribution poles
