A RECONNAISSANCE REPORT
ON
2008 WENCHUAN EARTHQUAKE*

Japan Society of Civil Engineers
Earthquake Engineering Committee
Earthquake Disaster Investigation Sub-Committee

May 19, 2008

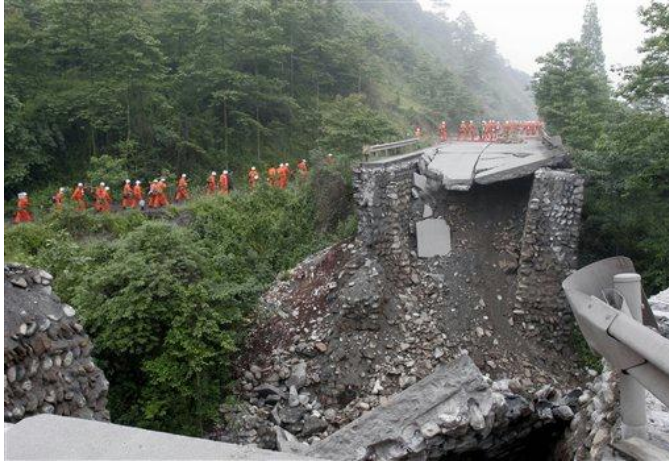
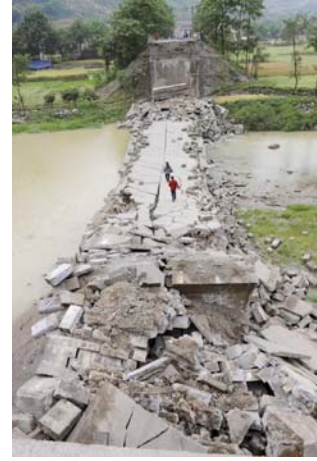
old stone masonry arch bridges generally performs well during earthquakes, they may collapse when there are permanent movements at abutments, piers or the both. Several examples of such collapses were observed in the earthquake epicentral area as shown in Figure 8.2.

Figure 8.2. Views of collapsed stone masonry arch bridges (from Xinhuanet)

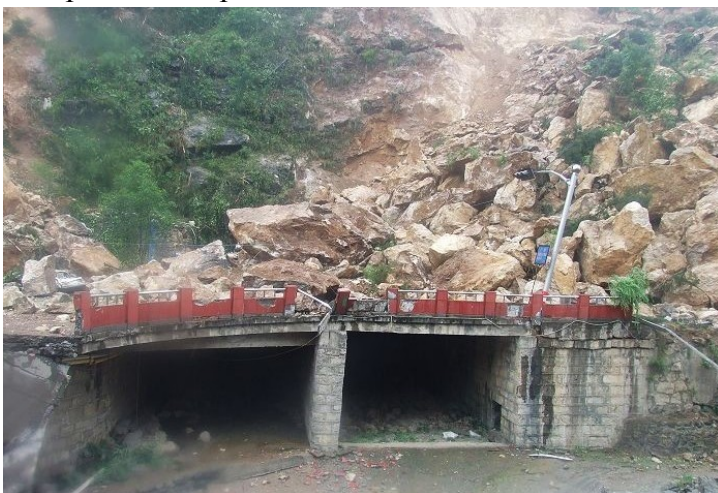
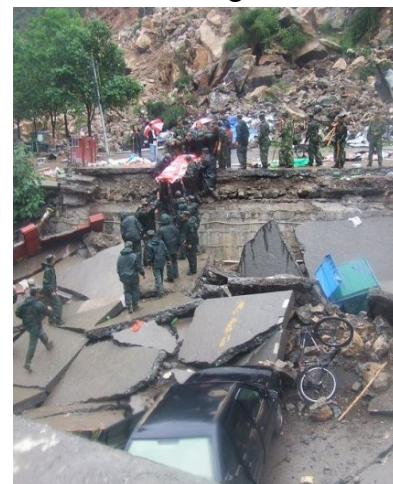
The second bridge type includes simply supported or arch cast-in reinforced concrete bridges. The simply supported cast-in place bridges performed very well during the earthquake. Except the settlement of embankment at abutments, the damage to such bridges were almost none or slight. However, some of these bridges become obstructed by rock slope failures at several locations and (Figure 8.3). Furthermore such bridges collapsed due to permanent movement of the abutment due to thrust faulting.

Figure 8.3. Damaged or collapsed bridges by rock slope failure or faulting (from Xinhuanet)

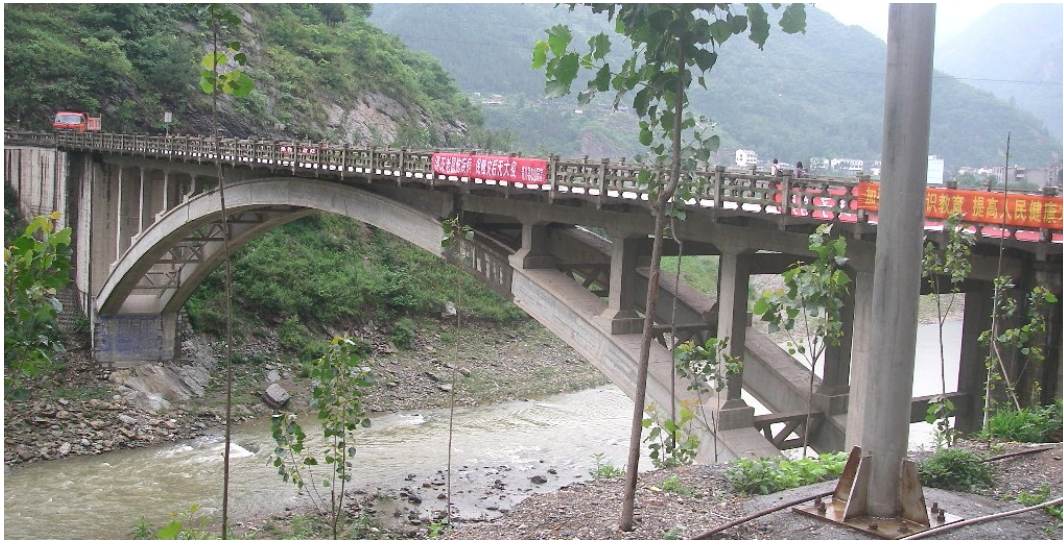
Figure 8.4. Non damaged arch bridge (Qingchuan province)

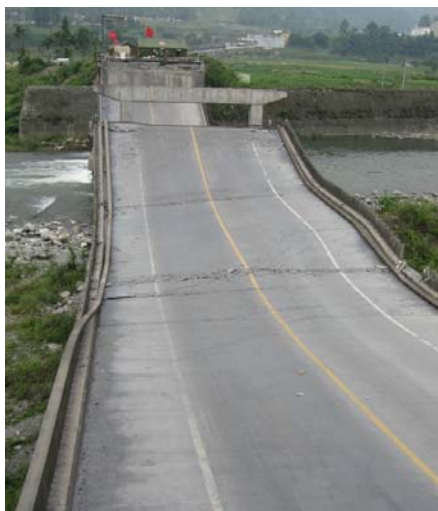
The heaviest damage occurred at the four span reinforced arch Hsiaoyudong bridge in Longmenshan town (Lin, 2008), from which the Longmenshan fault zone was named. The arch sections of the bridge were sheared as shown in Figure 8.6. Besides high ground motions in the vicinity of the bridge, the shearing of arched section in the longitudinal axis of the bridge implies permanent ground movements, which may result from thrust faulting and ground liquefaction beneath the riverbed.

Figure 8.6. Collapsed Hsiaoyudong bridge in Longmenshan town (pictures and figure from NRCEE, 2008)

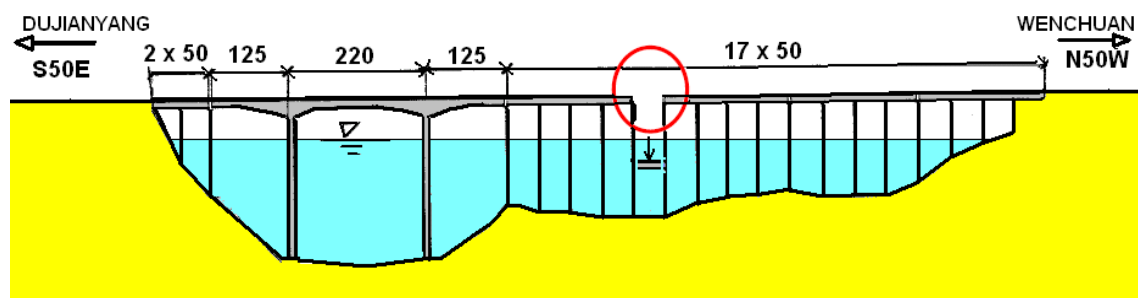
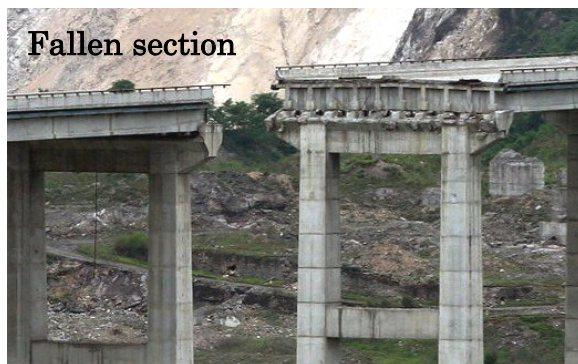
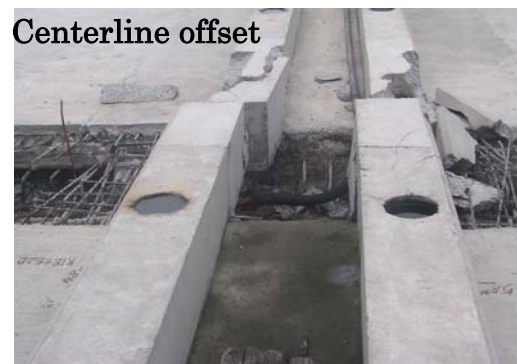
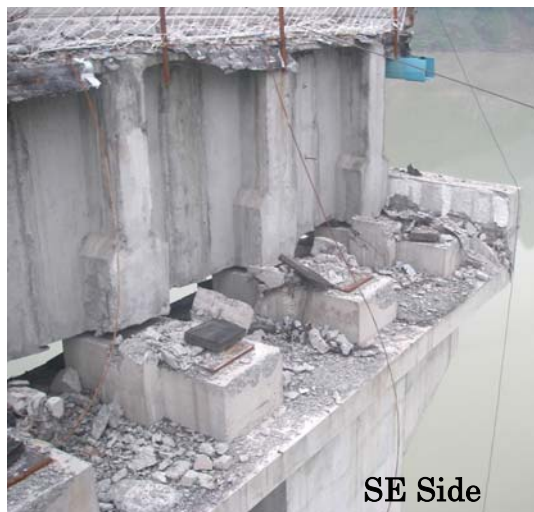
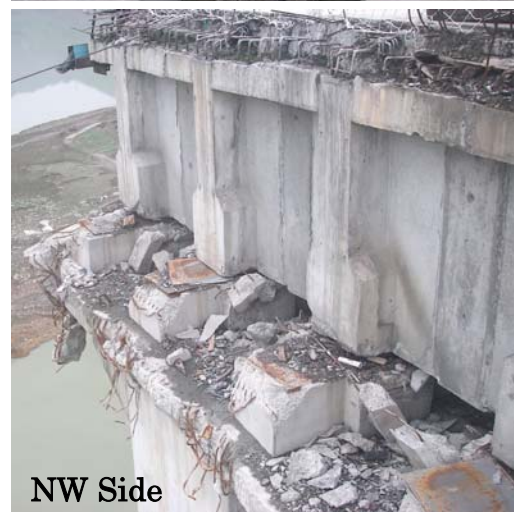
Miaoziping (Miaotzuping) bridge passes over Zipingpu dam reservoir. The bridge is 1436m long with a height of 100m (Figure 8.9). The main bridge is long span box girder bridge with 19 approaches with T-girders. The construction of the bridge was completed at the time of the earthquake. However, it was not open to traffic yet. The earthquake caused the shifting of bridge girders in longitudinally and laterally. One of the T-type girder approaches collapsed. The surveying indicated that the distance between piers was increased by more than 50cm and there were all-around fractures, spalling and bending cracks in the pier just above its foundation. While there were stoppers for lateral movements, there were no stopper longitudinally. Furthermore, the sliders (pedestals) were 40cm by 40cm.

Figure 8.9. Sketch and views of the fallen section of the Miaoziping Bridge

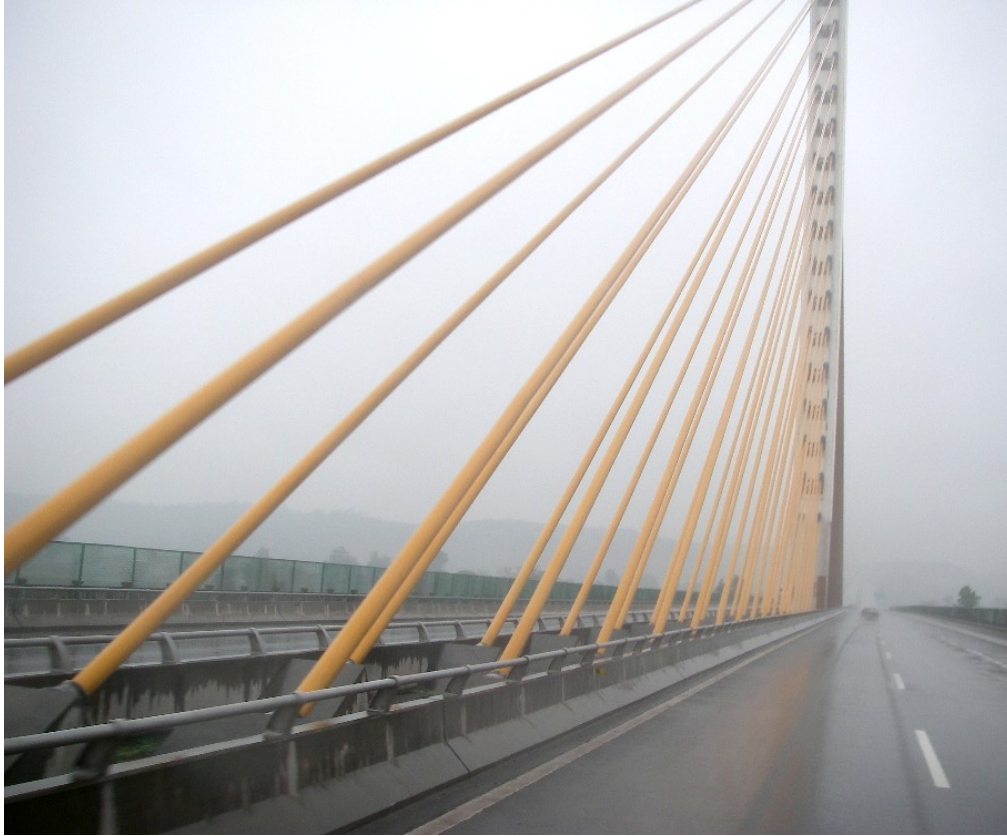
The forth bridge type is suspension bridges. There is a cable stayed bridge near Jiangyou on the expressway between Chengdu and Guanyuan. There was no visible damage to this bridge (Figure 8.12). However, There were some damage to suspension bridges for pedestrians due to the movement of anchorage blocks (Figure 8.13).

Figure 8.12. View of the cable-stayed bridge near Jiangyou

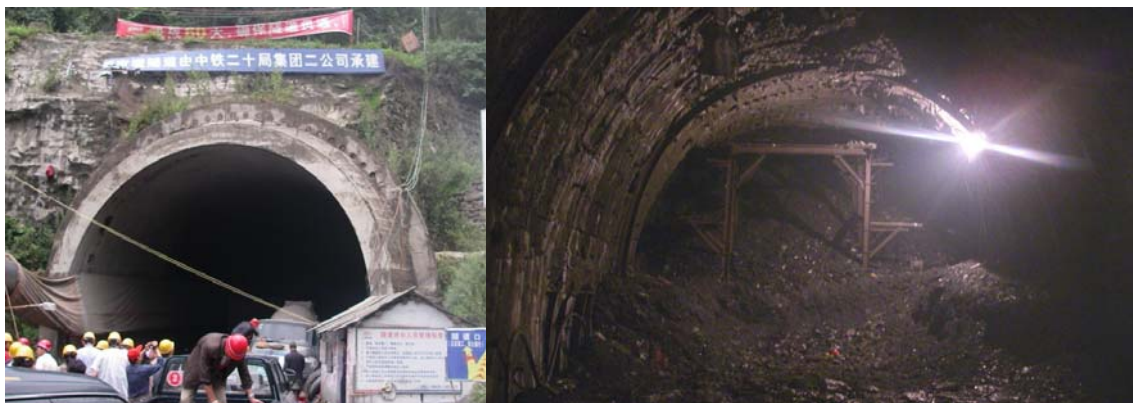
Figure 8.22. Views of damage at Jiujiaya Tunnel

Jiujiaya Tunnel is a 2282m long double lane tunnel and the coordinate of its south portal is N32.41288 and E105.12046. The tunnel is 226.6km away from the earthquake epicenter and it is about 3-5km away from the earthquake fault of Wenchuan earthquake. The tunnel face was 983m from the south portal at the time of the earthquake (Figure 8.21). The concrete lining follows the tunnel face at a distance of approximately 30m. The tunnel suffers from metan gas problem due to coal seams below the tunnel. The rock consists of phyllite with intercalations of dolomite. The bedding planes has the orientation of NW50/64, which is roughly similar to that of the Longmenshan fault zone. The geological investigation indicated that the tunnel pass through several fracture zones. The engineers informed the authors that 30 workers were working at the tunnel face and one worker was killed by the flying pieces of rockbolts, shotcrete and bearing plates caused by intense deformation of the tunnel face during the earthquake. The concrete lining was ruptured and fallen down at several section (Figure 8.22). However, the effect of the lining rupturing was quite large and intense in the vicinity of the tunnel face. The rupturing of the concrete lining generally occurred at the crown sections although there was rupturing along the shoulders of the tunnel. Furthermore, the invert was uplifted ue to buckling at the middle sections. Sometimes, the whole invert was pushed upward. The authors noticed that the tunnel heading was offset in a dextral sense with an upward with respect to the rest of the tunnel. The lateral and vertical offset displacements are approximately 100mm. This sense of deformation is very similar to that of the Longmenshan fault zone, which probably cuts through the tunnel with an acute angle of 50-60°. Besides the high ground shaking, the permanent ground deformations definetly played an important role on the damage observed in Jiujiaya Tunnel.

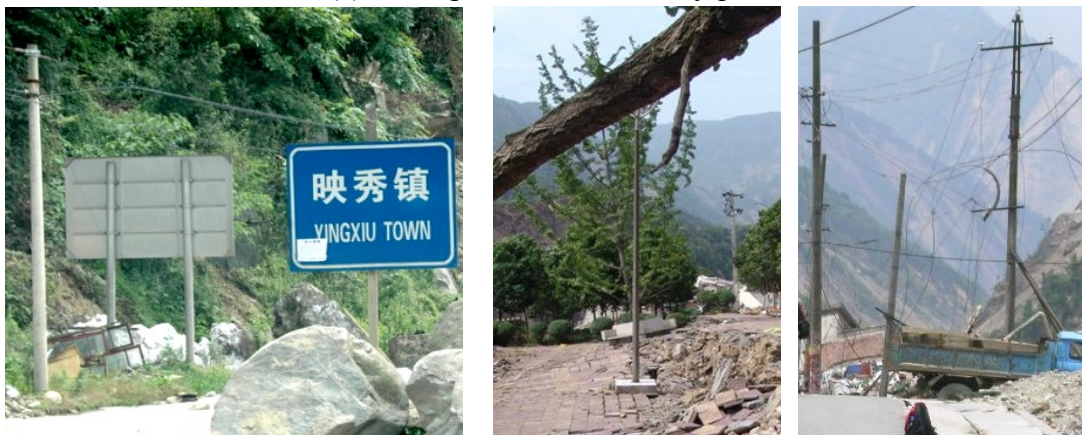
(b) Non-damaged utility poles

Figure 8.22. Views of damaged or non-damaged reinforced concrete utility poles

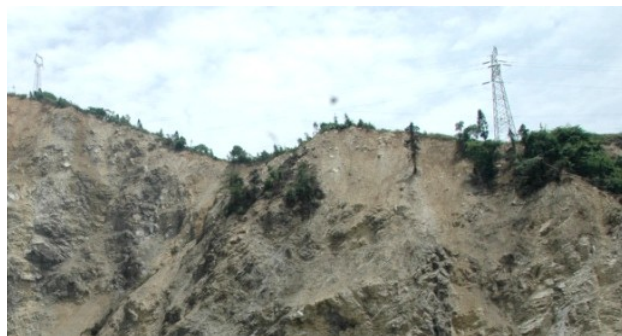
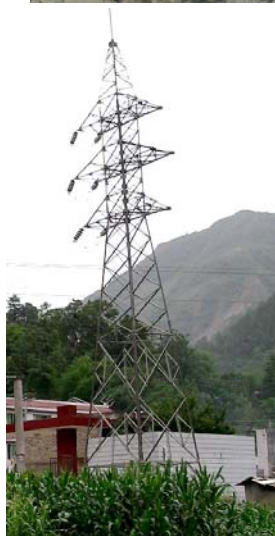
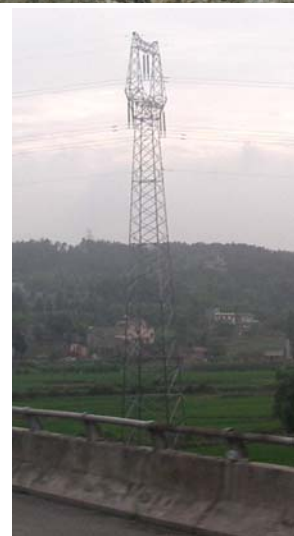
The preliminary site investigations and additional data and information other sources clearly indicated that the damage to pylons and poles were either caused by the collapse of buildings, slope failures or faulting. The effect of ground shaking on the damage to pylons and electricity poles seems to be small (Figures 8.22 and 8.23. Particularly the selection of foundation ground for high pylons and their structural design and construction should have been very carefully implemented.

Figure 8.23. Views of damaged and non-damaged pylons

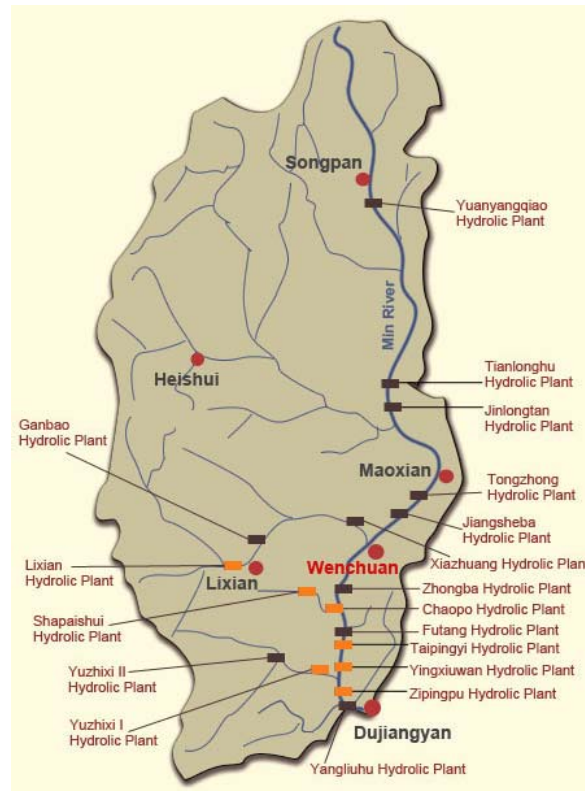
There are around 400 dams in the area of the earthquake, with four dams being classed as major dams with heights more than 100m (Figure 8.24). The nearest dam to the epicenter is Zipingpu dam built in 2006 with a height of 158m and it is concrete faced rock fill dam. The Zipingku Dam is about 9 kilometers upstream from the small city of Dujiangyan. The surveying indicated that the abutments of the dam moved inward and the maximum displacement was 101.6mm. The settlement of the crest of the dam was 734.6mm with a 179.9mm displacement towards the downstream side. (Figure 8.25). The seepage of the dam changed from 10.38l/s to 15.07 l/s. The Zipingpu dam was designed for the base acceleration of 0.26g but the acceleration at the crest during the earthquake was greater than 2g. The gates and power generating units were damaged by the earthquake.

Figure 8.24 Dams in the epicentral area

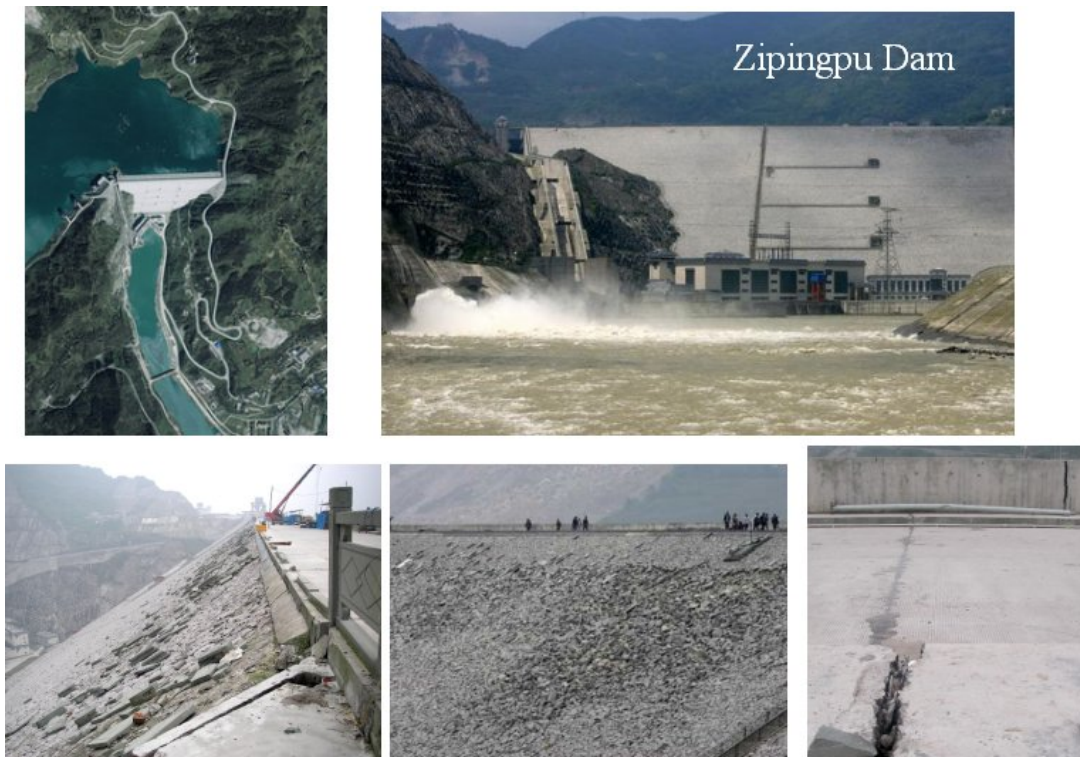
Figure 8.25: Views of Zipingpu dam

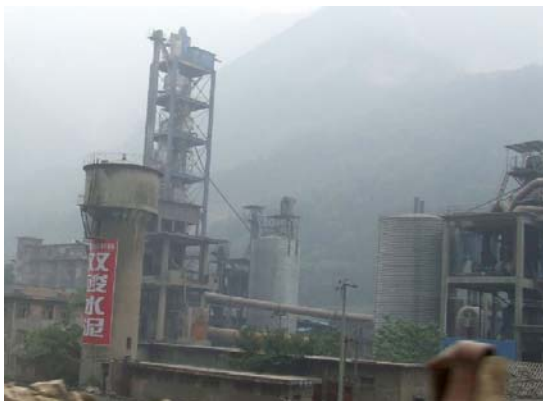
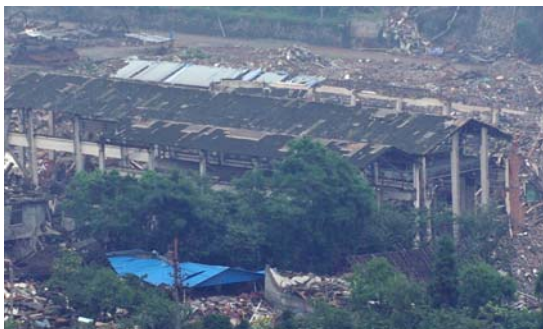
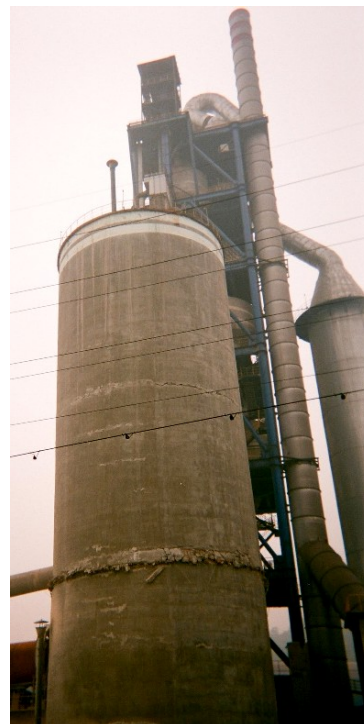
The heavy damage to industrial facilities were observed in Hongbai and Hanwang towns near Shifang, where ground accelerations up to 632 gals were recorded. These towns are 75km away from the epicenter. However, they are in the close proximity of the earthquake fault (within 15-20km). The reports indicated that two chemical plants were heavily damaged in Hongbai town (Figure 8.26 and 8.27). These plants released more than 80 tons of liquid ammonia. There are also some damage to industrial facilities in Yingxiu and Wenchuan (8.28).

Figure 8.30. Views of damage to industrial facilities at Yingxiu town

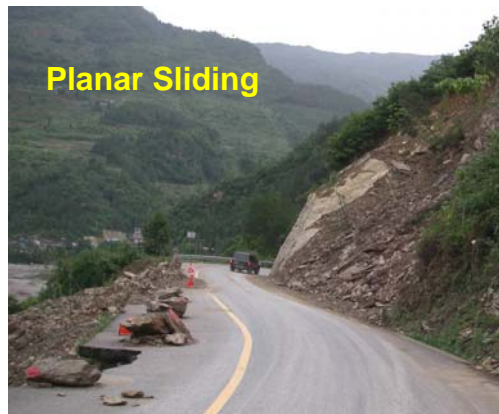
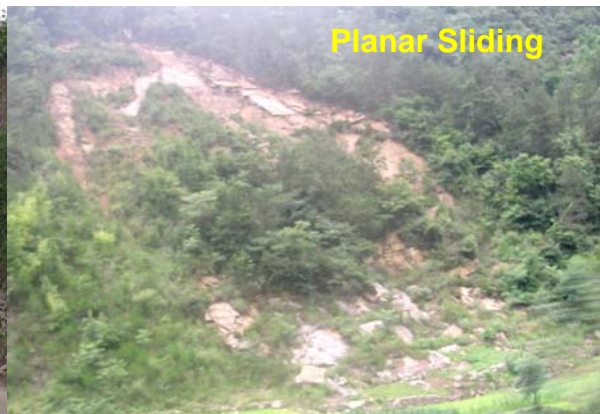
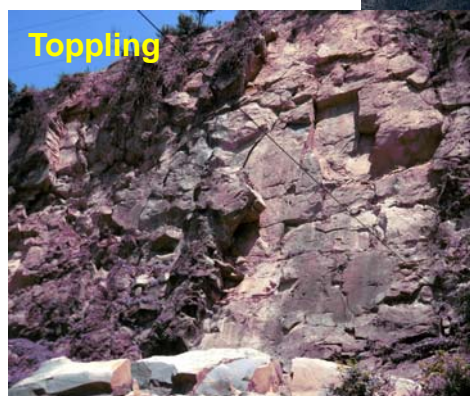
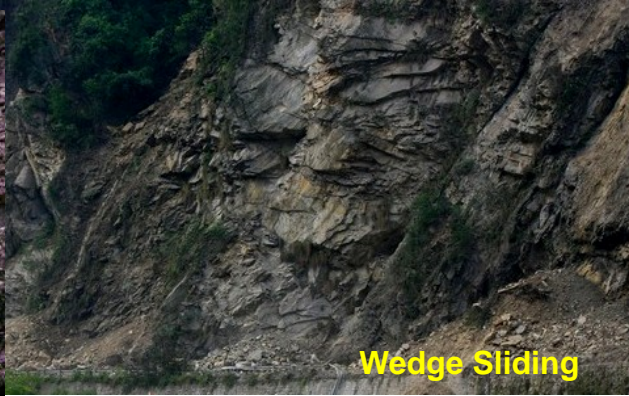
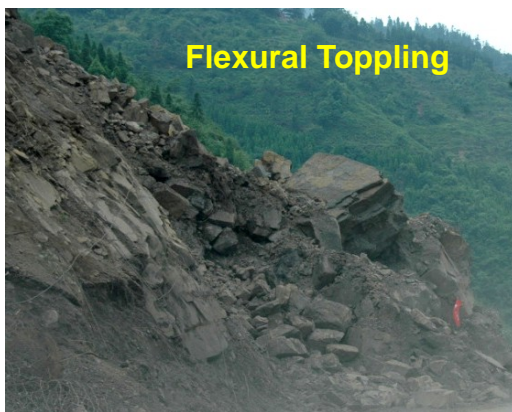
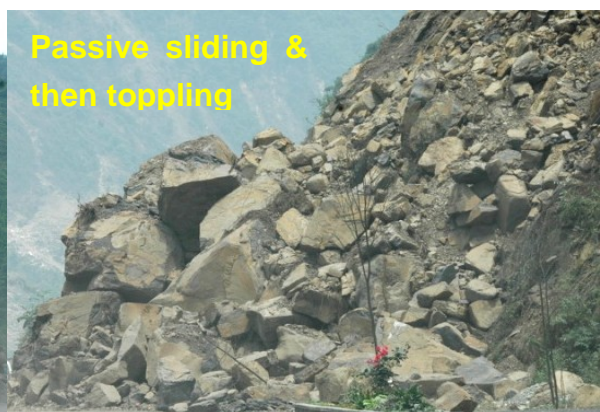
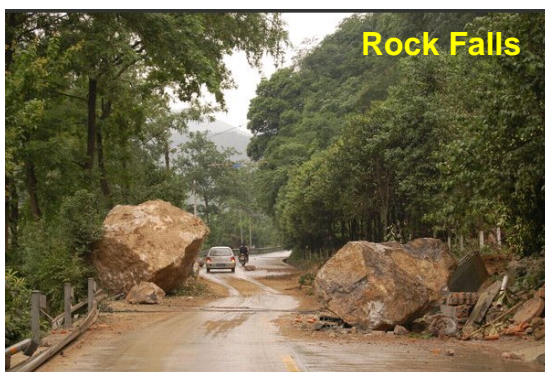
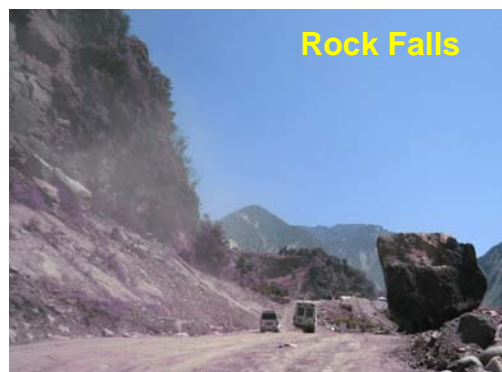
As said above, rock units are phyllite or slate, sandstone, mudstone, shale and limestone. Geologically, granitic unit exist in the epicentral area. However, the authors did not have chance to see such sites. Except granite, all rock unit has at least one throughgoing discontinuity set, namely, bedding plane or schistosity plane. Since rock units had been folded, they also include joint sets and fracture planes as a result of tectonic movements. Furthermore, the measurements on faults in limestone outcrops in the vicinity of Miaoziping bridge indicated three dominant faults, which divide the limestone unit into large blocks. Granite generally has at least three discontinuity sets. In regard with rock slope failures classified in Figures 9.1 and 9.2, the rock slope failures are mainly planar sliding, flexural or block toppling failure (Figure 9.4). In addition, passive sliding and toppling failures were observed in intercalated sandstone and shale units.

Figure 9.4. Some examples of rock slope failures and rock falls

Active planar sliding failures were probably much larger in scale as compared with other slope failures. Several large scale slope failures will be presented and discussed in next sub-section. Rockfalls in the epicentral area are generally result of the toppling of rock blocks due to excitation of the earthquake. Numerous rockfalls were observed for a great length of roadways. Rockfalls were common in sandstone and limestone slopes, which caused a huge number of vehicle crushing events resulting in heavy casualties.

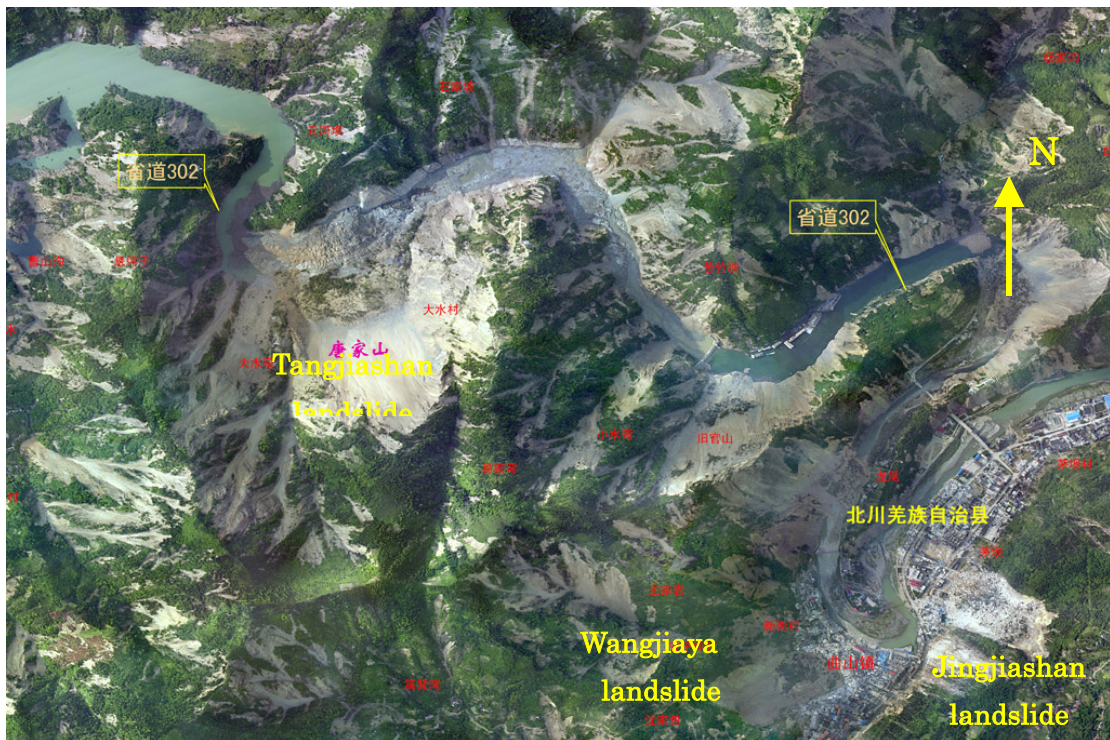
There are several large landslides in Beichuan town and its close vicinity including the Tangjashan landslide (Figure 9.6). UNOSAT (2008) recently released a topographic map of the area (unfortunately such topographic maps are generally inaccessible in China) and a part of this topographic map is shown in Figure 9.7. In association with the sliding motion of the earthquake fault, NW or SE facing slopes failed during this earthquake. There were two large scale slope failures (landslides) in Beichuan county, which destroyed numerous buildings and facilities. The NW facing landslide (Jingjiashan) involved mainly limestone while the SE facing landslide (Wangjiaya) involved phyllite (it is mudstone and sandstone according to some) rock unit, which is folded with the antcline axis plunging NE (Figure 9.8). Limestone layers dips towards the valley side with an inclination of about 30° . Furthermore, there are several faults dipping parallel to the failure surface within the rock mass. The angles of the lower and upper parts of the failed slope are 60° and $30-35^{\circ}$, respectively. The existence of several faults dipping parallel to the slope with an inclination of about $60-65^{\circ}$ creates a stepped failure surface. If the resistance is assumed to be purely frictional the expected lateral horizontal seismic coefficient should be greater than $0.18g$.

Figure 9.6. A satellite view of Beichuan and its close vicinity (modified from CGSI)

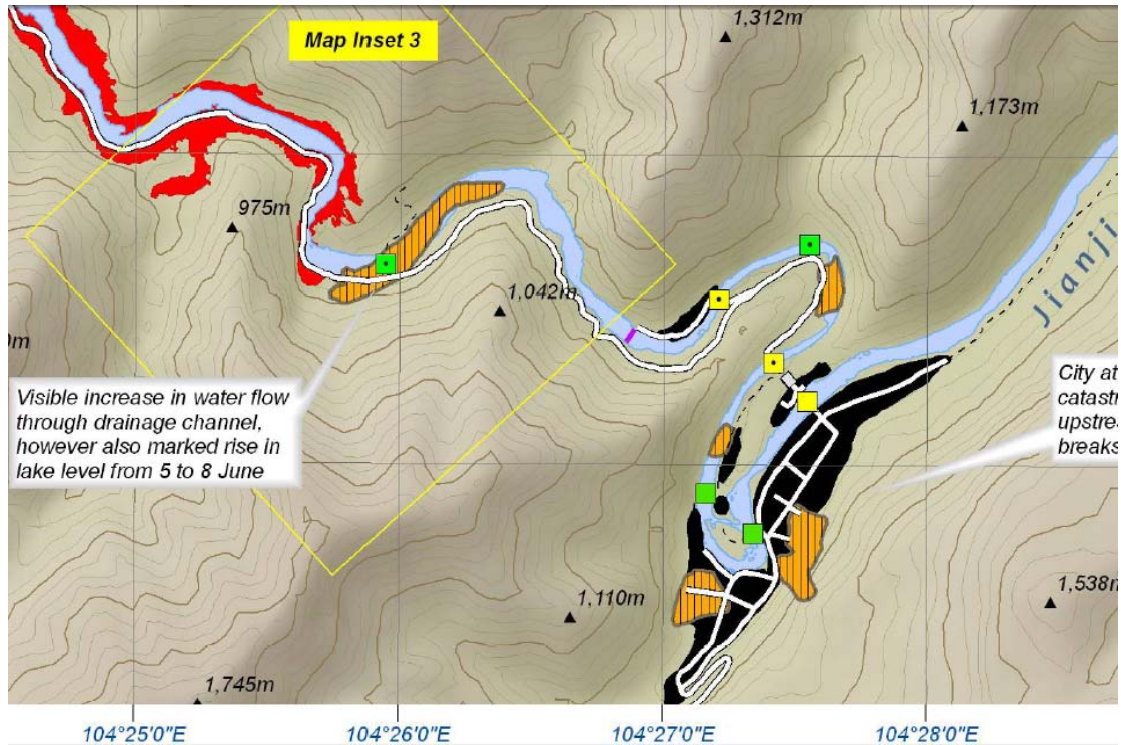
Figure 9.7. A topographic map of landslides in Beichuan and close vicinity (modified from UNOSAT, 2008)

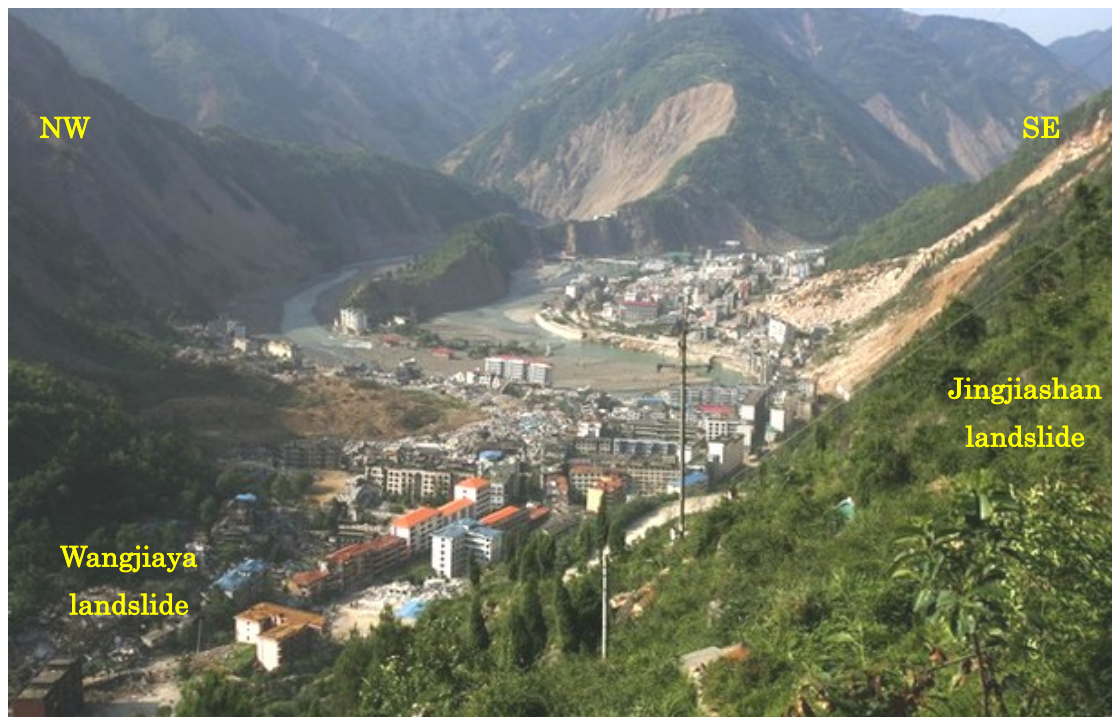
The SE facing slope (Wangjiaya landslide) may involve a slippage along the steeply dipping discontinuity plane (fault plane ?) and shearing through the folded rock mass. In other words, it may be classified as a combined sliding and shearing failure (Aydan et al. 1994). The angles of the lower and upper parts of the failed slope are $40-45^{\circ}$ and $30-35^{\circ}$, respectively. The layers dip at angle of 40° towards the valley and shearing plane is inclined at an angle of 20° . Since material properties and conditions of rock mass are not well-known for this site yet, no estimation on possible ground acceleration has been done. Nevertheless, it is more likely that such a high ground acceleration did act on this slope since Beichuan town was heavily damaged by this earthquake.

Figure 9.8. Views of landslides in Beichuan

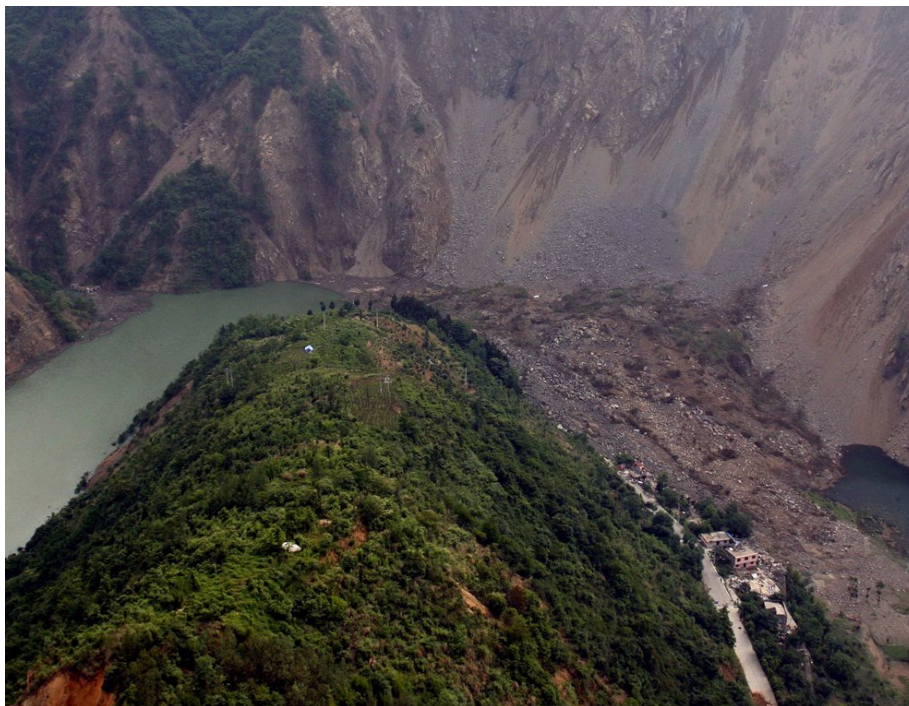
Tangjiashan landslide, which obstructed Jian River, is located about 2km NW of Beichuan (Qushan) town (Figure 9.9). The landslide faces NW. The rock units involved in this landslide is limestone (top part), and intercalated sandstone and shale (lower part). Rock layers dip towards the valley at an inclination of $40-50^{\circ}$, Although the upper part of the mountain has a slope angle of $40-45^{\circ}$, the lower part is more steeply inclined up to 70° due to the toe erosion by Jian River. The earthquake induced almost a planar sliding of 600m wide and 450m long body of rock mass. This landslide blocked Jian River for a length of 800m and created a landslide dam with a maximum height of 124m.

Figure 9.9. A view of Tangjiashan landslide (arranged from the image by Xinhuanet)

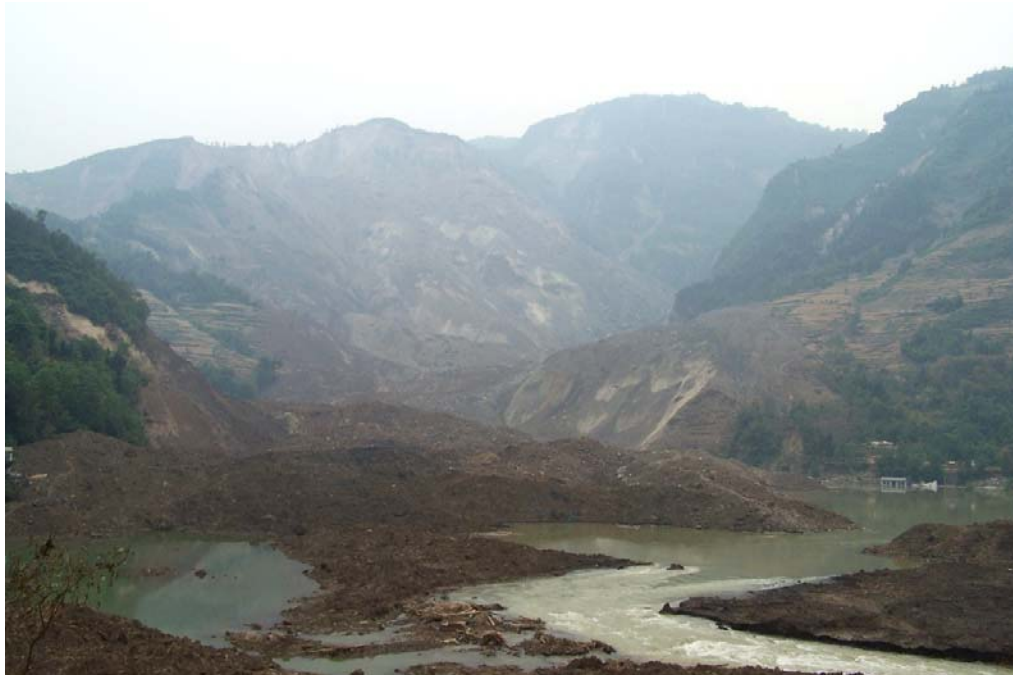
This landslide occurred at Donghekou village of Hongguang Township, Qingchuan County and it is located at the NE tip of the earthquake fault. The upper part of the mountain covered by limestone, below which phyllite exist. This phyllite formation is considerably thick and it is inclined at an angle of $30-45^{\circ}$ to NE and it is slightly discordant with upper limestone formation. A paleo landslide exist to the east of the new landslide source area. The in-situ tilting tests on the phyllite schistosity (bedding) plane surfaces yielded the friction angle as $22-24^{\circ}$, which is considerably small. In other words, slopes facing NE can not be stable even under static conditions if the resistance is only frictional. The initial movement of the unstable part of the mountain should have

been in NE direction and then its direction of motion rotated towards SW (Figure 9.10). Further investigations and laboratory tests on samples from this site should provide essential parameters for investigating the conditions for the failure of the slope at this site.

Figure 9.10. A view of Donghekou landslide in Qingchuan County

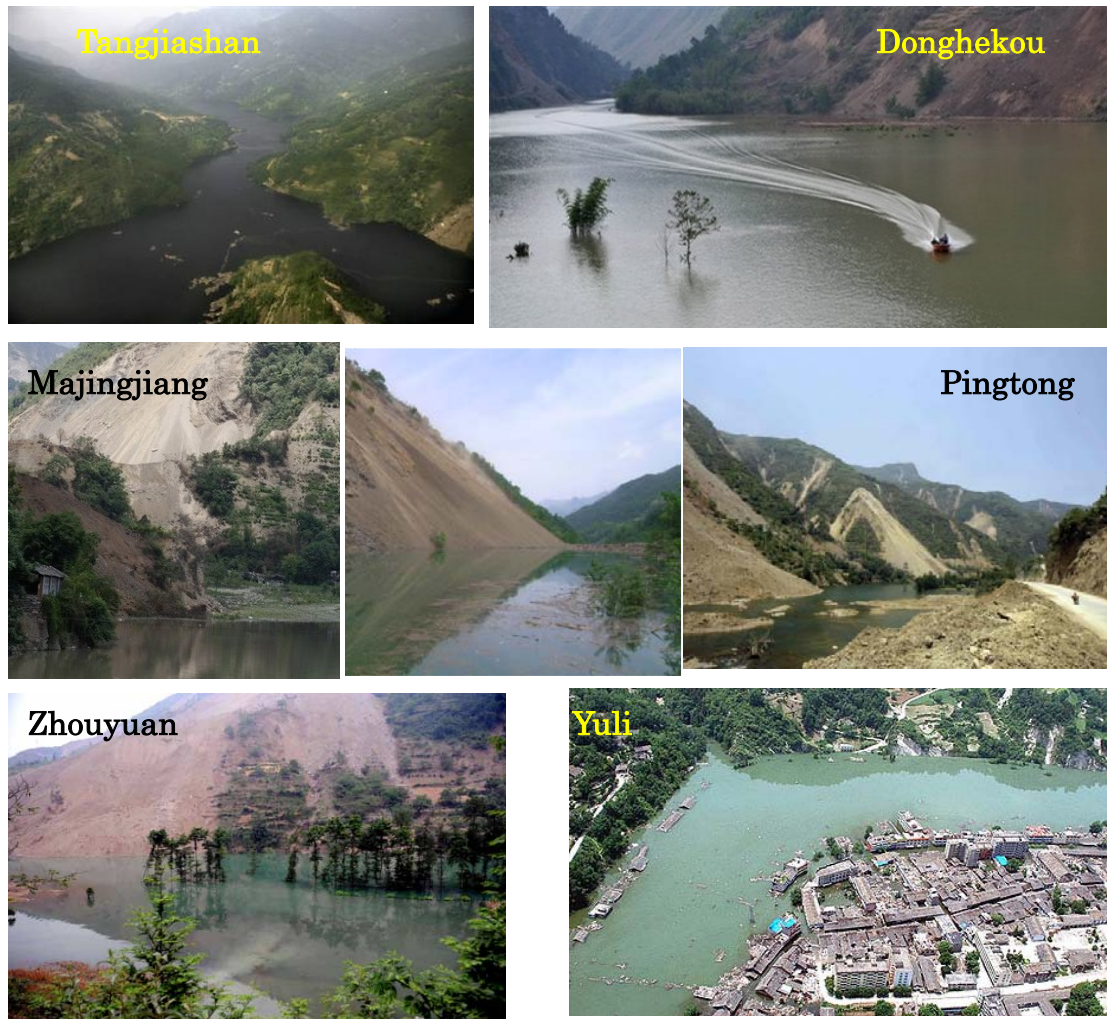
Figure 9.14. Views of some of quake lakes before breaching (partly from Xinhuanet)

Among 34 quake-lakes, three quake-lakes formed in Anxian, Qingchuan and Beichuan counties, were of great scale and were caused by mainly the planar sliding failure of mountains. Among all, the biggest quake-lake was the Tangjiashan "quake lake", which was formed by the collapse of a section of Tangjiashan Mountain. Tangjiashan quake-lake was formed 2 km from Beichuan and at its peak was 803m long by 612m wide and 70-124m high. The estimated volume of water of the Tangjiashan quakelake was 250M m^3 . Initially several spillways were constructed. However, the drainage through constructed spillways was not successful and several leakages occurred. At the final stage, explosives were used to create channels. However, these measures were not sufficient and missiles were used to control the drainage and erosion of the flow path (Figure 9.15, pictures by Xinhuanet (2008)). This dangerous operation resulted in a successful drainage of the Tangjiashan quake-lake almost one-month elapsed after the

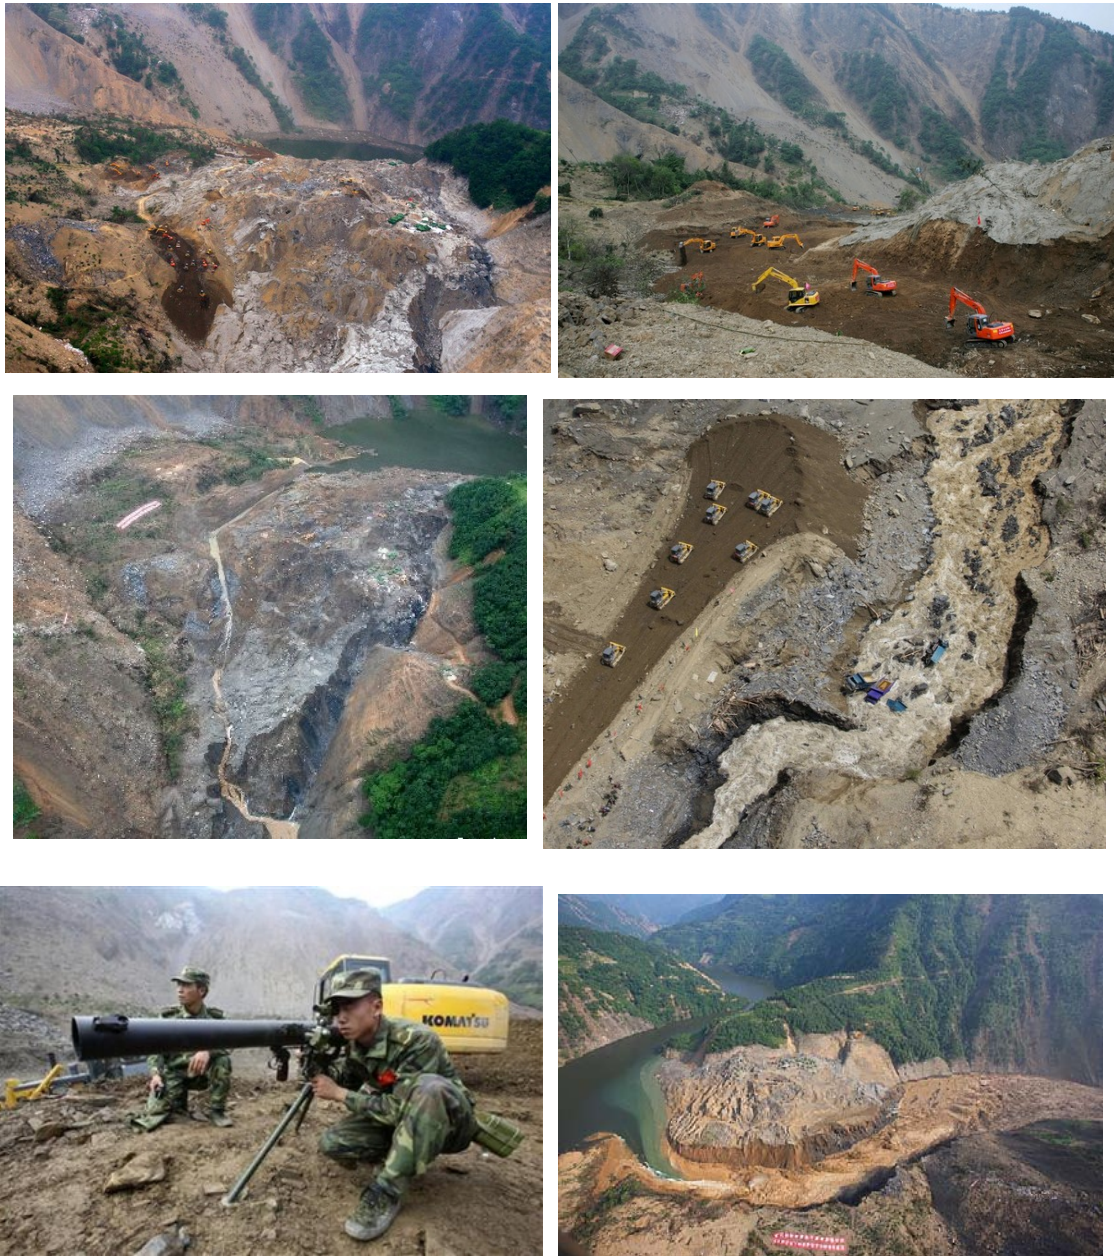
Figure 9.15. Views of several stages of Tangjiashan quake-lake (from Xinhuanet)

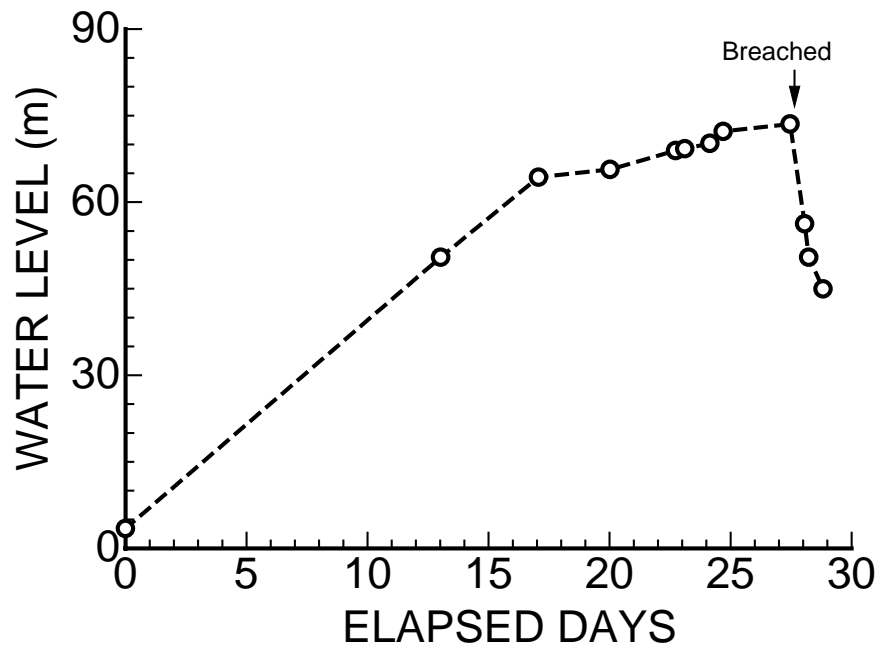
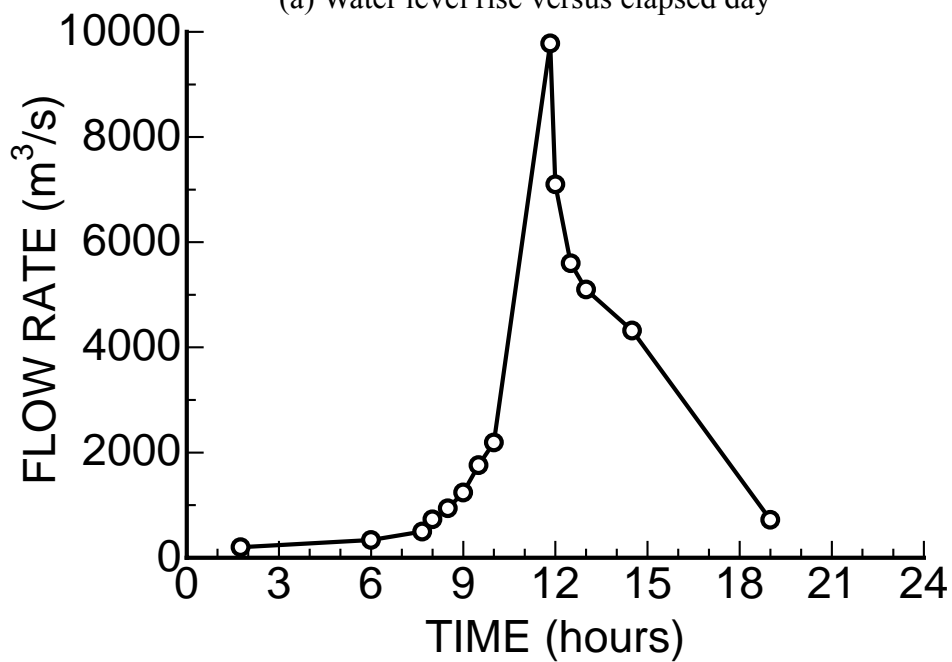
earthquake and a peak discharge of 980 m³/s was observed at 11:50 on June 10. Some 250,000 people downstream had already been evacuated during the drainage on June 10, 2008. Figure 9.16 shows the water level rise between May 12 and June 10 and drainage flow rate on June 10.

Figure 9.16. The water level rise between May 12 and June 10 and drainage flow rate on June 10 (data from China Water Resources)

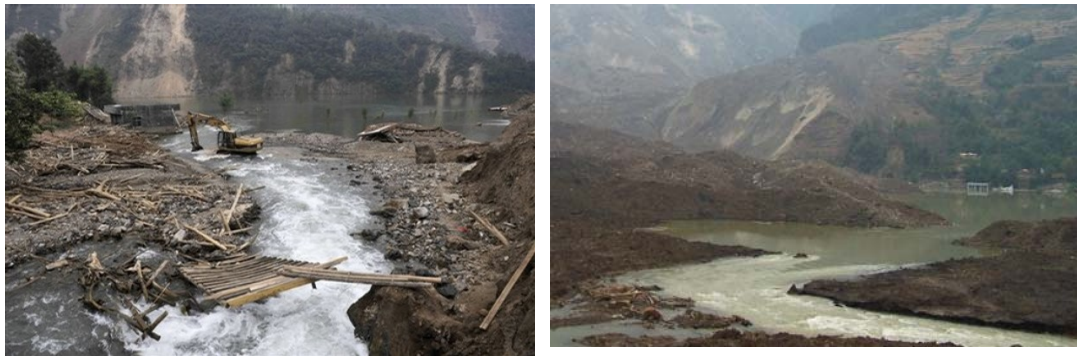
Figure 9.17. Views of the drainage of Donghekou quake-lake

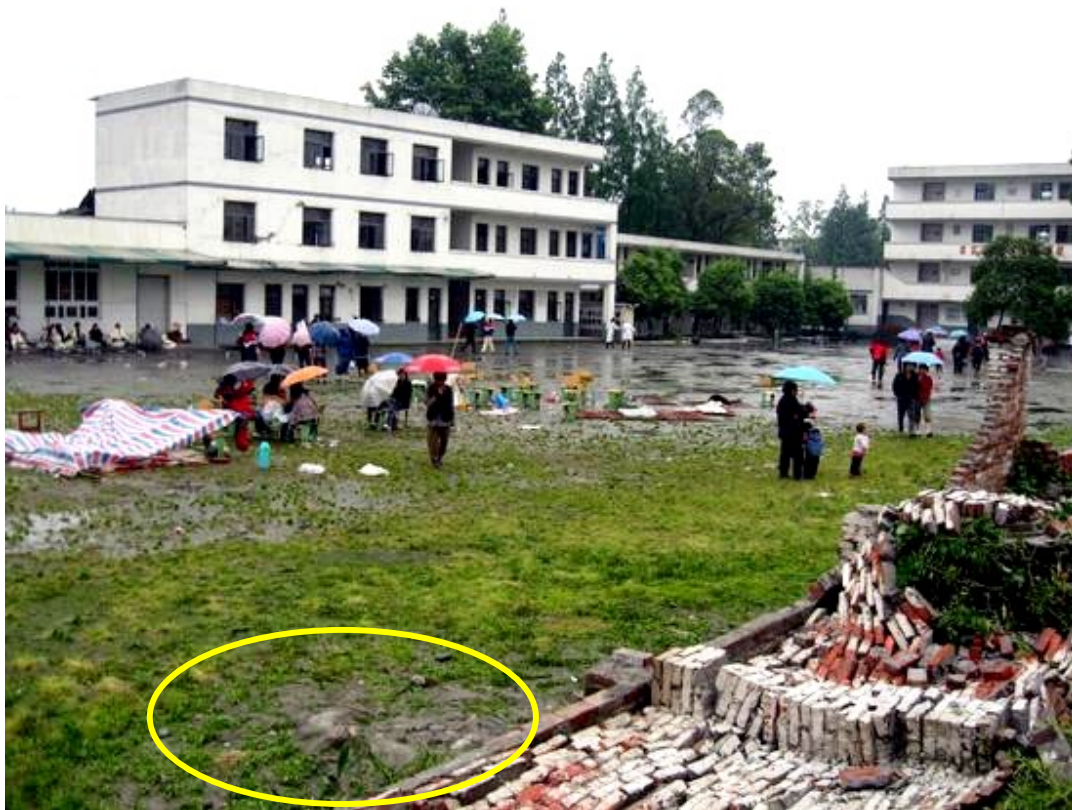
Figure 9.5. Sand boil in a school yard
