A RECONNAISSANCE REPORT
ON
2008 WENCHUAN EARTHQUAKE*

Japan Society of Civil Engineers
Earthquake Engineering Committee
Earthquake Disaster Investigation Sub-Committee

May 19, 2008

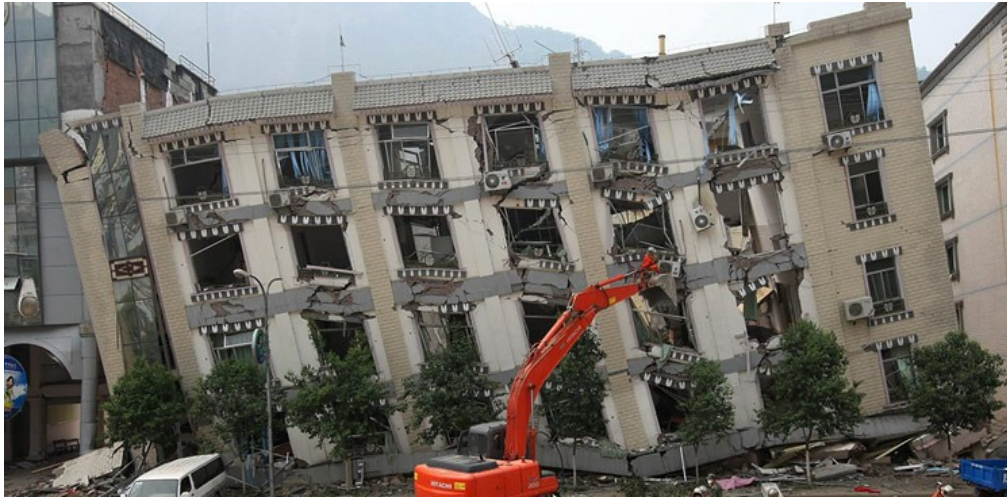
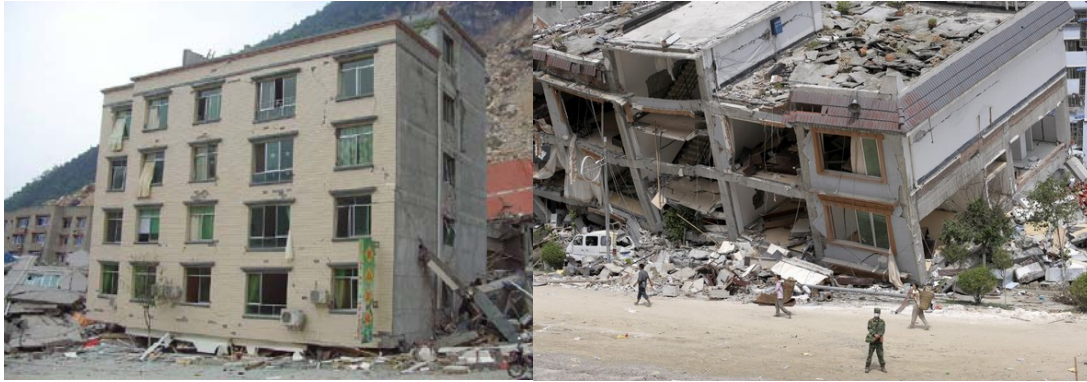
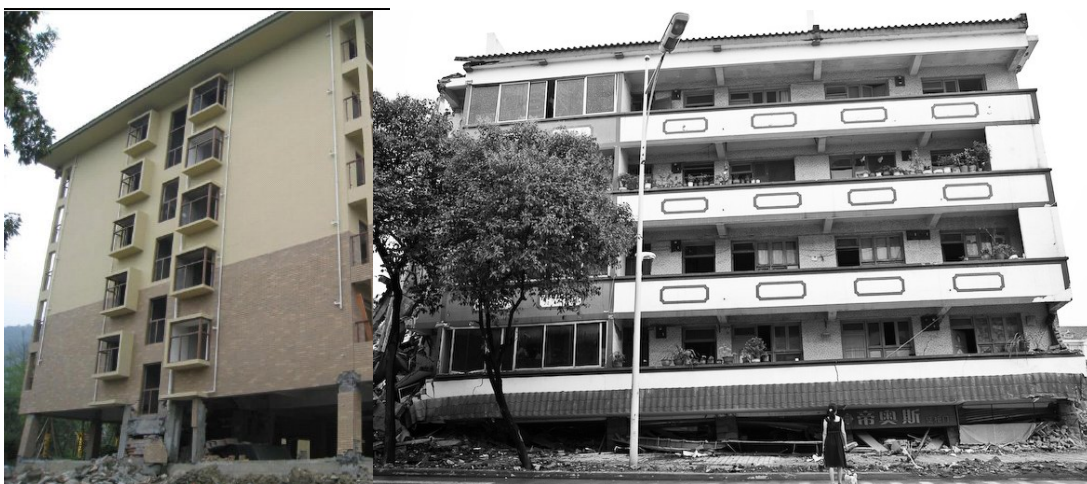
Figures 11.5 to 11.8 show some examples of heavily damaged or totally collapsed cast-in-place reinforced concrete buildings associated with some causes listed above. Although the earthquake mostly damaged these buildings, they performed much better than the pre-cast reinforced concrete buildings. They were more ductile. The collapse of these buildings occurred at ground floor due to soft-floor problem mainly. Since the building stands mainly on columns, the quality of the workmanship on beam-column joints and the concrete itself become of paramount importance. There were many examples of inadequate spacing of stirrups, insufficient and small diameter of bars. The use of hollow bricks considerably reduces the weight of the building. Nevertheless, they are more fragile and fail in a brittle manner. The infill walls are constructed as brick falls and they act as a shear wall upon the plastic hinging at column-beam joints. Due to the fragility of the infill walls, the resistance of the infill walls were expected to be none during the response of these buildings against strong motions induced by the 2008 Wenchuan earthquake. There are also some high-rise buildings particularly in Chengdu. These building were almost non-damaged during this earthquake. Since the ground motions in Chengdu was small during the Wenchuan earthquake, the structural seismic resistance of such building must be checked by considering nearby earthquakes such as on Dayi fault.

Figure 11.5. Several examples of collapsed cast-in-place reinforced concrete buildings due to soft (weak) floor problem

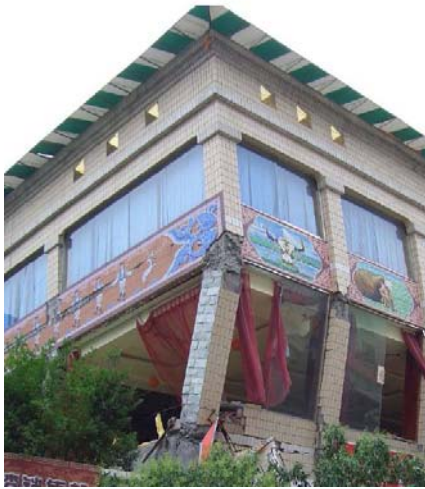
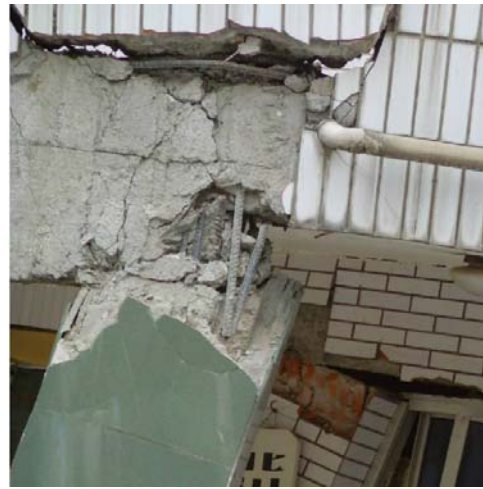
Figure 11.6. Several examples of plastic hinge development at the beam-column joints, due to lack of shear reinforcement and confinement

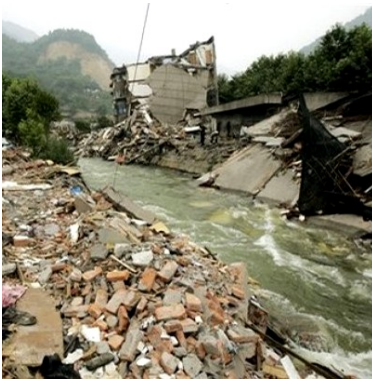
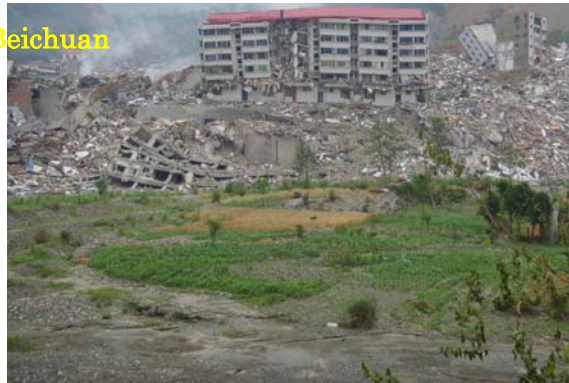
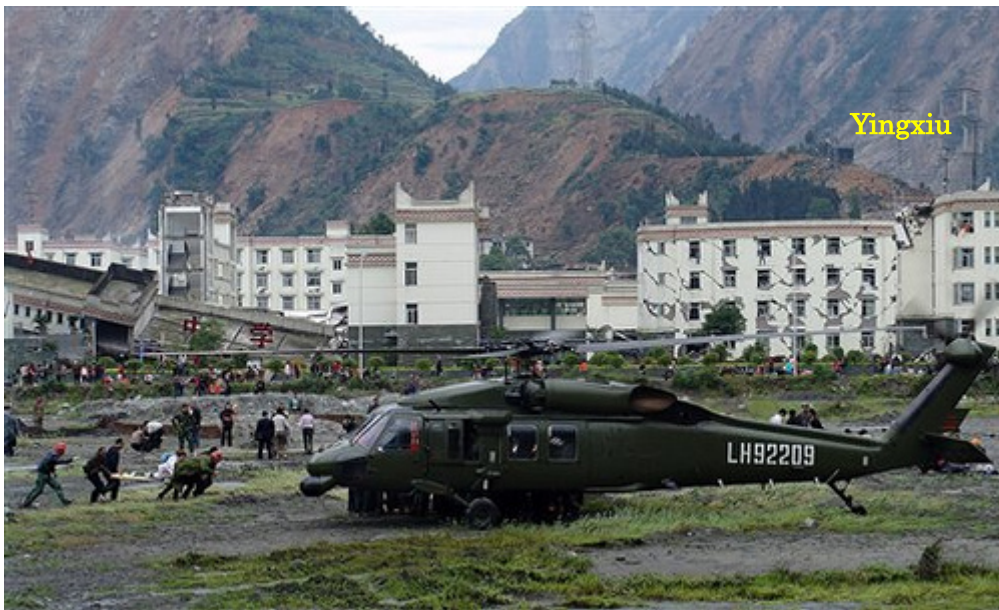
Figure 11.7. Several examples of damage to reinforced building due to soft ground conditions

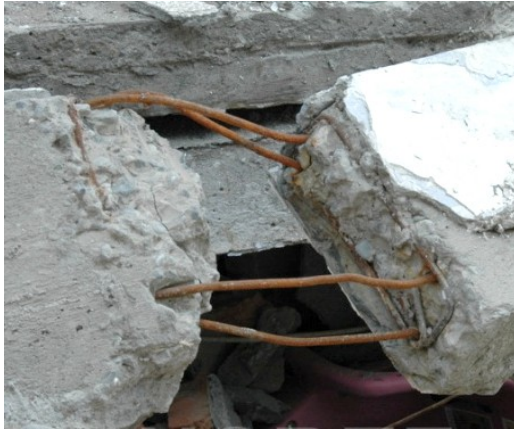
(a) Thin bars

Figure 11.8. Construction quality problems

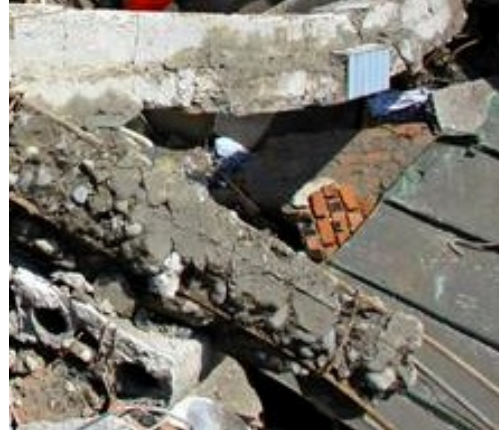
(b) poor granulometry

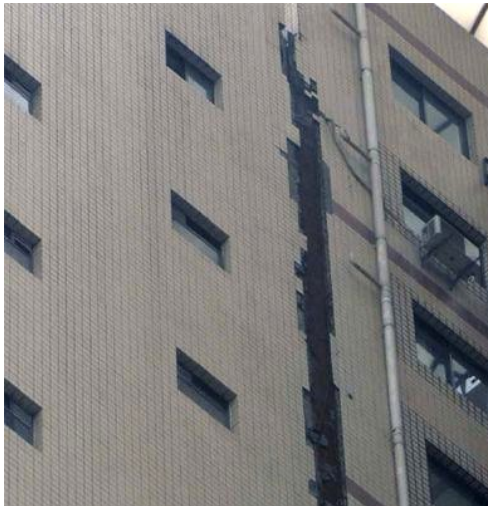
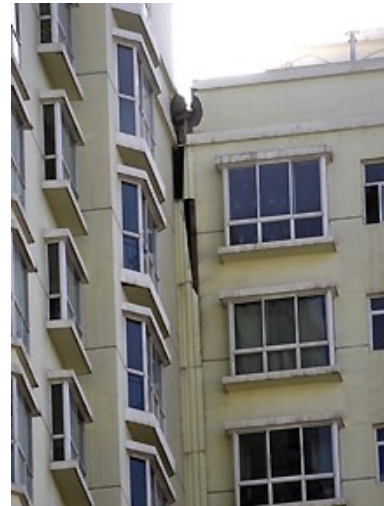
Figure 11.9. Damage due to pounding of adjacent buildings

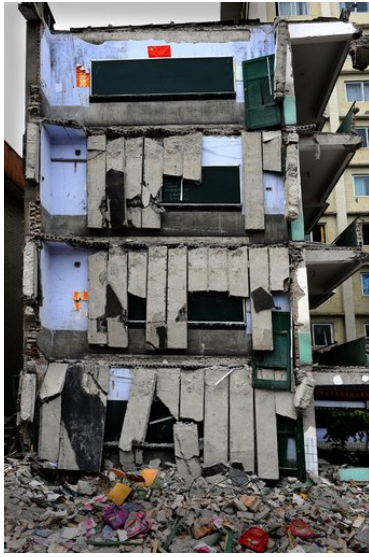
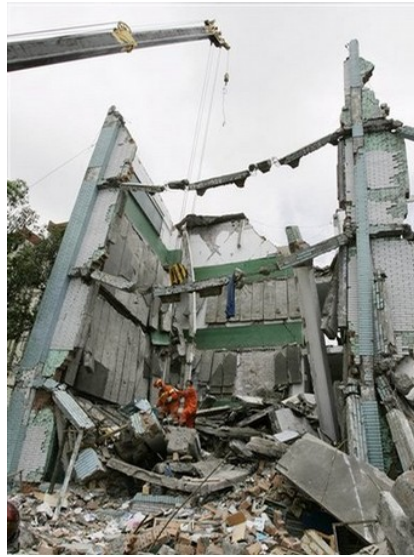
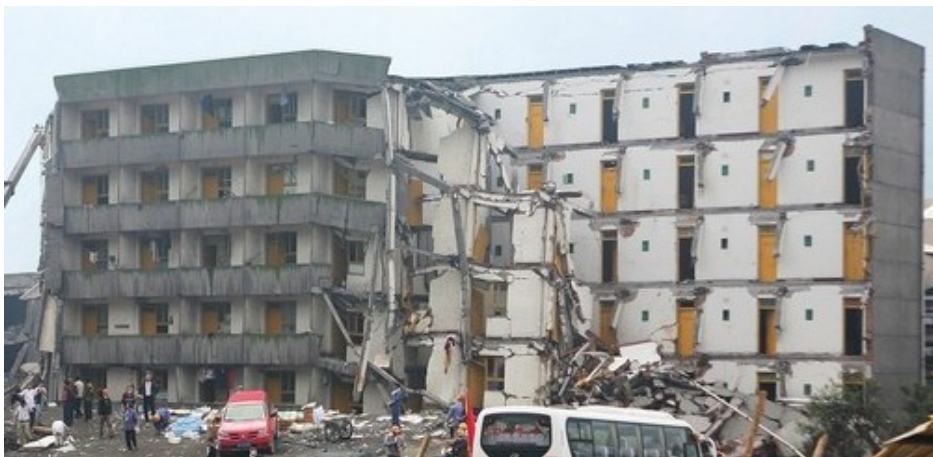
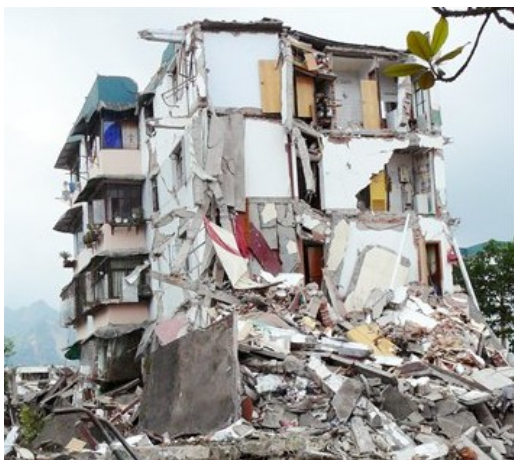
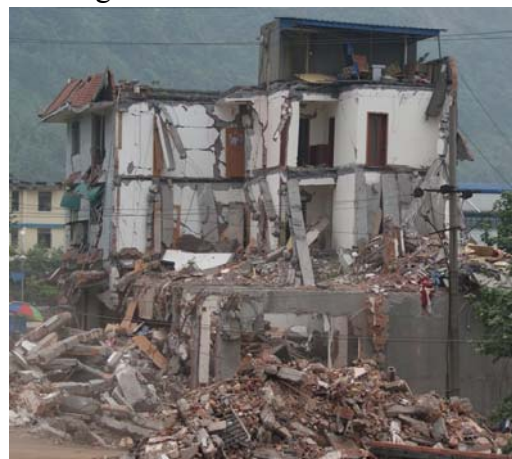
Most of casualties occurred due to the total collapse of the pre-cast reinforced concrete building constructed as residential buildings and school buildings (Figures 11.10 and 11.11). These buildings collapsed due to insufficient lateral resistance against the strong ground motions. The lateral beams with insufficient resistance failed at the column-beam connections. The lack of sufficient reinforcing bars and structural rigidity, these buildings dilapidated like LEGO houses. The all stories of the buildings piled up in a pan-cake fashion. These buildings were built undoubtedly in a short period of time. The technique of construction was probably imported from a country or countries without any major seismicity.

Figure 11.10. Collapsed pre-cast reinforced concrete buildings at various places

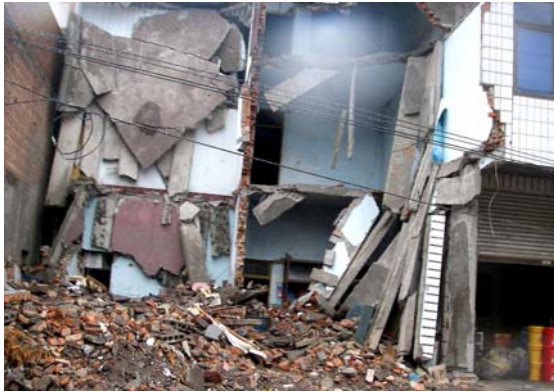
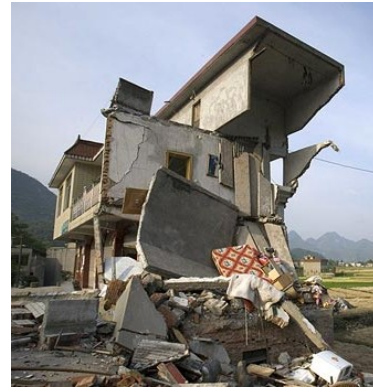
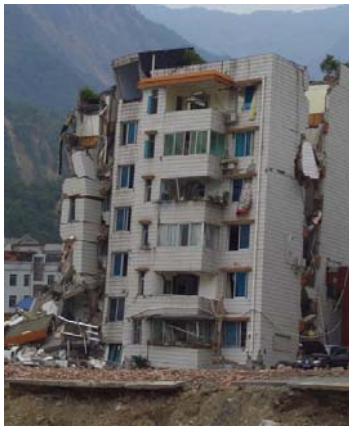
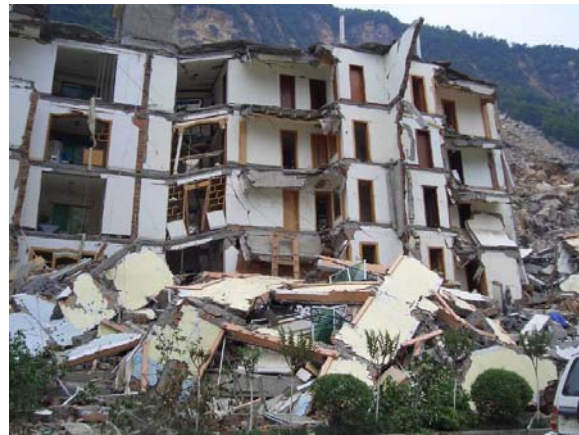
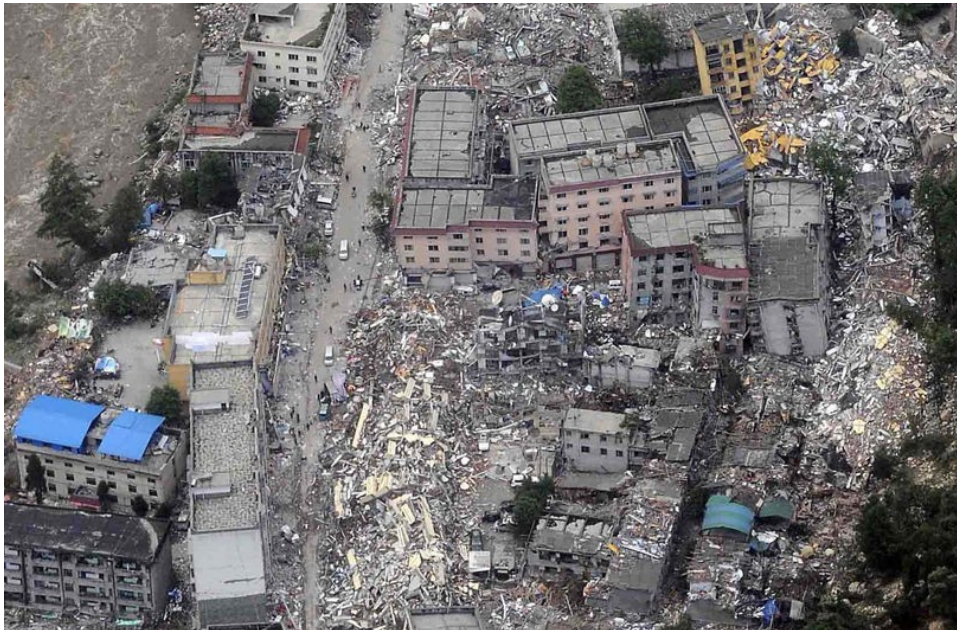
Figure 11.11. Collapsed pre-cast reinforced concrete buildings at various places

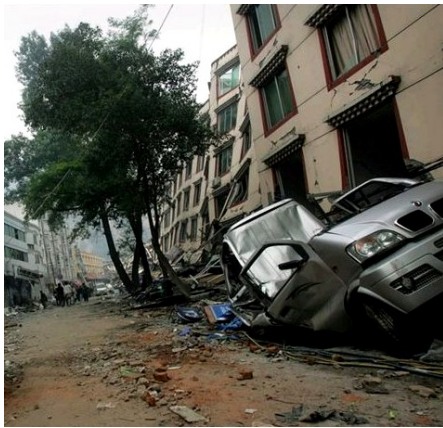
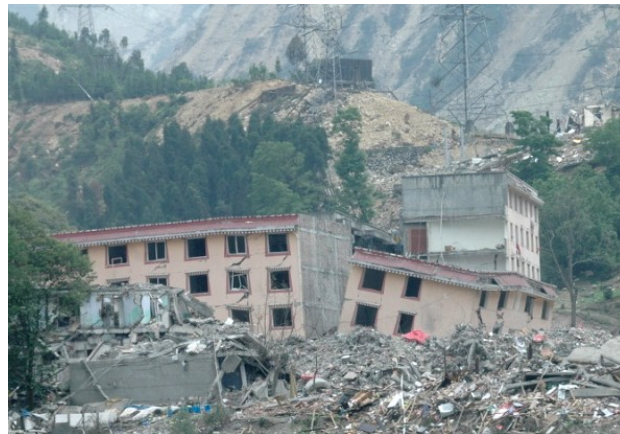
The earthquake fault, known as Yingxiu-Beichuan fault started to rupture in the west of Yingxiu, passed through Beichuan and extended to Qingchuan County. Yingxiu and Beichuan town are situated just above the earthquake fault. The fault splays into numerous surface ruptures when it closes to the ground surface due to vertical stress reduction. Some surface ruptures measured in Yingxiu, Beichuan and Qingchuan are more than 2-3m. The permanent ground displacement as well as individual surface ruptures causes topographic changes and impose forced displacements on the surface and underground structures. Many buildings as well as other structures were damaged or totally collapsed due to these forced displacements induced by faulting (Figures 11.11. to 11.14). In spite of some damage some structures survived these displacements and deserve further detailed studies.

Figure 11.13. Damage to structures due to forced displacements induced by faulting in Yingxiu

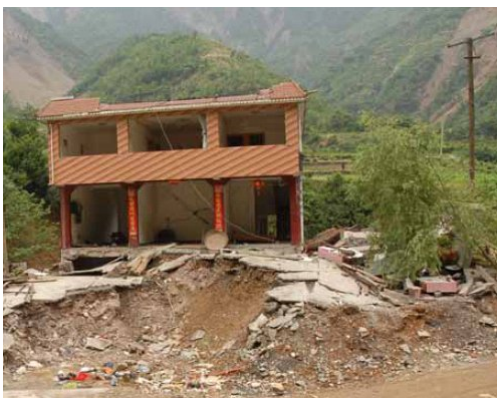
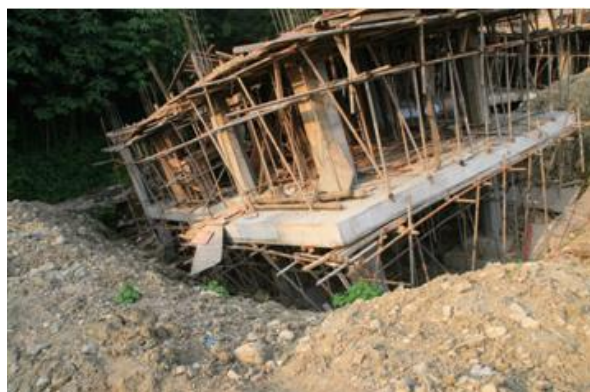
Figure 11.14. Damage to structures due to forced displacements induced by faulting in Qingchuan

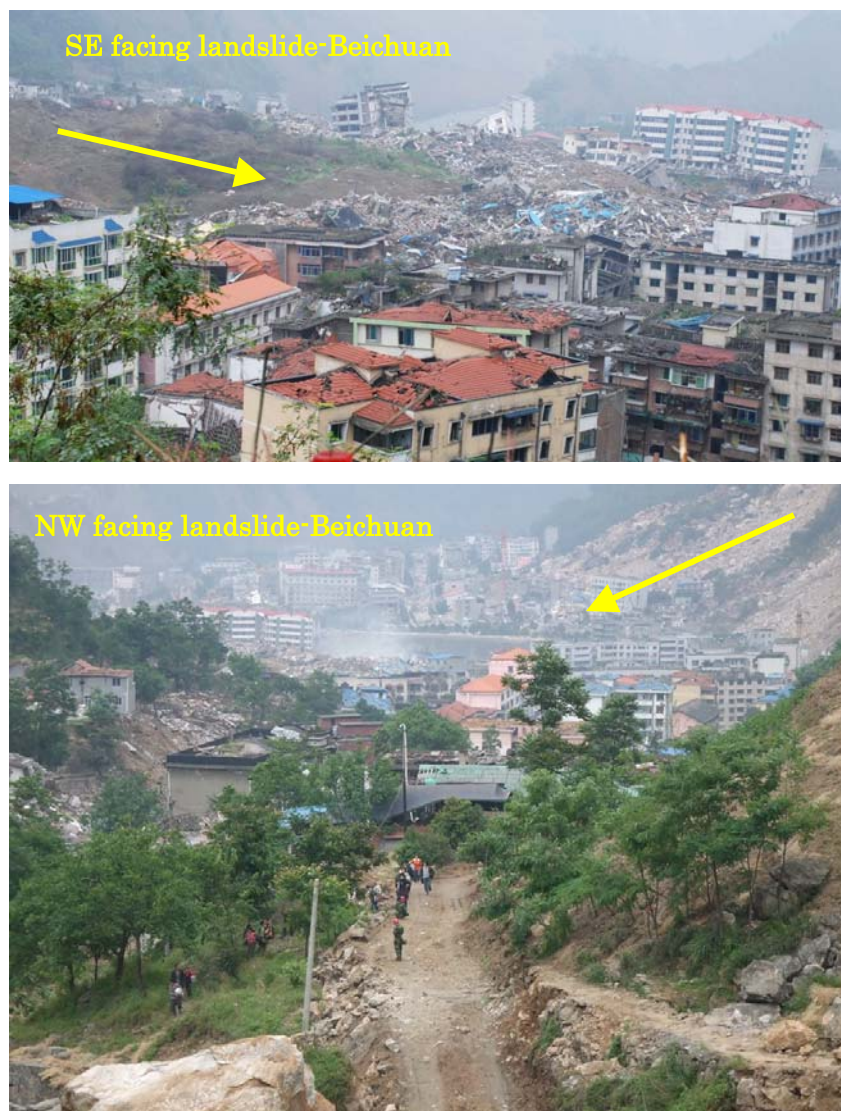
This earthquake caused many slope failures resulting in large-scale failures called landslides. Such landslides were observed particularly in mountainous area and the hanging-wall side of the earthquake fault. Among all large-scale landslides, the landslides in Beichuan destroyed town and the landslides came from both mountains adjacent the town. The NW facing slope caused by mainly the sliding of limestone formation, while the SE facing slope was caused by the sliding along bedding plane and shearing of the phyllite-like layers (some referred it as mudstone???) (Figures 11.15 and 11.16). Another landslide at Donghekou destroyed the entire village. These scale landslides induced damage on buildings of a town are very rare and deserve further studies.

Figure 11.15. Views of the landslides in Beichuan

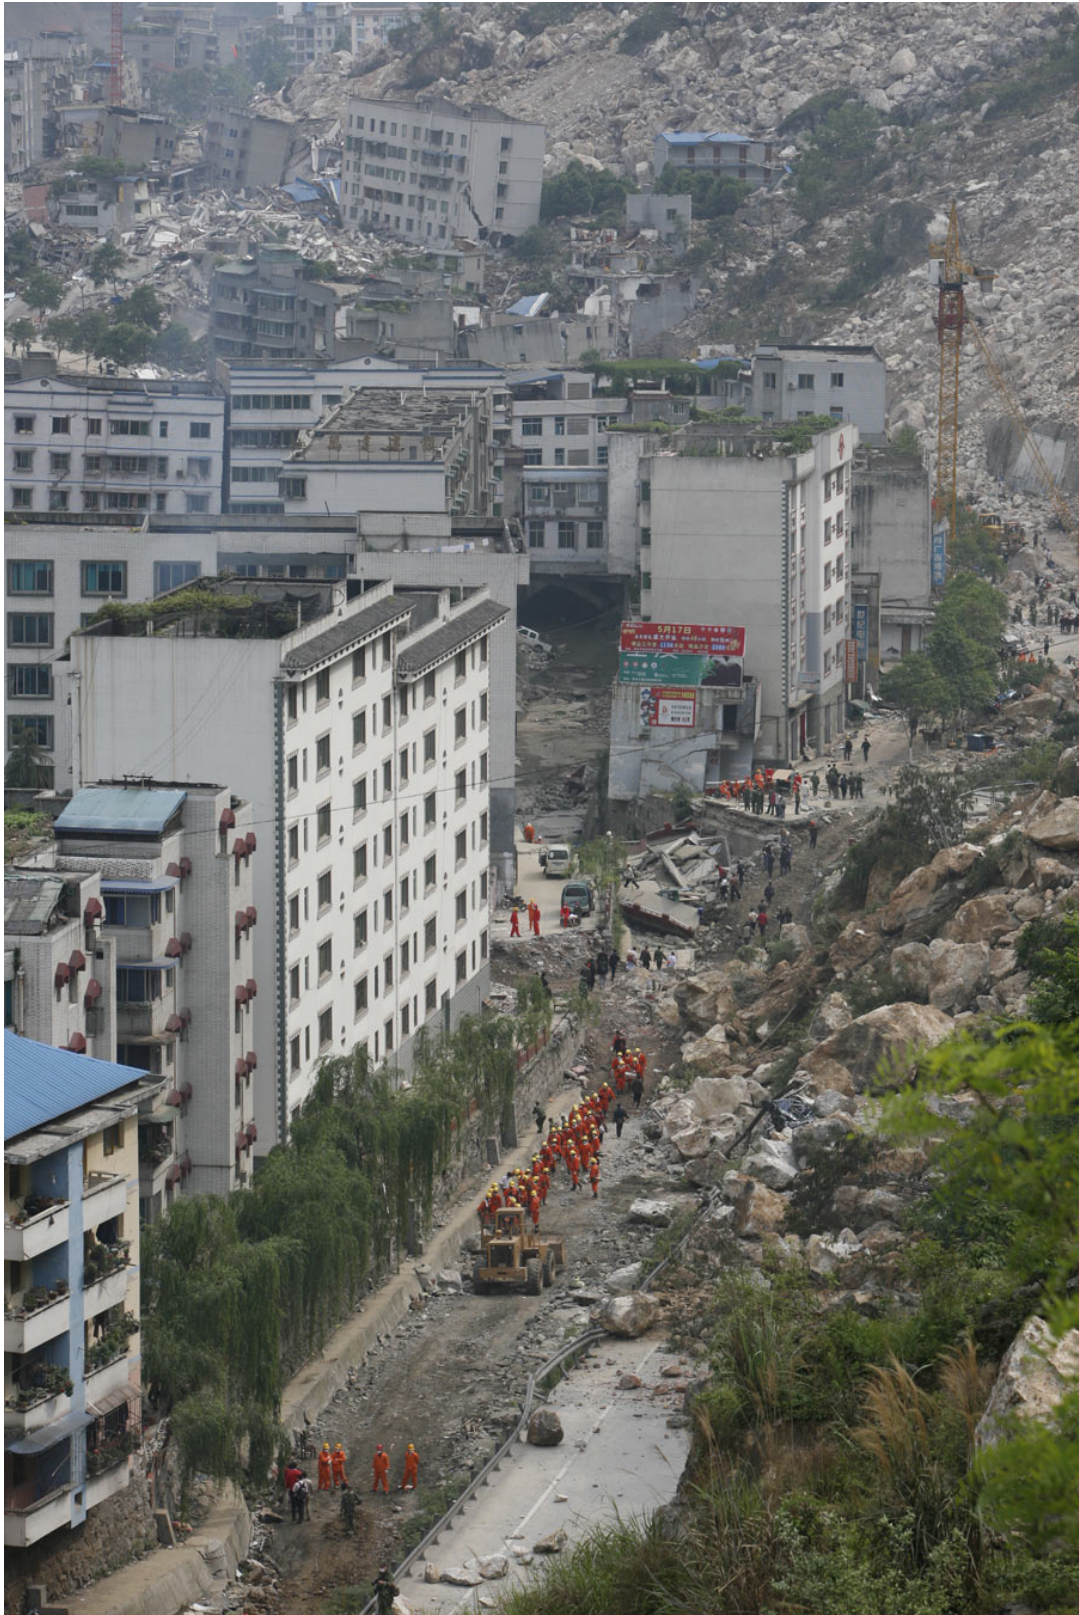
Figure 11.16. A close-up view of the NW-facing landslide in Beichuan

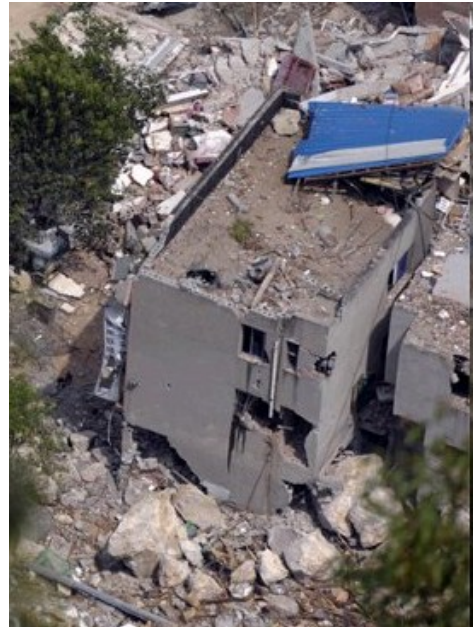
Rockfalls induced by ground shaking also caused damage in many places in the mountainous area. Figure 11.17 shows several examples of such damaged. Their impact may be of a large scale and the damage induced in residential buildings can be particularly of great concern. Especially, the question will be how to identify such blocks, which may be put into motion during earthquakes.

Figure 11.17. Rock fall induced damage on buildings
