Japan Society of Civil Engineers
Yotsuya 1, Shinjuku-ku, Tokyo 160-0004
<http://www.jsce.or.jp/>

3. BUILDINGS AND DWELLINGS

The January 13, 2001 Off the Coast of El Salvador Earthquake

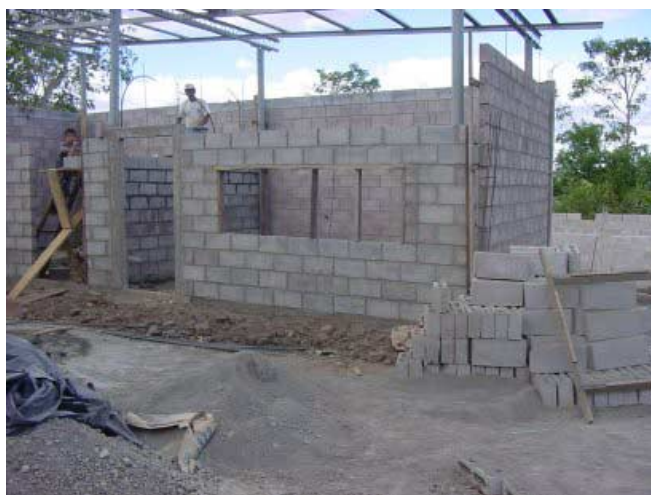
The reinforced masonry is popular in El Salvador. The use of concrete blocks is more extended than the use of clay bricks due to economical reasons. **Figure 3.1** shows a typical reinforced masonry building under construction.

Figure 3.1. Reinforced masonry house with concrete blocks

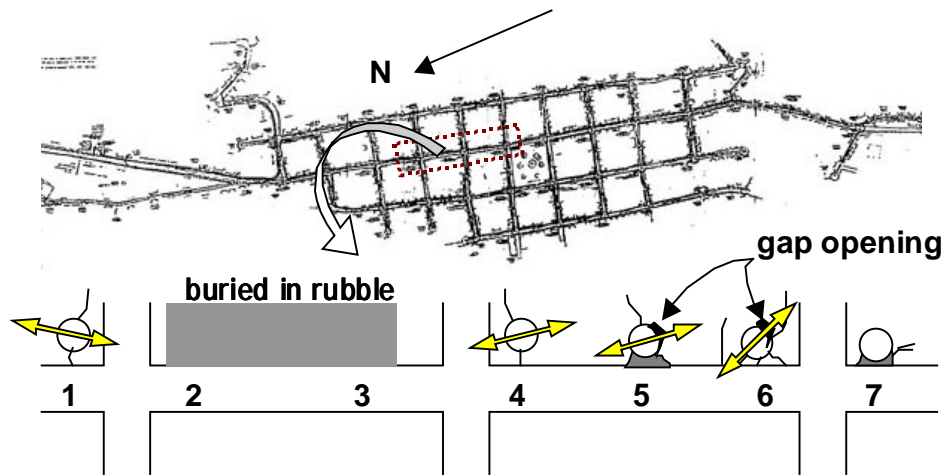
Utility poles (5m tall) are embedded upright in concrete-paved sidewalk in this town (**Figure 3.10**). Cracks developing outwardly on the pavement from these poles suggest possible directions in which ground motions were intense (**Figure 3.11**). Some poles (**No. 6** and **7**) are very close to the step-shaped edge of the sidewalk. The thin cover concrete thus might have affected the crack pattern. Though the number of the examined utility poles is not sufficient for thorough statistical manipulations, some poles seem to have been forcibly shaken in about N-S direction.

Figure 3.10. Locations of utility poles
