4. LIFELINES AND CRITICAL FACILITIES

The January 13, 2001 Off the Coast of El Salvador Earthquake

4.2 ELECTRICITY

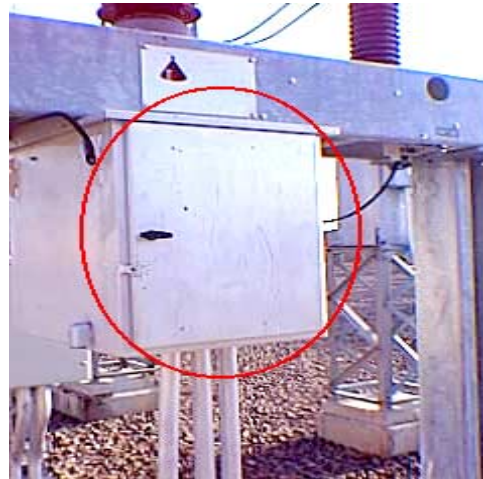
Figure 4.7. Main switch board

Shortly after the earthquake, functioning installations in some damaged substations were brought in full operation to make up for the drop in power supply caused by damage to their transformers, bushings, interrupters, connectors, radiators, and circuit breakers. At Soyapango and Nejapa substations, some insulators and bushings for lightning rods and transformers (30/40/50 MVA and 110-46/23 kV) were broken (**Figures 4.2 and 4.3**). Heavy equipments such as power transformers and their radiators were broken, and oil leaked from their bottoms (“15 de Setiembre” substation, **Figure 4.4**). Supporting rods of interrupters were broken at their bottom ends (Nejapa Substation, **Figure 4.5**). For interrupters, the intense shake was not the sole cause of the damage to them. Flashovers (electric arcs) around or over the surfaces of insulators and/or short-circuits damaged equipments at Nejapa Substation (**Figure 4.6**). At Tecoluca Substation, short-circuit in a circuit breaker caused the damage to the main switchboard of an isolator (**Figure 4.7**). Obviously, porcelain insulators and/or bushings for substation equipments were quite susceptible to intense shakes and easily broken during the strong shaking. In addition to the abovementioned substations, major damages to porcelain devices were reported at Nuevo Cuscatlan, San Martin, Ateos, San Antonio Abad, but less at other substations.
