Summary of Las Colinas Landslide

2.6 OTHER LANDSLIDES

2.7 SUMMARY AND RECOMMENDATIONS

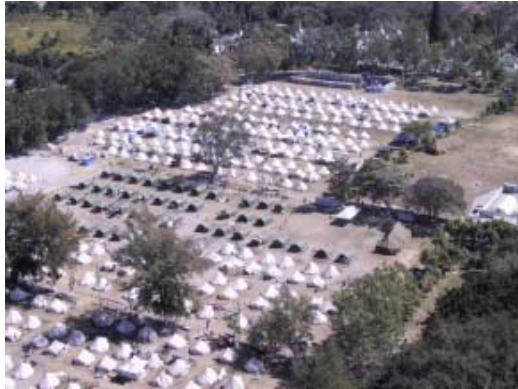
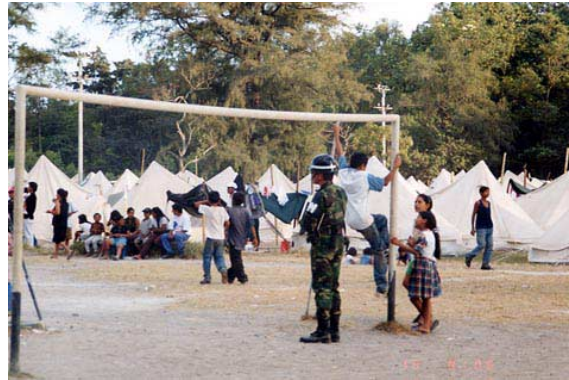
Figure 2.51. Refugees' camp

Extensive cracks remaining along El Balsamo ridge are certainly the serious threat of further slides. The city of Santa Tecla was controlling the potential hazard zones, the red zone with the highest risk and the yellow zone of slightly less danger (**Figure 2.50**). A week after the earthquake, the number of residents evacuated from the zones exposed to the menace of possible landslides reached 14,000, and as of Feb. 3, about 4,000 refugees were still being forced to live in tents (**Figure 2.51**). Since the rainy season starts in April or May, necessary countermeasures should be taken because even flat-lying areas away from sudden changes in slope angle may be still within the possible reach of the soil mass. Recommendations will be given in Section 2.6.

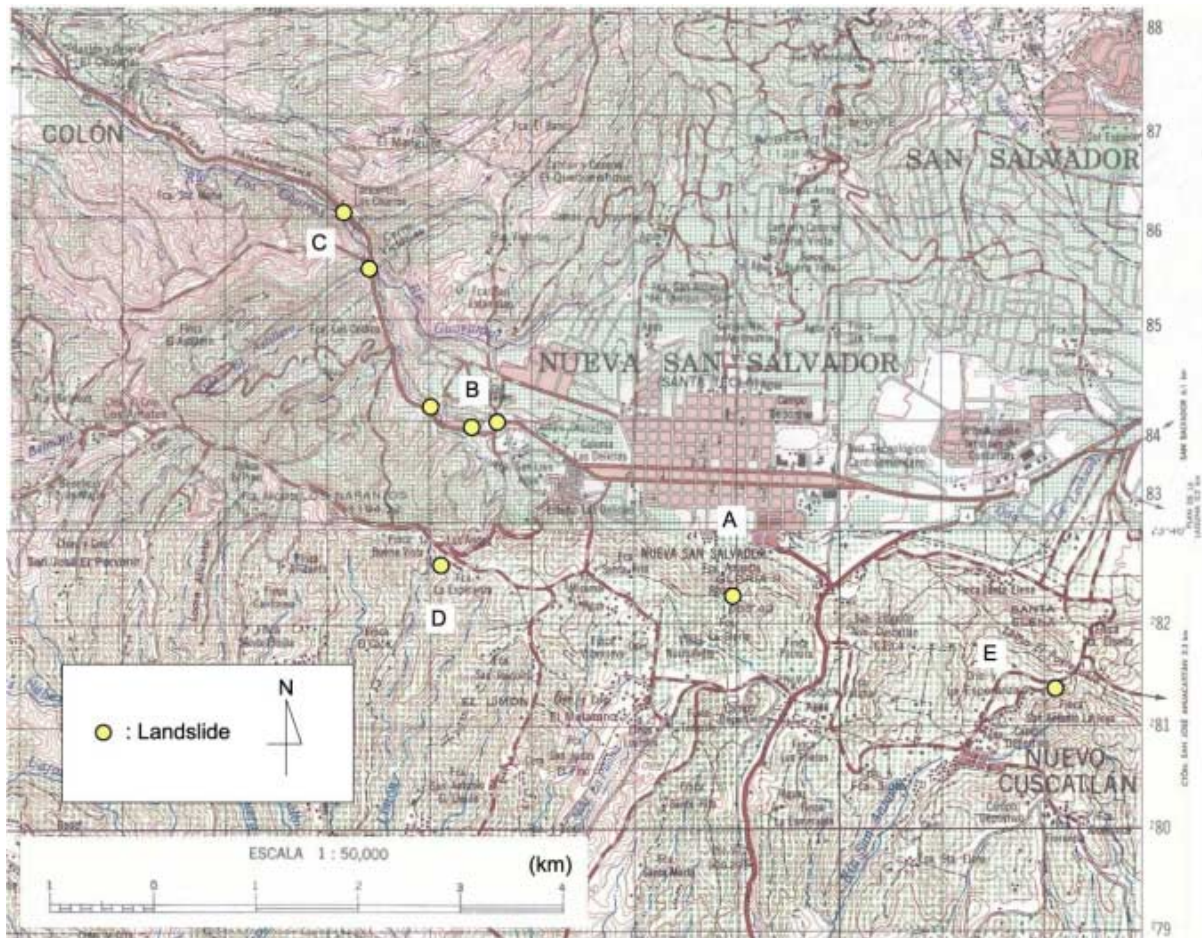
Figure 2.52. Locations of landslides in the vicinity of Nueva San Salvador (Topographical map: Ministerio de Obras Públicas, 1984)

This section describes the other landslides that the JSCE team investigated. The team had little chance to cover a wide area of the nation during their short stay, and thus they narrowed their target mostly to the slides in the vicinity of Nueva San Salvador (see **Figure 2.52**: Ministerio de Obras Públicas, 1984). They include:

Point B, C and D (Some landslides in Los Chorros area. **Points B** and **C** are found along the Pan-American highway. **Figure 2.7** in Section 2.3 shows the slide at **Point D**.) and

Point E (Slope failures in Nueva Cuscatlán).
