Japan Society of Civil Engineers

## THE BİNGÖL EARTHQUAKE OF MAY 1, 2003

**Investigated and Prepared by**

July 2003

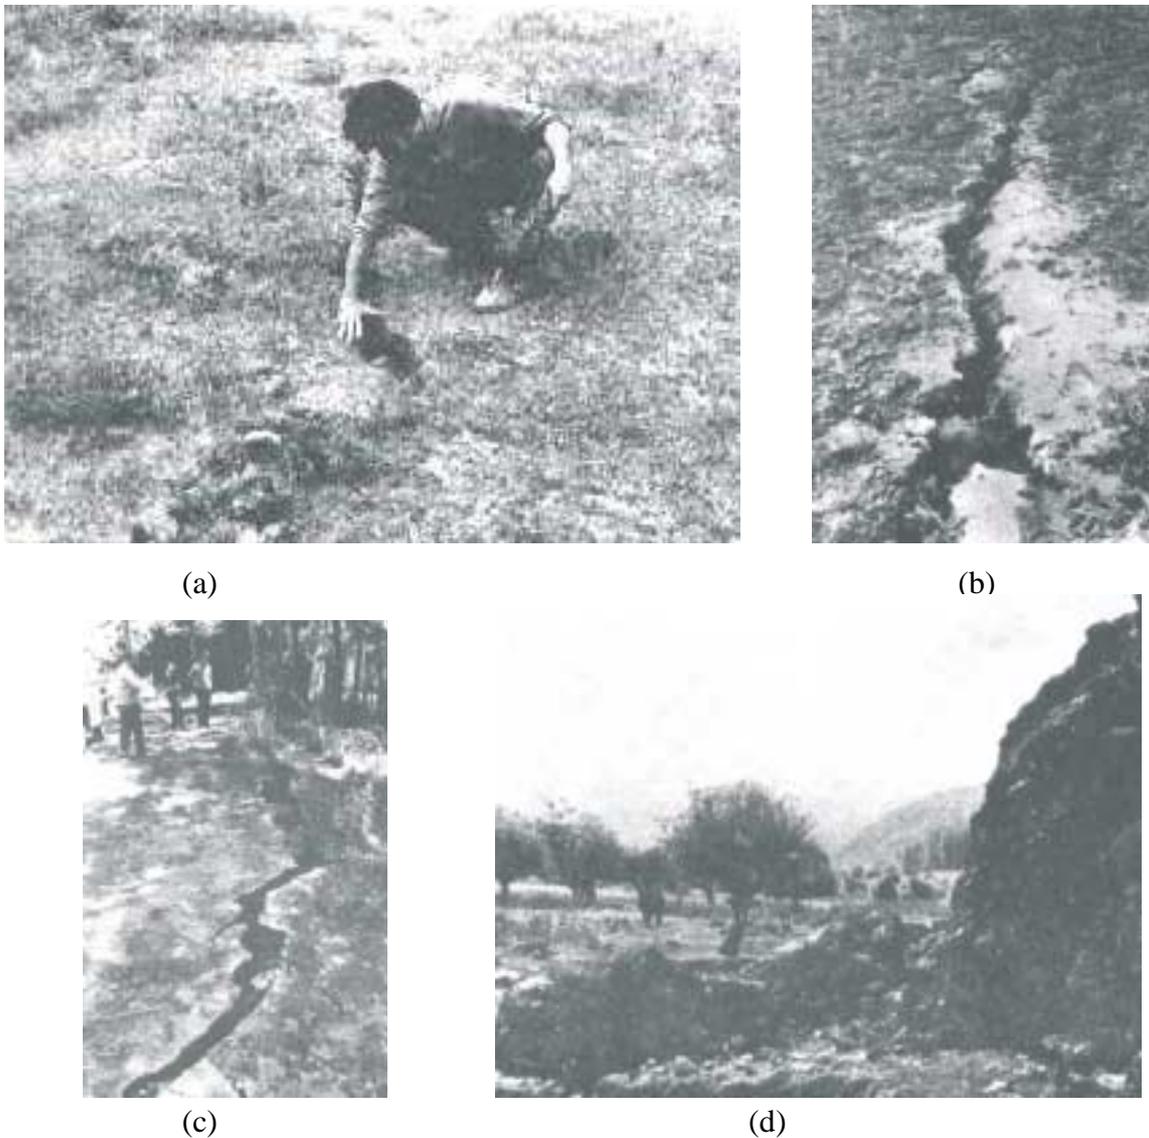
between 50 and 500 m as reported by Seymen and Aydın (1972) and Arpat and Şaroğlu (1972). These investigators also noted that although small vertical drops along the slip zones appearing on inclined topography were observed, the absence of vertical drops along the surface ruptures occurred on flat areas indicated that the causative fault had almost a horizontal component (Figure 6.4a). In addition, sand ejections along some surface cracks were observed at some locations in the alluvial sequence such as near Göynük Brook and Çeltiksuyu Brook as seen in Figure 6.4b (Aktan et al., 1972). Similarly to those observed in the recent Bingöl earthquake of 2003, landslides and rock falls were also observed on the slopes of Göynük Brook, Kös stream, and Bilaloğlu and Elmalı villages (Figure 6.4c,d).

Figure 6.4 Some views of surface fractures and liquefaction and slope failures caused by the 1971 Bingöl earthquake (after Aktan et al., 1972)

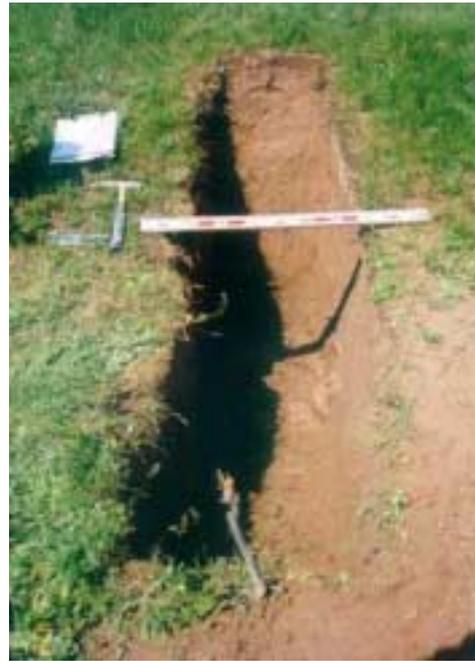
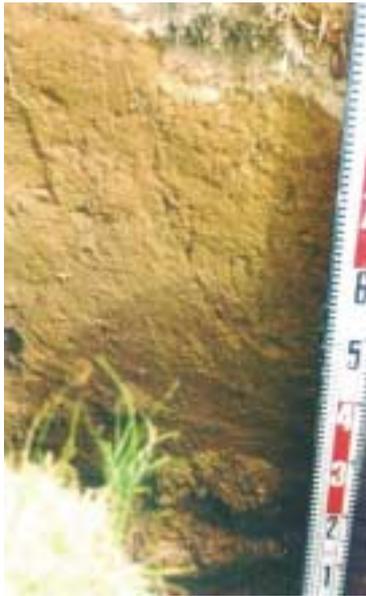
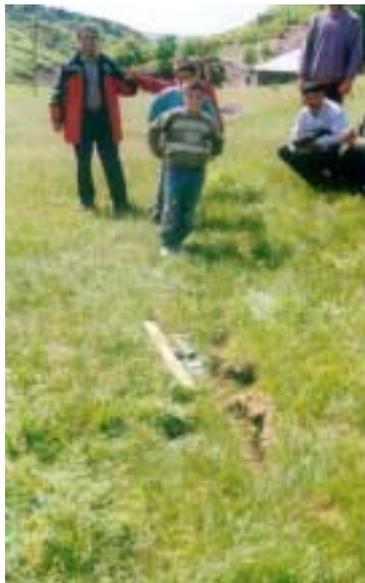
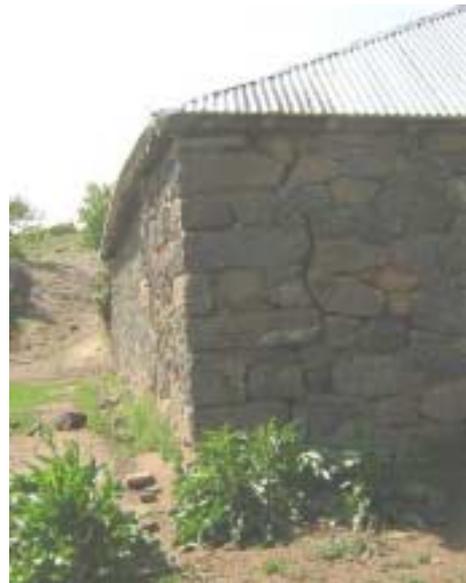
Figure 7.12: Some views of surface cracks at Hanoçayırı

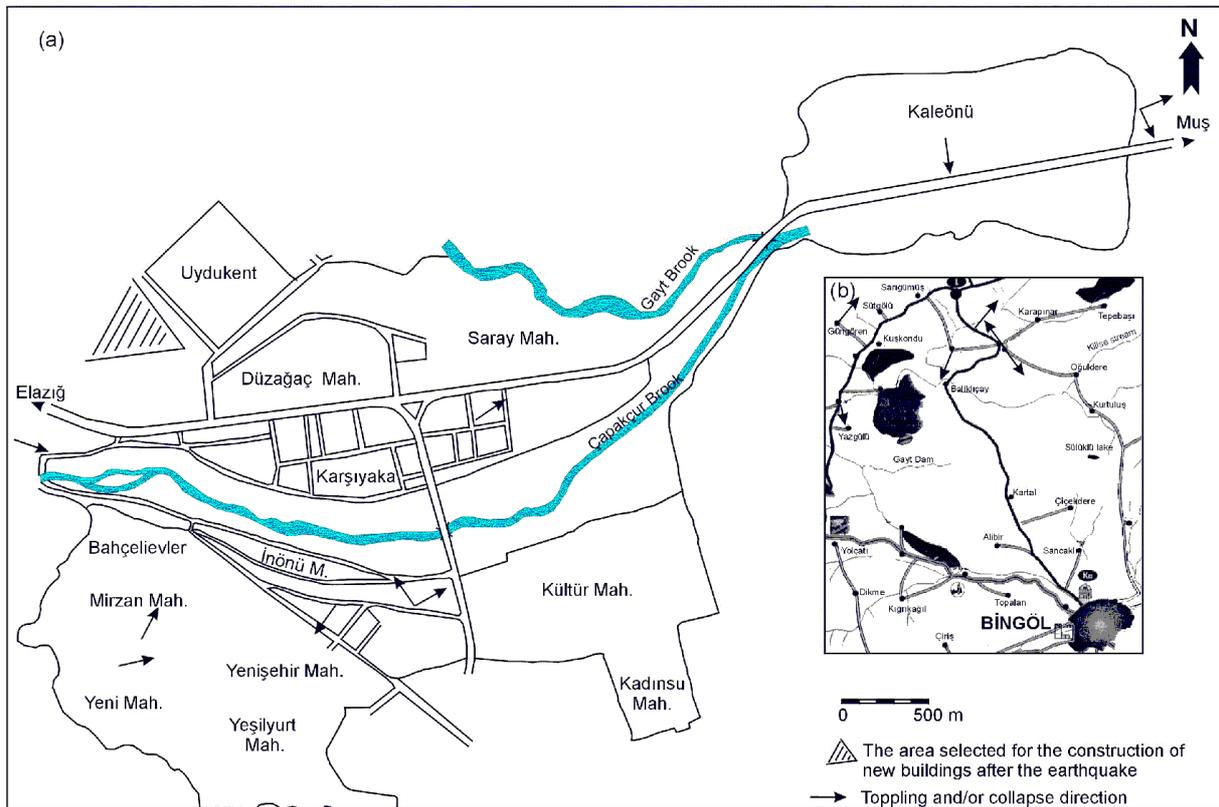
Collapse directions of buildings, minarets, garden walls and chimneys were measured by the JSCE team at some settlements, particularly in Bingöl, and are plotted in Figure 7.14. Distribution of collapse directions in Bingöl is generally concentrated in SE and NE directions. However, a few collapses are in SW and NW directions. At the north of Bingöl near to the epicenter (in Çimenli and Sudüğünü villages) different directions of collapses in SW, SE, NE, and NW were measured (Figure 7.14b). Some typical examples of collapses are shown in Figure 7.15.

Figure 7.14: Directions of collapses or toppling in the earthquake affected region

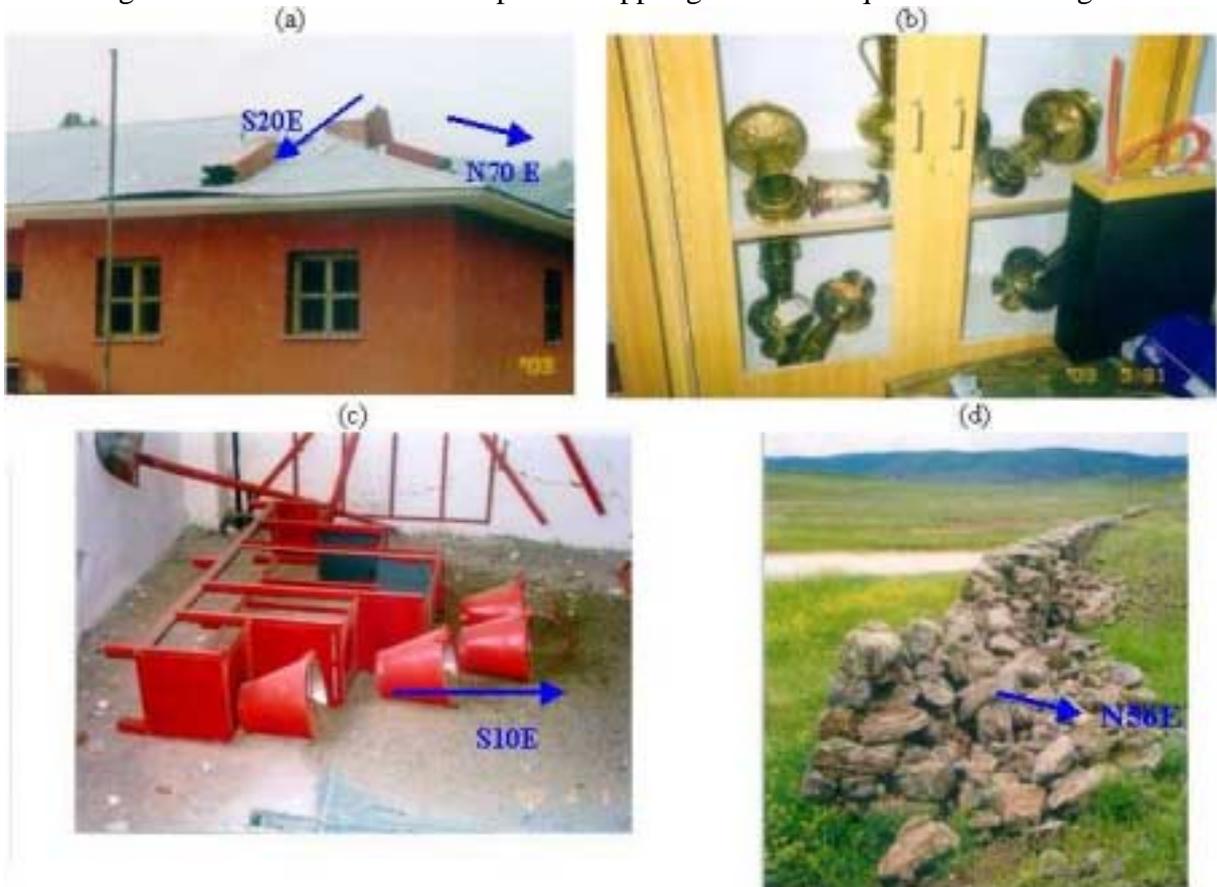
Figure 7.15: Some examples of collapses

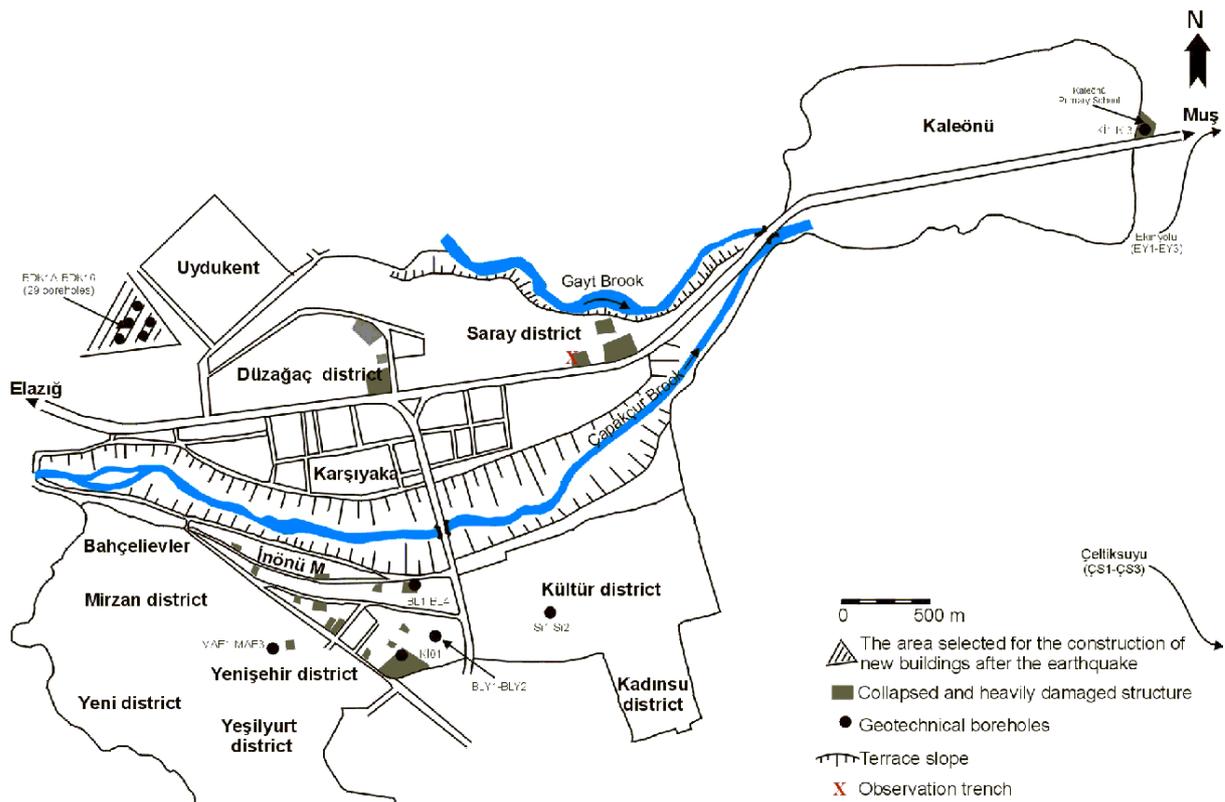
Figure 8.1: Locations of boreholes and trenches in Bingöl City

Based on the observations by the JSCE team, collapsed and heavily damaged buildings in Bingöl are also shown in Figure 8.1. These damages (Figure 8.5) are concentrated on the cliff sides of the terraces bounded by the Çapakçur and Gayıt Brooks. This situation suggests a possible amplification at the cliff sides due to topographical effects as presented in Chapter 7 and illustrated in Figure 8.6. These effects may also be responsible from the considerably high peak horizontal ground acceleration values measured at the Bingöl station, which is located close to the cliff side in Düzağaç district adjacent to the Gayıt Brook.

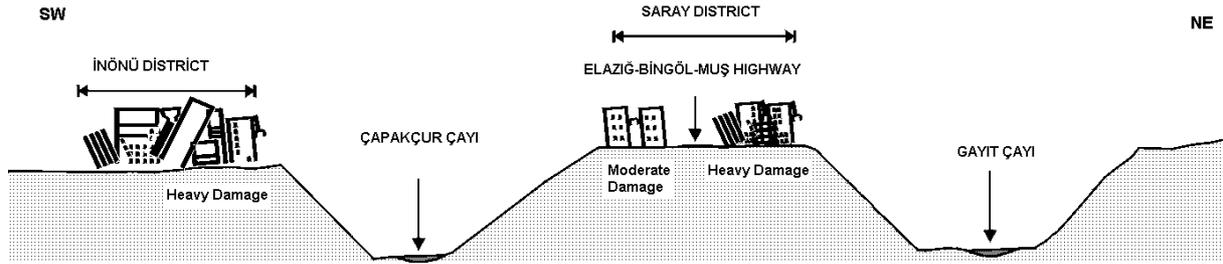
Figure 8.6: A topographic profile in NE-SW direction and its relation to damage state

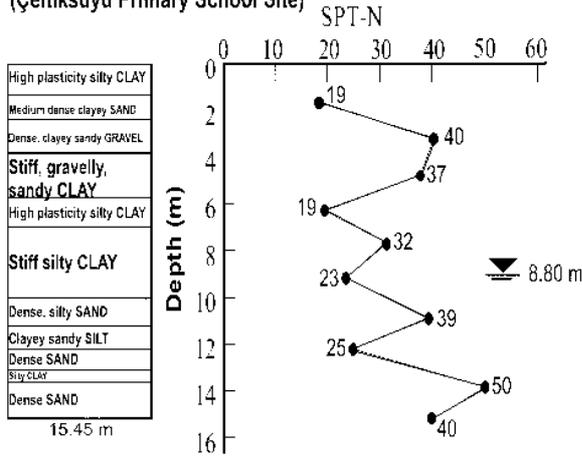
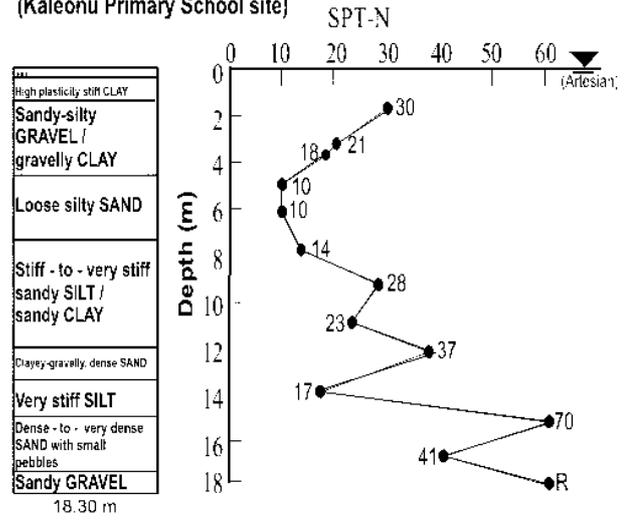
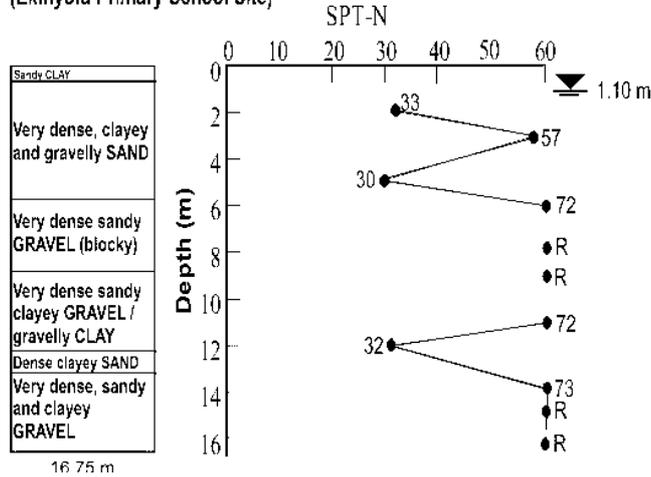
Figure 8.9: Logs of some boreholes at the sites of collapsed school buildings

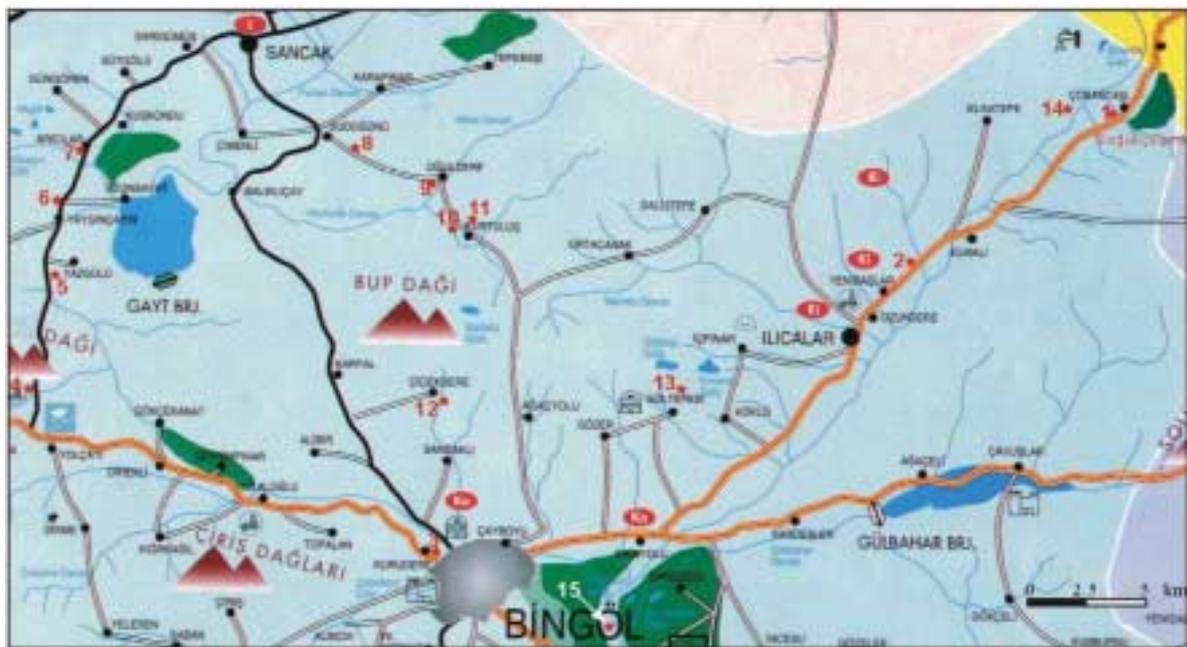
1,2,3,5,9: Rotational slide; 4,7,10,12,13: Rock fall; 6,8: Liquefaction and lateral spreading;1,14,8: Flow; 15: Liquefaction

Figure 8.10: Locations of geotechnical failures

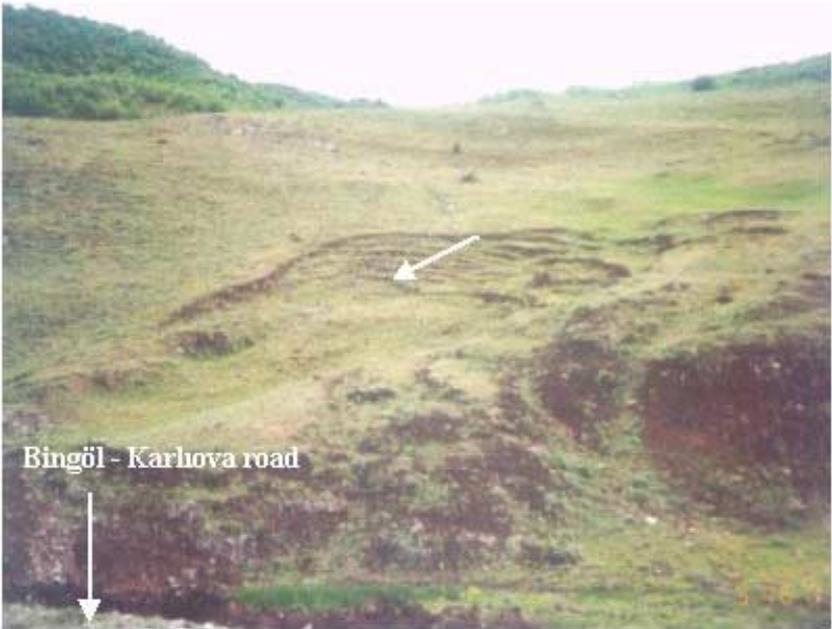
**Herdere slide:** This small local slide was observed at Herdere location between Ilıca and Soğukçeşme on the SW cut of the Bingöl-Karlıova road (Location 2 in Figure 8.10). The failed material is similar to that observed at Soğukçeşme slide (Figure 8.12).

Figure 8.12: Landslide at Herdere

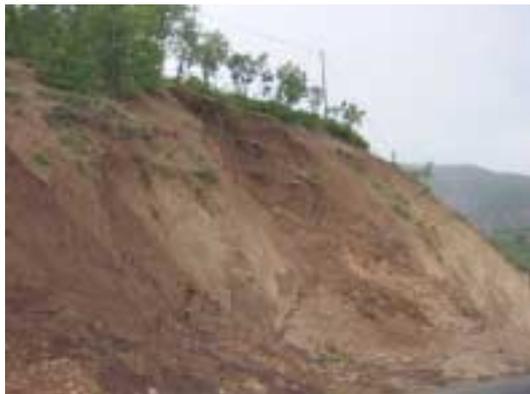
**Bingöl slide:** A local slide on the southern cut of the Bingöl-Elazığ road occurred at the western end of Bingöl (Location 3 in Figure 8.10). The sliding material is composed of terrace deposits involving relatively high amount fines. It is a 10m high slope with an inclination of  $65^{\circ}$  (Figure 8.13).

Figure 8.13: Bingöl slope failure

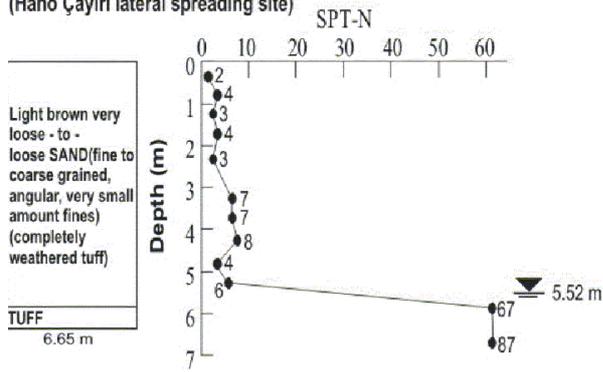
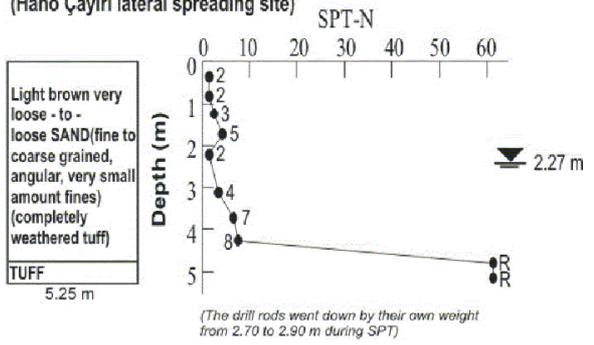
Two boreholes (H1 and H2), 6.65 m and 5.25 m deep, respectively, were drilled at Hanoçayırı. The distance between the boreholes is about 100 m. Simplified logs of these boreholes are depicted in Figure 26. It is evident from Figure 26 that the uppermost level of the sequence approximately between 0 and 5.5 m consists of light brown-to-beige, very loose-to-loose sand sized material derived from the tuffs (Figure 27). This material is moist-wet, fine-to-coarse grained, and includes angular-subangular grains with some fines. SPT tests were carried out at every 50 cm interval throughout both boreholes. In this material, very low SPT-N values, which ranged between 2 and 8 and generally between 2-4 near to the surface, indicated a very loose state suitable for liquefaction. The bedrock (tuff) lies at about 5 m from the surface. Depth of the groundwater table at the location of borehole H1 was measured as 5.5 m, while it was at 2.25 m below the surface in borehole H2. If the relative elevations of the boreholes and topographical inclination ( $3^{\circ}$ ) are considered it can be concluded that position of the groundwater table was nearly parallel to the surface at the time of drilling. However, it is expected that depth of the groundwater table could have been very shallow during the earthquake than that of measured from boreholes, probably because of heavy rains occurred before the earthquake.

Figure 8.26: Simplified borehole logs at Hanoçayırı

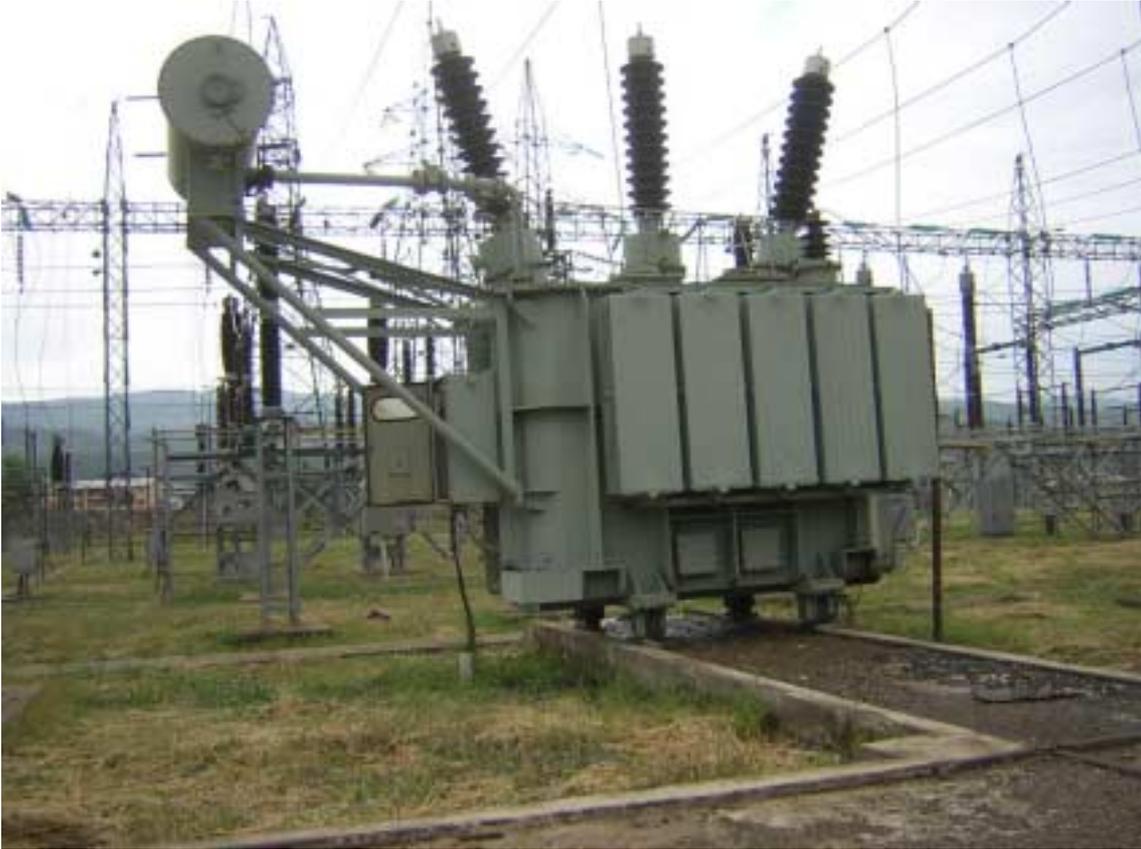
There was one main sub-station, namely, Bingöl, which reduce the voltage from 154.0 kV to 33 kV (Figure 9.3). During this earthquake, the sub-station was not damaged, although some sliding and rocking of three transformers of Bingöl sub-station of TEDAŞ occurred because of shaking (Figure 9.4). However, the effects were minimal without disturbing their functions. Some elevated transformers on pylons in the towns and cities were displaced from their locations. Poles and pylons of the electricity distribution system in Bingöl and nearby towns and villages were not damaged due to ground shaking. The electricity was back 4 hours after the earthquake. The electricity was first supplied to the state hospital. At 9AM, the other two hospitals and semi-underground water reservoirs were supplied with electricity. Due to sliding of transformers at water reservoirs, they can not be in operation by 2 PM on May 1.

Figure 9.3: Non-damaged Bingöl sub-station

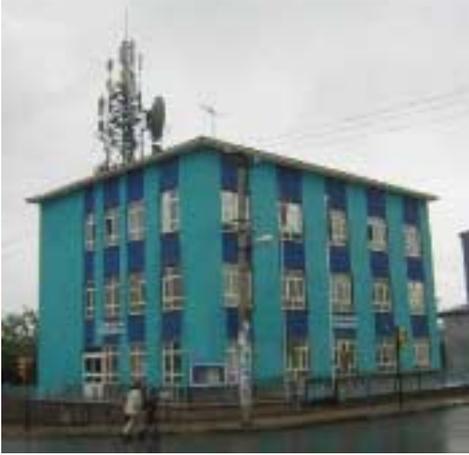
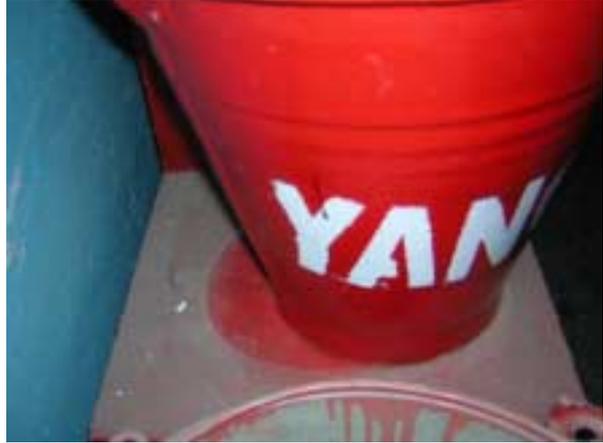
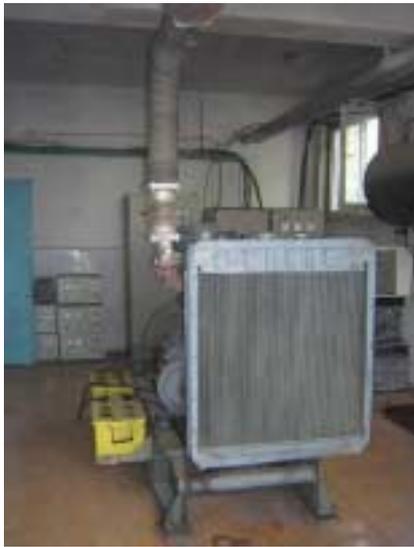
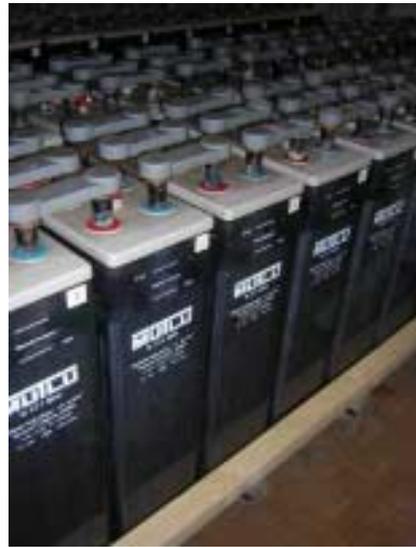
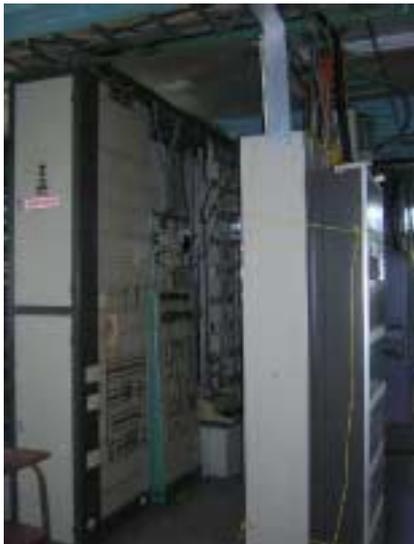
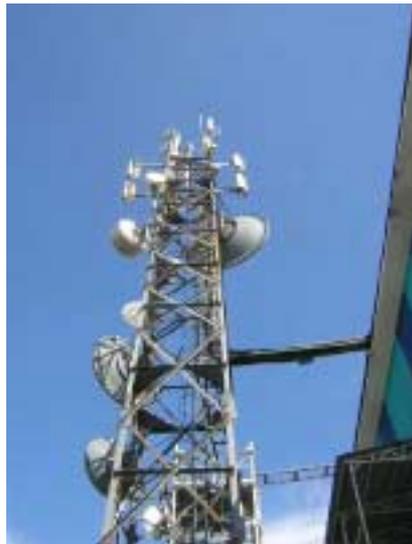
The telecommunication system in Turkey is run by the TÜRK-TELEKOM. During the earthquake, the main building of the TÜRK-TELEKOM was slightly damaged in spite of its poor construction quality. However, the relay towers of the system were almost non-damaged. The generator anchored to foundation was non-damaged and it was in operation as soon as the electricity supply was cut. The telephone system was almost uninterrupted except the heavily damaged areas. The telephone service was well-functioning and no congestion of phones to the region was observed. Additional first aid telephone lines were set up by the TÜRK-TELEKOM and were free of charge soon after the earthquake, including all public telephones. Figure 9.5 shows some views of the equipments of facilities of the telecommunication station.

(b) Displaced sand bucket (1<sup>st</sup> floor)

(e) Tilted racks

Figure 9.5: Views of equipments and facilities at Bingöl Telecommunication station

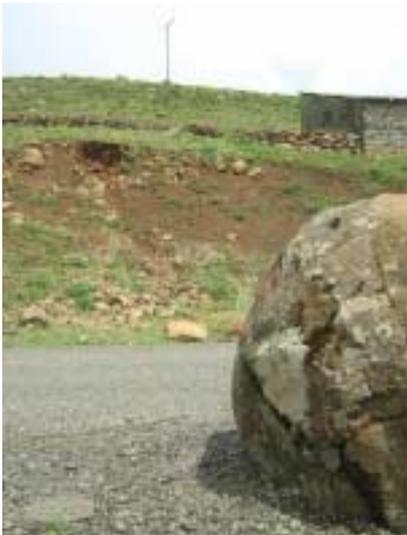
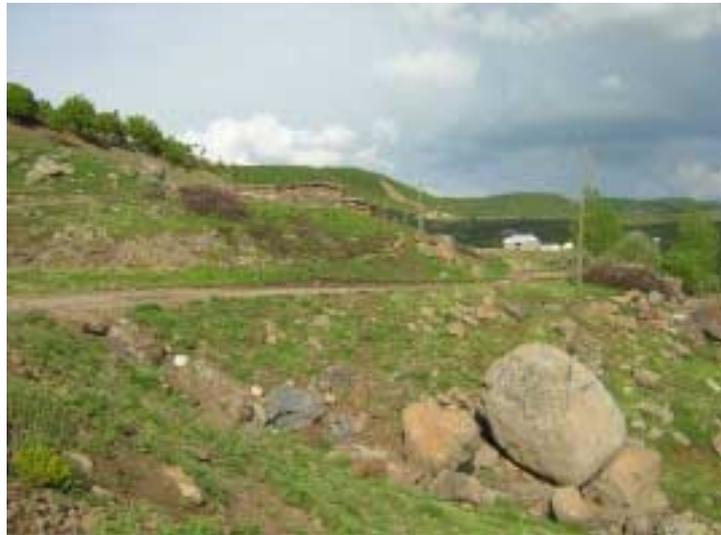
Figure 10.3: Fallen rock blocks on roadways

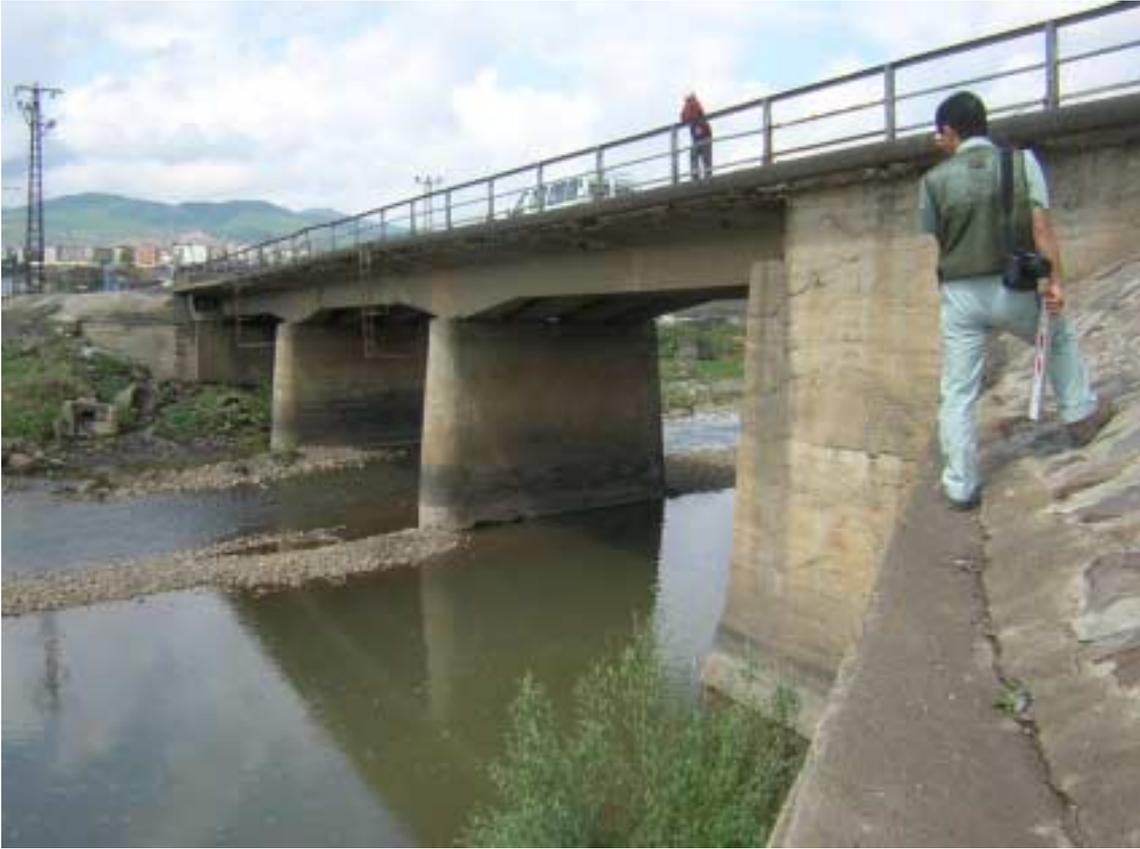
The highway bridges over Gayıt, Çapakçur and Göynük Suyu brooks nearby Bingöl City and a highway and railway bridge over Keban dam lake at Gülüşkür and small bridges in the epicentral area were investigated. The RC three-span bridge (Axis is EW) over Gayıt brook (Bingöl-Erzurum Highway) was not damaged (Figure 10.4). The bridge is cast in-place and girders are simply supported. Another RC two span bridge (Axis NS) at the north of Bingöl City was also non-damaged.

Figure 10.4: Non-damaged RC three-span highway bridge on Gayıt brook

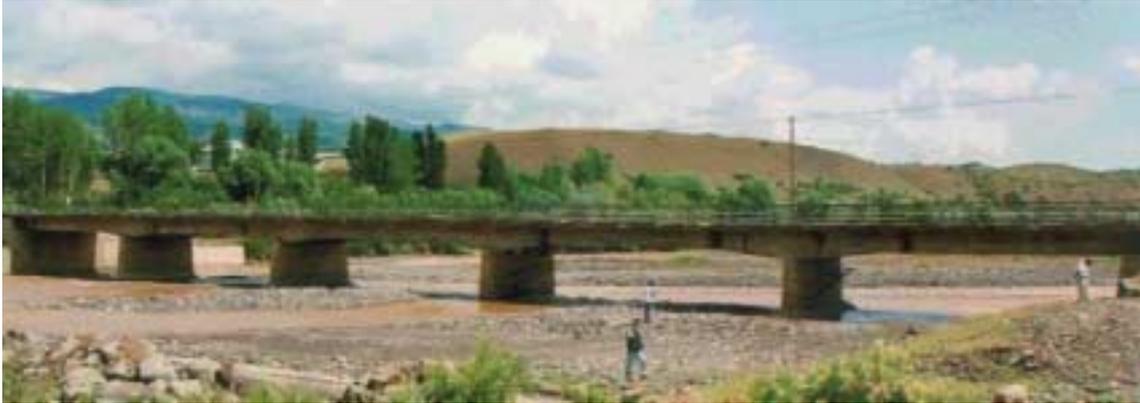
(a) Göynük Brook Bridge on Bingöl-Muş Highway

The RC five span bridge (Axis NS) over Göynük brook was slightly damaged. This bridge is about 60m long and its structural mechanics model is Gerber-type as shown in Figure 10.6. Some flaking of piers and sliding of Gerber-type girder were observed. The offset sliding of the girder at the southern part of the bridge was about 10cm. Similar damage to this bridge was also observed in the 1971 earthquake (see the report by Aktan et al. 1972).

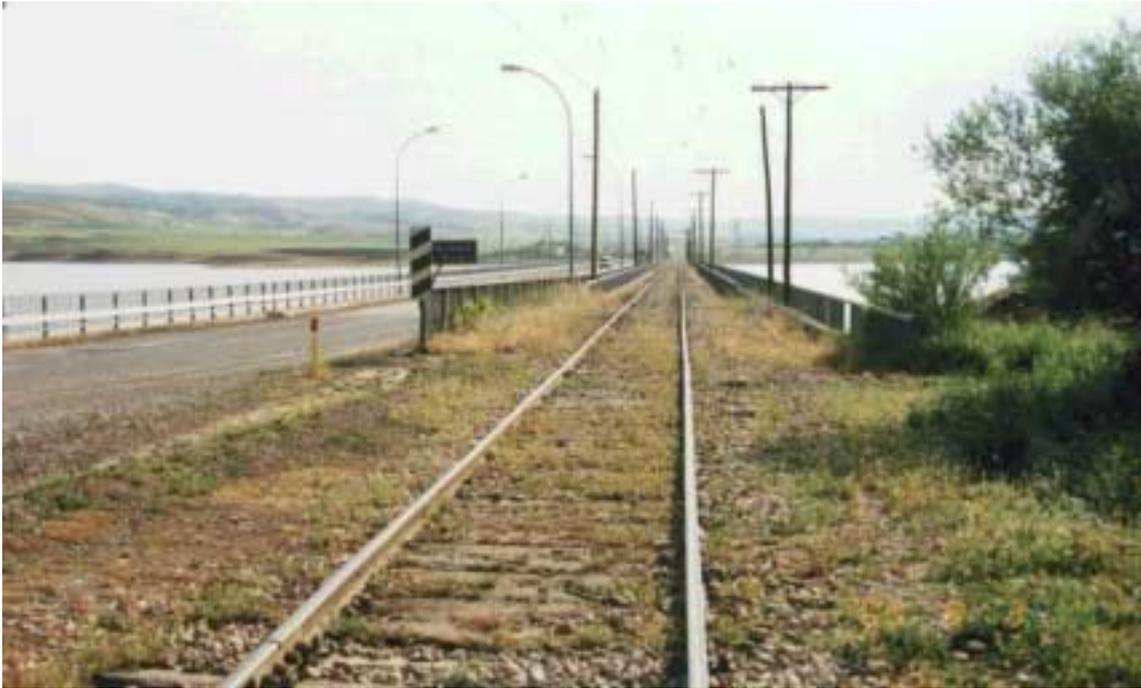
The highway and railway bridges over Keban dam lake at Gülüşkür were non-damaged (Figure 10.7). The RC two span bridge at Çimenli village and small bridges nearby Arıcılar and Punan brook between Sancak and Sudüğünü in the epicentral area were non-damaged (Figure 10.8).

Figure 10.7: Non-damaged highway and railway bridges over Keban dam lake at Gülüşkür

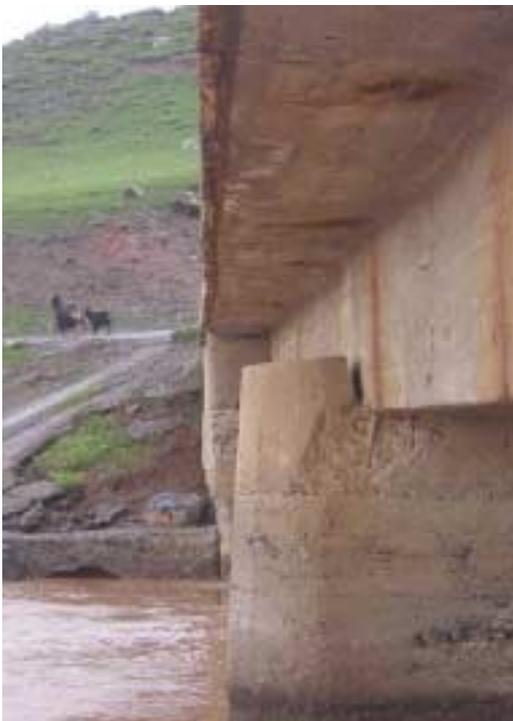
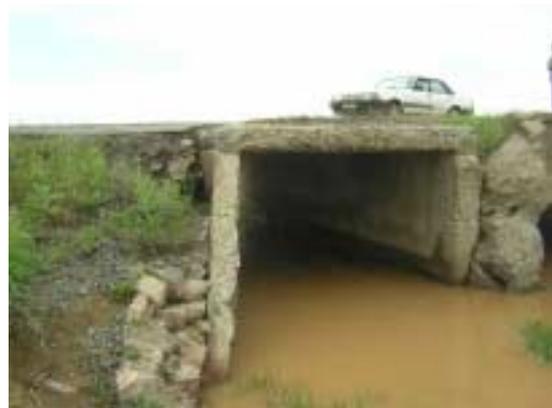
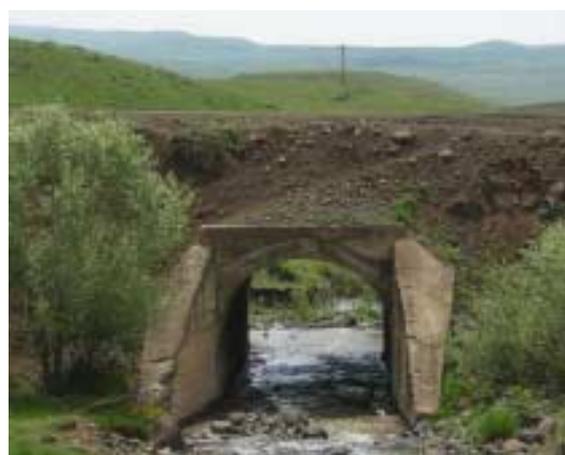
Figure 10.8: Non-damaged bridges in the epicentral area

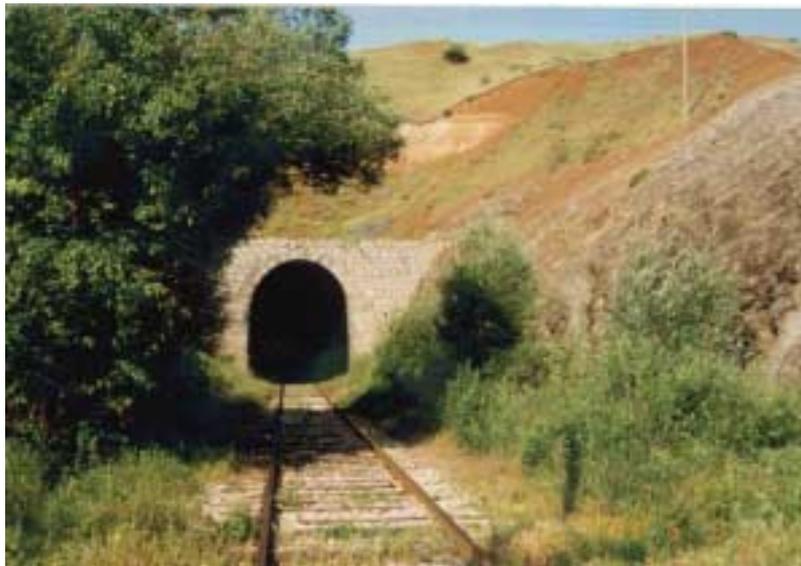
The tunnels in the earthquake region are associated with the state railway. There is no report about any damage to tunnels in the region. During the investigation, the authors could only check two tunnels. Figure 10.9 shows views of the single track tunnel at Gölüşkür and Palu. Palu is a town situated on the East Anatolian Fault and Murat River flow the town of Palu.

(a) Gölüşkür Tunnel nearby Keban Dam Lake

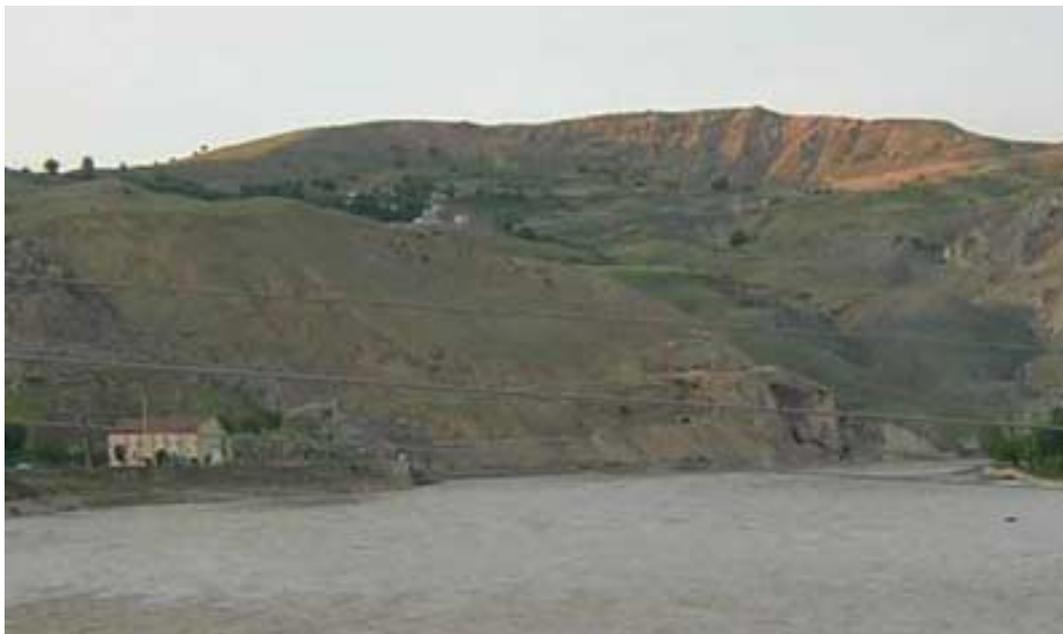
(b) Palu Tunnel along Murat River on East Anatolian Fault

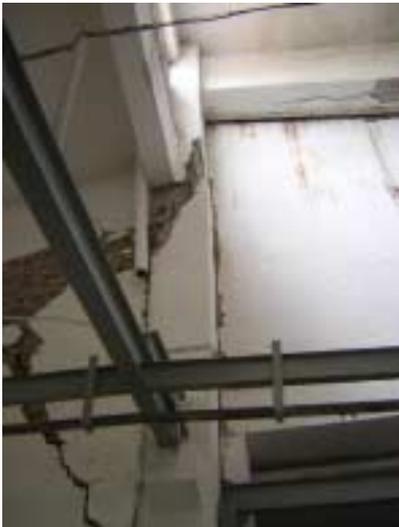
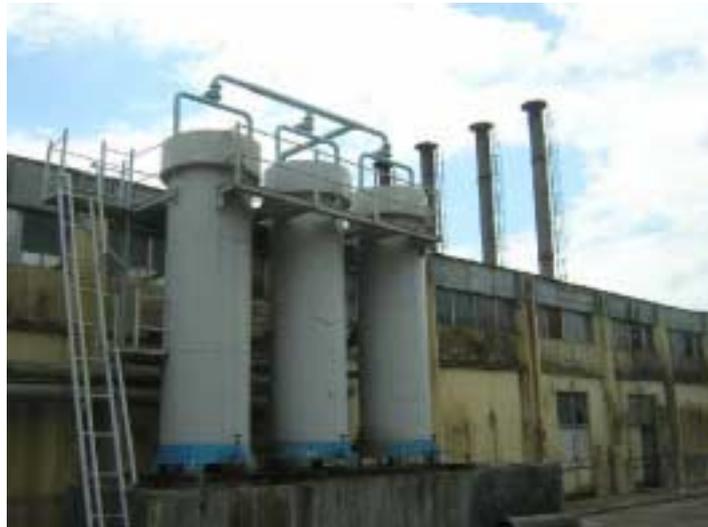
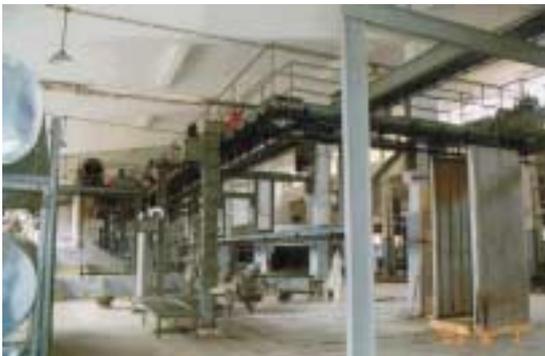
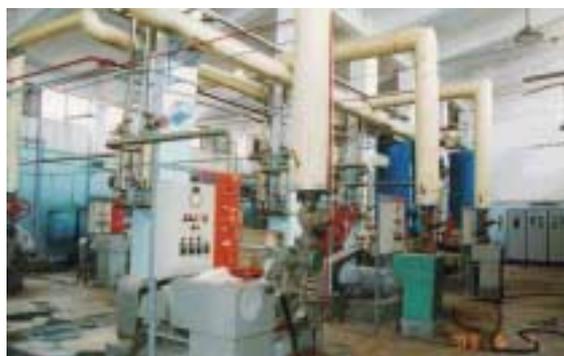
Figure 11.1: Some views of Et-kombinas plant

Et-Kombinas owned by the state company (T.C. Et ve Balık Kurumu – Meat & Fish State Company) has a huge plant for animal slaughtering and meat processing and storage. The damage was limited to shear fracturing of some concrete columns. The building was a RC structure with solid brick infill walls. Since the machinery was fixed to the foundation through anchors, no sliding or overturning of machinery took place (Figure 11.1).

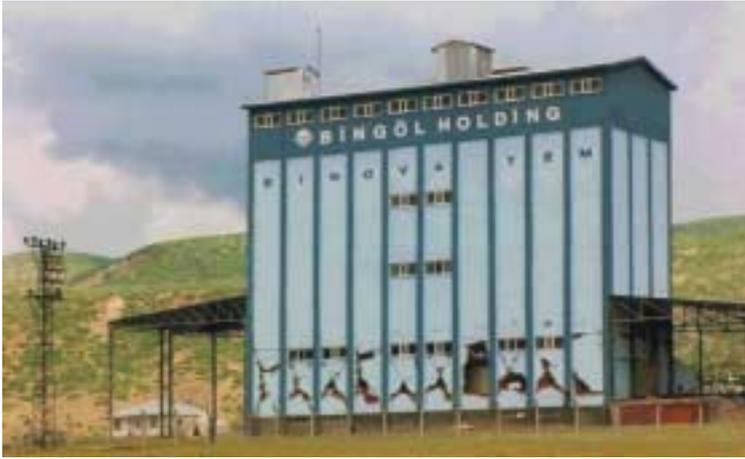
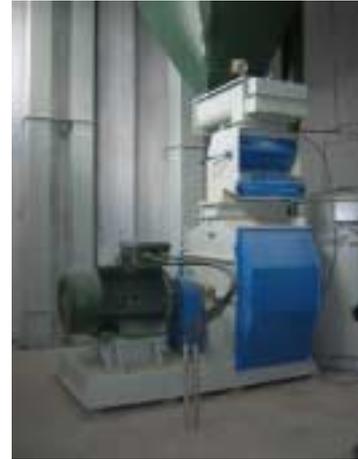
Figure 11.2: Views of Binova Yem Plant

Binova Yem plant is an animal-food processing and storage facility. The RC structure is about 12m high and built in 1999 (Figure 11.2). Two columns of the building were heavily damaged. Nevertheless, no damage to machinery or silos of this plant was seen. The overturned fire-extinguisher device at this plant implied that the ground acceleration should have been greater 0.25g at this plant.

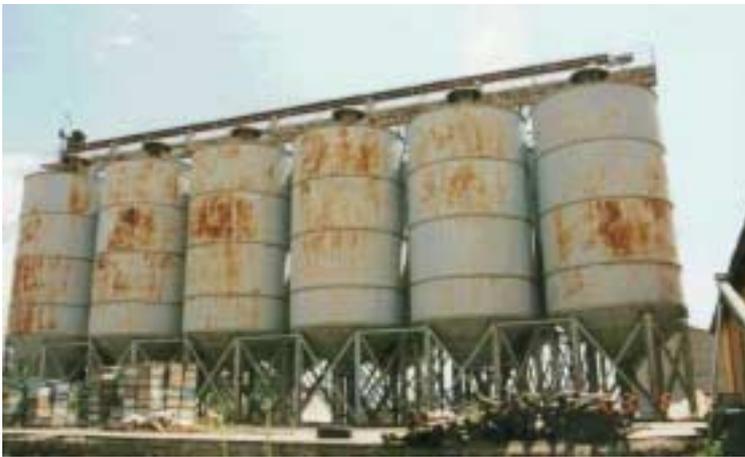
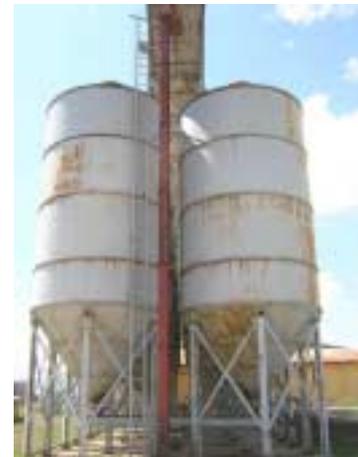
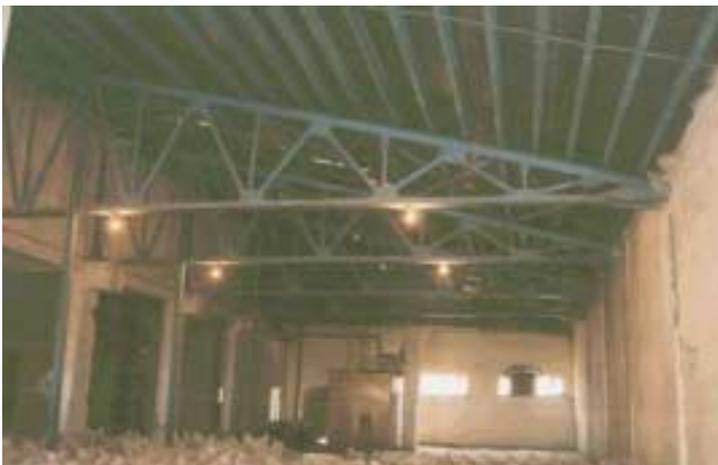
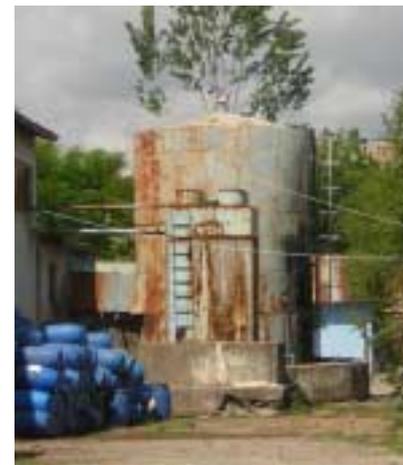
Figure 11.3: Some views of Bingöl Yem Sanayi Plant

Yem Sanayii plant is owned by the state and it is mainly used for an animal-food storage facility. The plant has crushing and grinding units in an RC building built after the 1971 earthquake and steel storage silos, which are anchored to the foundation and connected to each other in a truss-type fashion (Figure 11.3). The visual inspection indicated that there was no structural damage to silos and RC building and machinery of the plant.

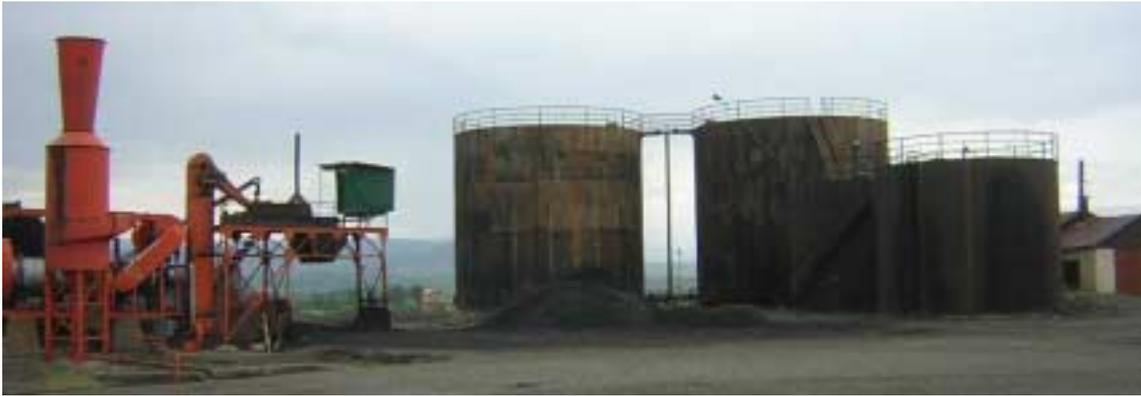
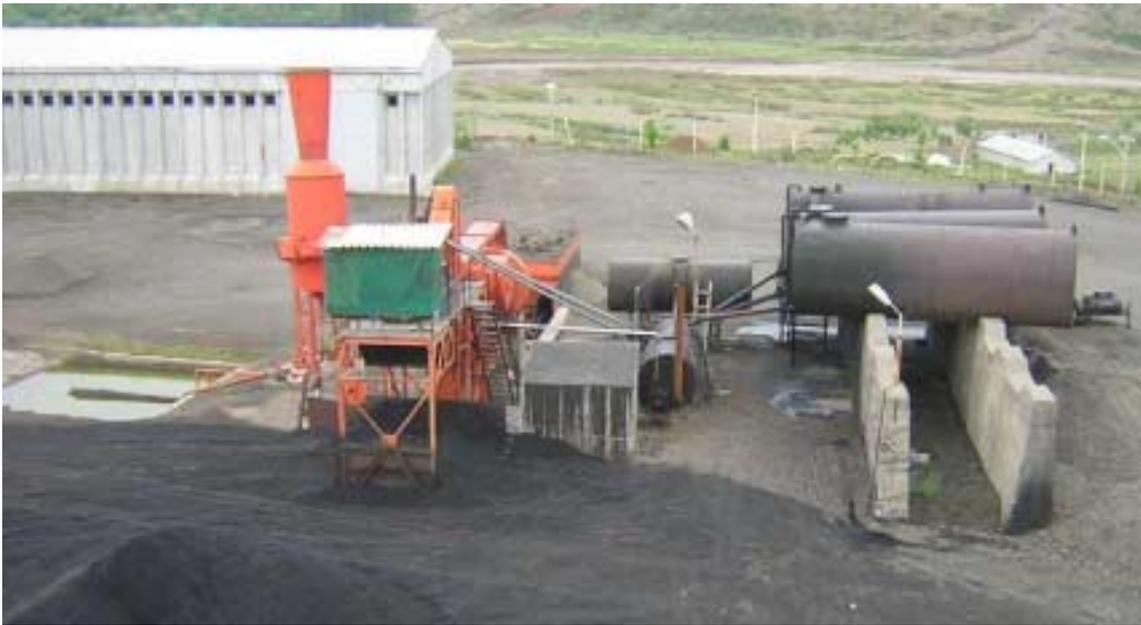
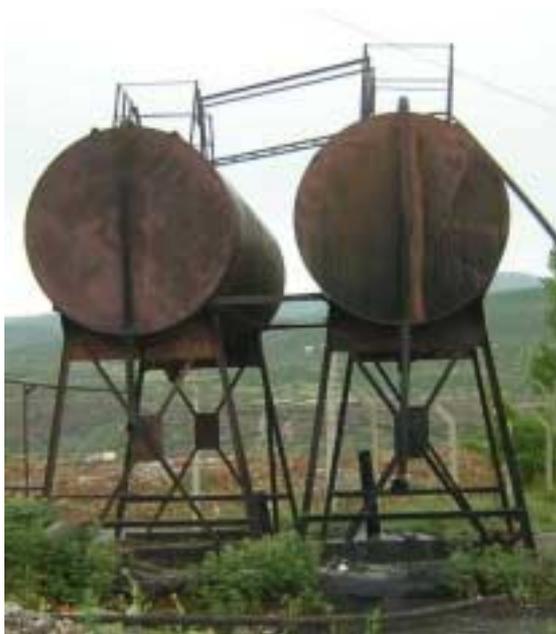
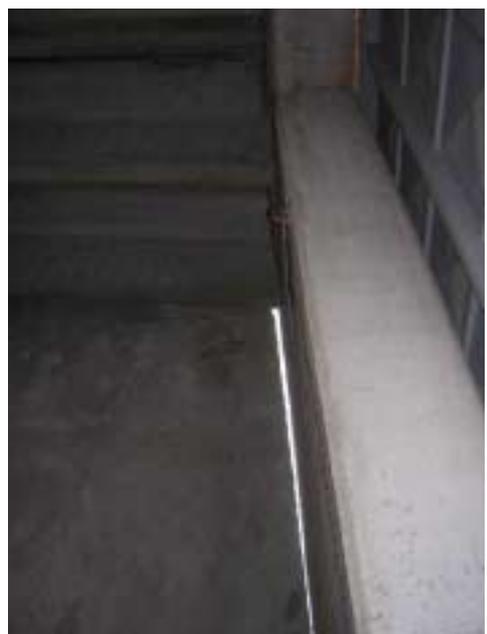
Figure 11.4: Some views of TCK plant

Turkish Roadway Authority (TCK) has a plant for crushing, paving and asphalt and gravel storage in Bingöl City. Asphalt is stored in vertical cylindrical tanks placed on concrete foundations and elevated horizontal cylindrical tanks (Figure 11.4). The inspections on vertical and horizontal tanks indicated that there was no earthquake-induced damage to the tanks. Crushed gravel is stored in a pre-cast storage-house. The pre-cast reinforced concrete panels were slightly displaced by the earthquake shaking. Nevertheless, the structure was structurally stable after the earthquake.
