Japan Society of Civil Engineers

## THE BİNGÖL EARTHQUAKE OF MAY 1, 2003

**Investigated and Prepared by**

July 2003

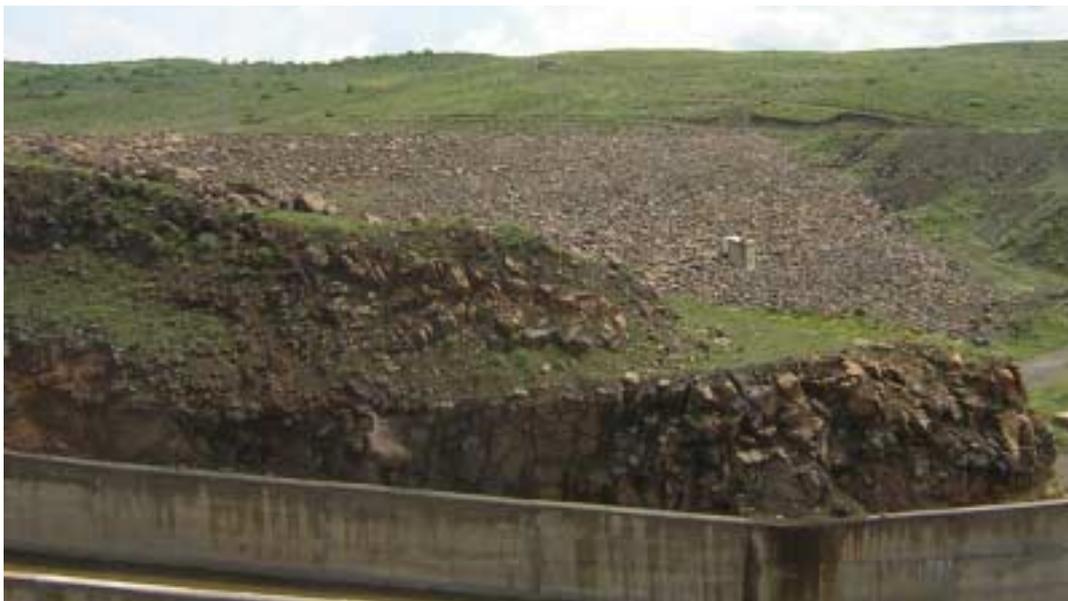
(e) Gayt Dam

There are several dams around the earthquake epicenter and they are either earth-fill or rock-fill type built by DSI (Table 12.1 and Figure 12.1). The nearest dams to the earthquake epicenter are Gayt, Kiğı and Özlüce dams. While Gayt dam is an earthfill dam with rockblock facing for irrigation purpose built on Gayıt brook, Özlüce and Kiğı dams are rock-fill dams for hydraulic energy on Peri brook. The investigation team visited the site of Gayt dam, which was built on basaltic rock (Figure 12.2). While cracks at the crest of the dam was filled by the repair teams, no seepage was observed at the downstream side or any rotational failure towards the reservoir site, which is quite common form of failure for this type of dams. Nevertheless, a slight spreading type deformation on the upstream side towards the reservoir could be noticed as seen in Figure 12.2(a). No damage to spillways or gates were observed. There was a small earthfill dam nearby Gayt Dam as seen in Figure 12.2(e). Some small rotational movements were observed in the middle of dam nearby its crest on the downstream side. The movement was towards the epicenter.

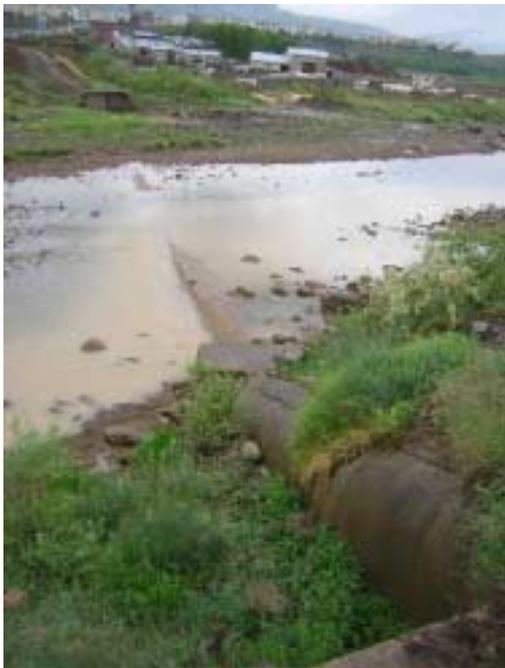
Syphon system beneath Gayıt brook

Bingöl basin is the largest basin in the province and it has an irrigation channel network for agricultural purposes. The channels have an inverted trapezoidal shape and were generally lined with lightly reinforced concrete panels (Figure 12.3). At two locations, the channels pass beneath Gayıt brook and Göynük brook through a siphon system. During the investigation no severe damage to the system was observed. Nevertheless, there was some slight seepage at the joints with the channel and concrete conduit type siphons, which indicated that some cracking took place. In spite of slight seepage from such spots, the system was functional.

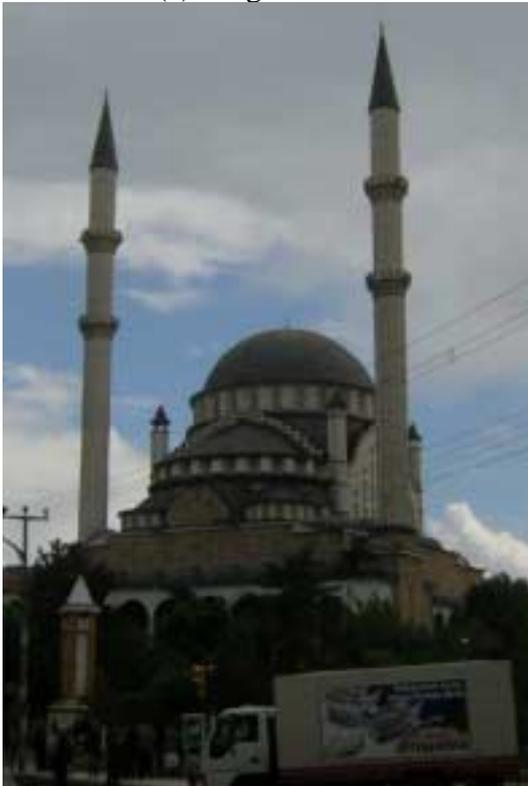
(b) Bingöl Ulu Mosque

Most of the main compounds of mosques in the earthquake affected region were intact or suffered very slight damage (Figures 13.1 and 13.2). The damage was generally concentrated at corners as observed in the previous earthquakes of Turkey. The main compounds of mosques generally have single dome or multiple semi-spherical domes and they are structurally symmetric. Probably for this reason, the main compounds remain intact during shaking. The main compounds of the mosques were damaged when the falling minarets hit the structures. The most severe damage was observed at Yeni Mahalle mosque in Bingöl due to also the weak-floor situation at its ground floor. The same type failures were also observed in the 1998 Adana-Ceyhan Earthquake and the 1999 Kocaeli and Düzce Earthquakes. Minarets in the region, which are generally 15 to 25 m high, are mainly non-reinforced cast-in place blocks. Minarets were mostly separated from the main compound of the mosques. Failures of minarets occurred at the junctions where the cross-section configuration of the structure changes from square to cylinder by toppling due to ground shaking (Aydan et al. 1999, Ulusay et al. 2003).

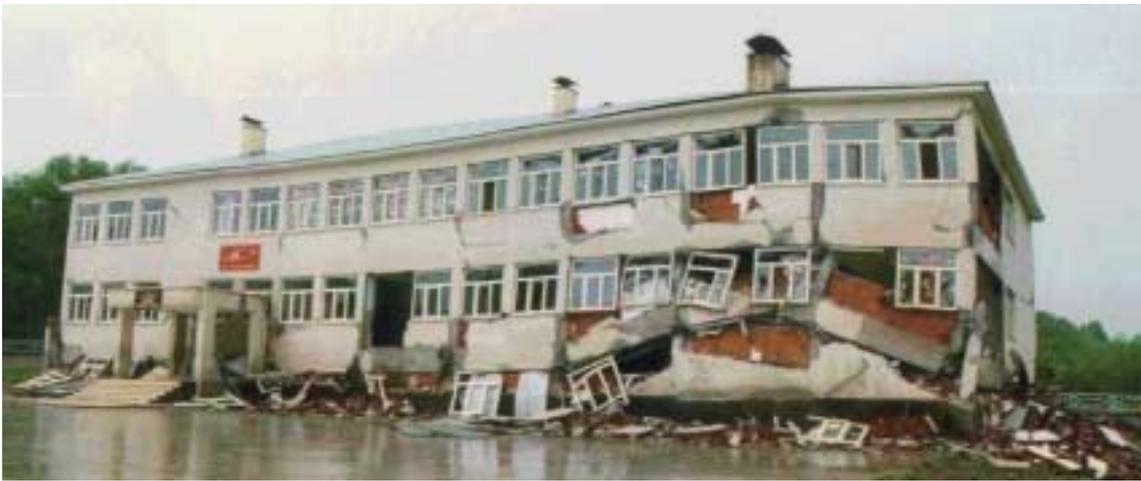
(b) 3 story RC Primary school building at Kaleönü

The totally collapsed or heavily damaged school, residential and office buildings had mainly 3-5 stories (Figure 13.3). These structures are designed as moment-resistant frame structures with in-fill walls made of hollow bricks. The diameter of reinforcing bars and stir-ups were mostly 13-16 mm and 3-4 mm, respectively. The bars were generally of smooth type. However, the use of deformed bars was observed in buildings under construction or new buildings. Most of heavily damaged or collapsed reinforced buildings were observed in Bingöl City, Ekinyolu, Çeltiksuyu, Kaleönü and Sarıçiçek villages. While Ekinyolu, Çeltiksuyu, Kaleönü and Sarıçiçek villages are located on soft alluvial deposits, Bingöl City was located over firm alluvial terrace deposits. The failure of RC structures was due to soft-story (weak-floor) situation as it is a common problem resulting in high casualties in earthquakes since 1960. The collapsed buildings were mostly located nearby the crest of terrace deposits bounded by three brooks, namely Gayıt, Çapakçur and Göynük (Figure 13.3). The ground floors of collapsed buildings were mostly used as either shops or garages. As a result, this type of usage constitutes a weak(soft)-floor situation. Furthermore, many buildings had heavy balconies of cantilever type.

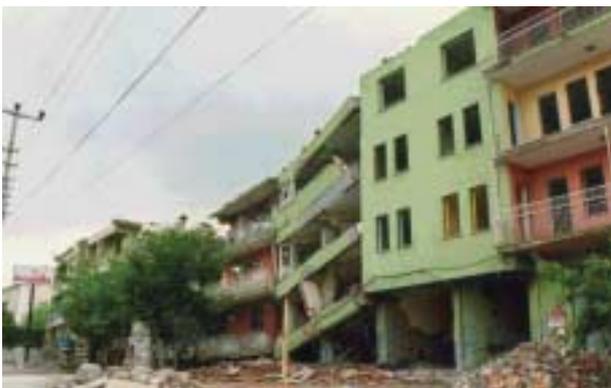
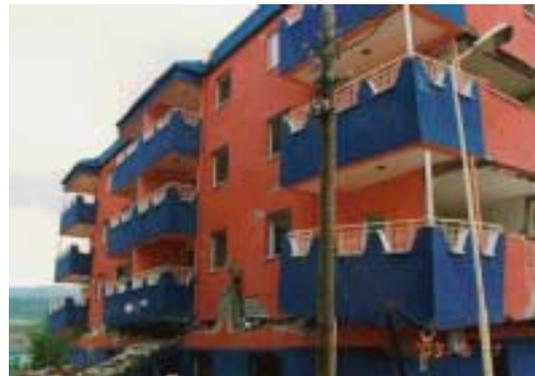
(c) Collapsed 4-5 story RC buildings

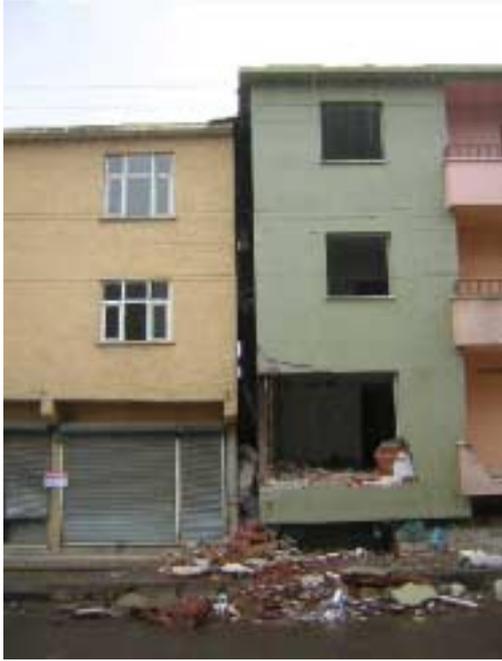
**Soft Story:** Many buildings had shops at their ground floor. Since there are generally no shear-walls to take up the load during earthquakes, the total load is transferred onto the columns. The super structure acts as a top-heavy structure on the columns and in-fill walls, which are in poor contact with columns and beams, has no effect against the earthquake loading and they fail subsequently as seen in Figures 13.3 to 13.4). It was also interesting to note that structures having solid bricks or angular rock blocks as in-fill walls and columns constructed after the walls performed much better and damage was none or very limited. This good performance is probably due to the integrated behaviour of buildings during earthquake loading.

(a) Soft-floor effect

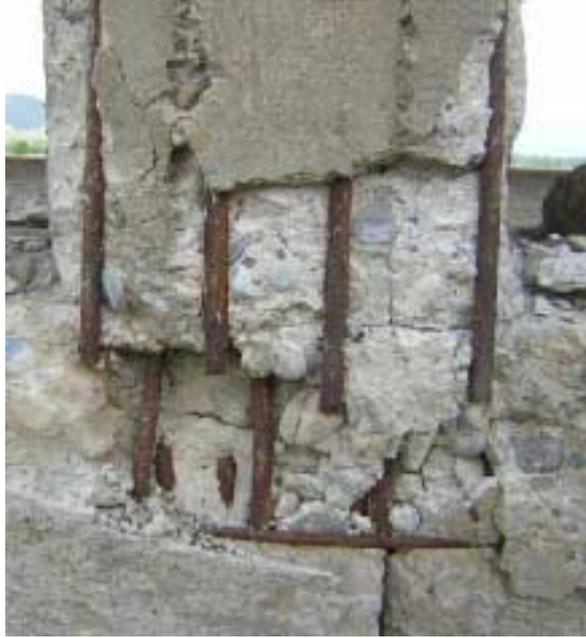
and weak connections. Such connections were quite common in collapsed or heavily damaged buildings. During shaking, it seems that concrete at the connections first failed and this subsequently caused the buckling of steel bars at such locations and rupturing in-fill hollow brick walls in a brittle sense. As a result, the collapse of buildings ended up in a pancake mode.

(b) Column-beam joint

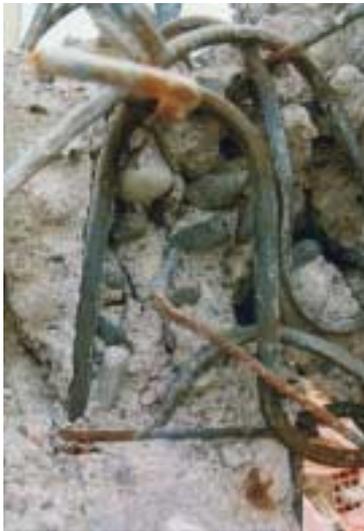
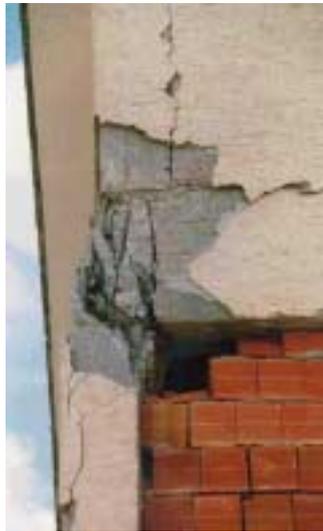
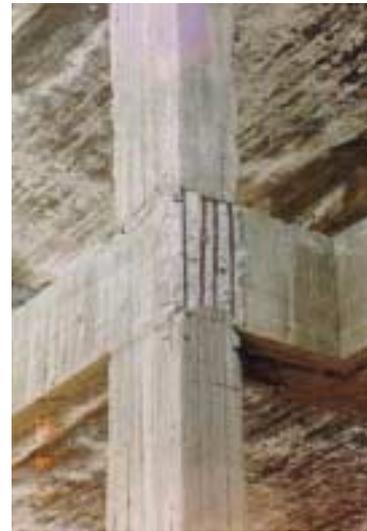
**Construction negligence and lack of moral:** One of the most striking construction negligence was the confinement of concrete at the beam-column connections in spite of the Turkish design code for seismic regions. As stir-ups were very few at such locations, the failure of concrete was very brittle and it could not absorb the work done by the earthquake forces. Furthermore, the diameter of steel bars was less than that required which indicates the lack of moral of construction companies.

(c) Column-beam joints

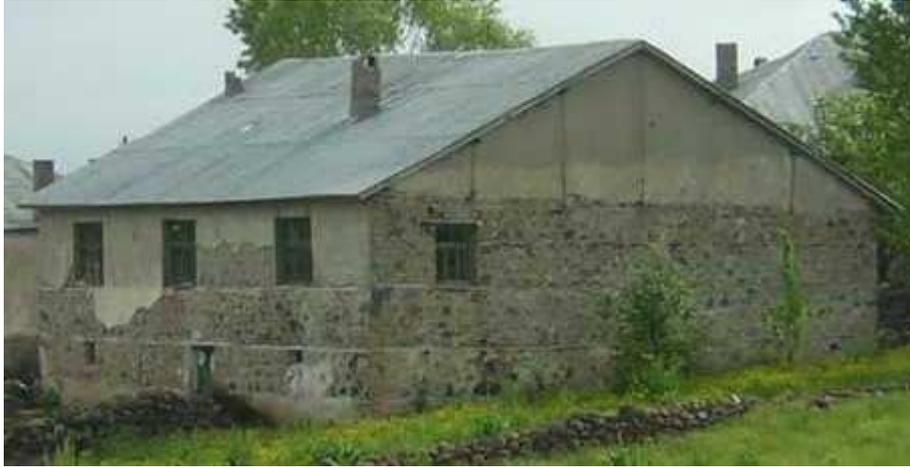
The stone masonry buildings and stables are quite common particularly in villages. The wooden slabs of 9-10cm thick are installed at spacings of about 1m such that the integrity of the wall is achieved during construction and also the earthquakes (Figure 13.5). The walls are generally 60cm thick. The roofs are covered with thin corrugated zinc plates or earthen. Most severe damage was observed in houses with few wooden slabs and earthen heavy roofs. The houses made with appropriate spacing of wooden or concrete slabs for the continuity of structures performed very well during the earthquake.

(a) Typical stone-masonry house

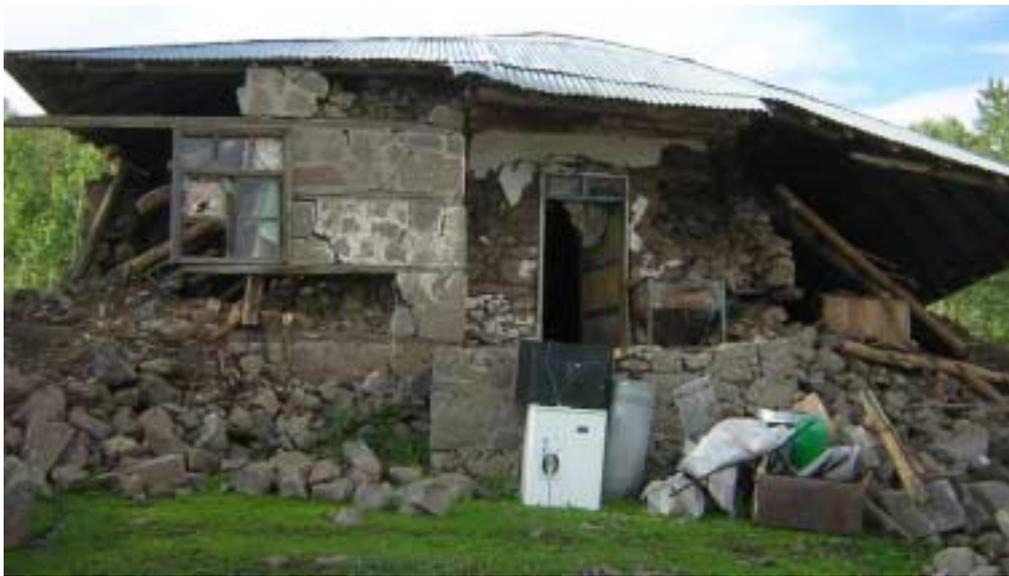
Figure 13.5(b) shows a damaged one-story building. The damage to this buildings displayed some known characteristics of damage to masonry structures. Some walls fail by shearing and some walls fail by toppling (Aydan et al. 2003). The separation and damage occurred at the corners of the building in a well-known fashion. The difference in the behaviour of these two buildings may be directly related to the existence and continuity of slab-like elements within the structure. The damaged building has very short concrete slabs over the door and window openings and/or heavy roofs while the non-damaged building has all-around continuous concrete slabs with light roofs. Similar behaviors of stone masonry buildings were observed in other earthquakes such as the 1992 Erzincan, the 1995 Dinar, the 1998 Adana-Ceyhan and the 1999 Kocaeli Earthquakes, 2002 Çay-Eber earthquake (Hamada and Aydan, 1992; Aydan and Kumsar, 1997a; Aydan et al., 1998 and 1999a, Ulusay et al. 2002).

(b) The collapse of a stone masonry house (ground is very soft)

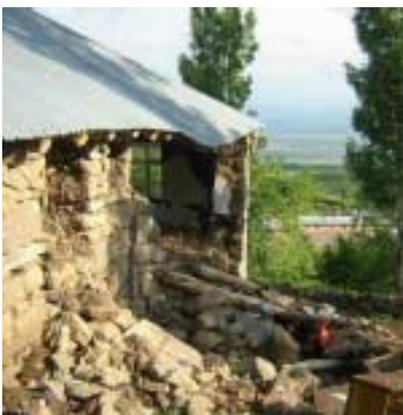
(c) Out-of plane failure

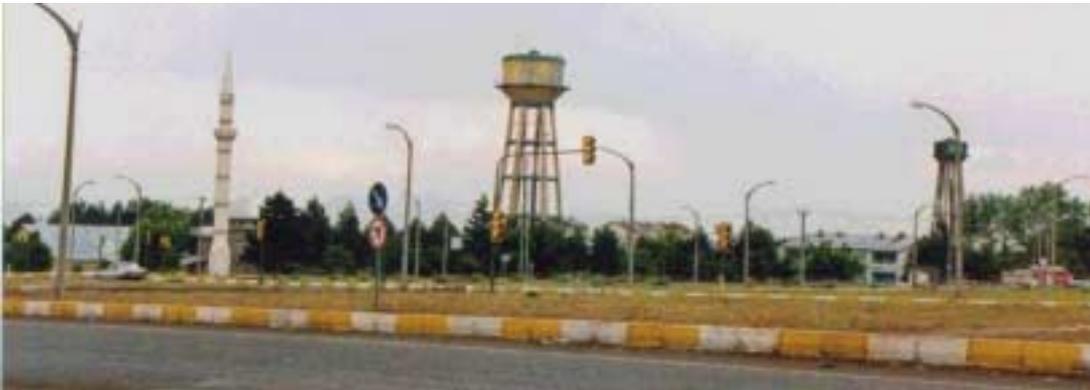
Water towers are RC structures and their height generally ranges between 25-30 meters. The towers generally have 6-8 columns and they are symmetric structures. Figure 13.6 shows two water towers together with a minaret at Saray district of Bingöl City. No damage was observed at these two water towers. The water tower in Çeltiksuyu village, where two RC 3-4 story buildings were collapsed, was not even slightly damaged (Figure 13.7). Taking into account observations in other Turkish earthquakes, the water towers exhibit a good performance during earthquakes. One reason is probably the period of this structure, while the other could be the damping effect of sloshing water in the water tanks.

Figure 13.6 Non-damaged water towers in Bingöl City nearby the strong-motion station

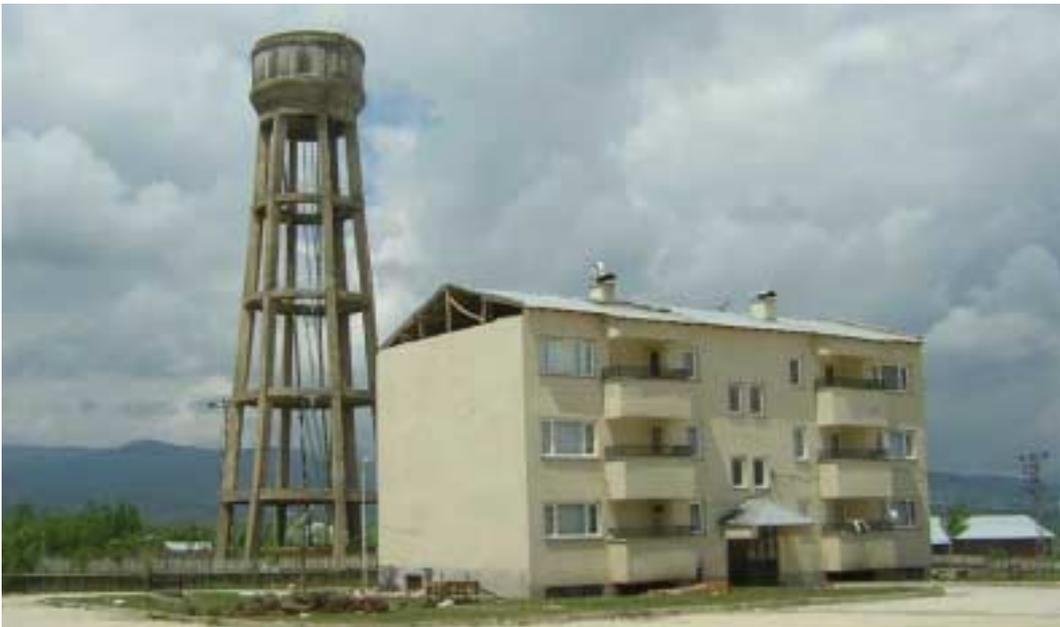
Figure 13.7: The non-damaged water tower in Çeltiksuyu village where two school buildings with 3-4 floors were all collapsed
