4 STRONG GROUND MOTION AND FAULT RUPTURE

During September 5 to 12, the members of the JSCE team for the survey on the strong ground motion and the fault ruptures visited the strong motion observation stations in the earthquake-affected region and measured the shear wave velocities using a portable elastic wave exploration device. Strong motion simulations have been done according to a fault rupture model. The estimated waveforms by using the fault rupture model show a good agreement with observed records.

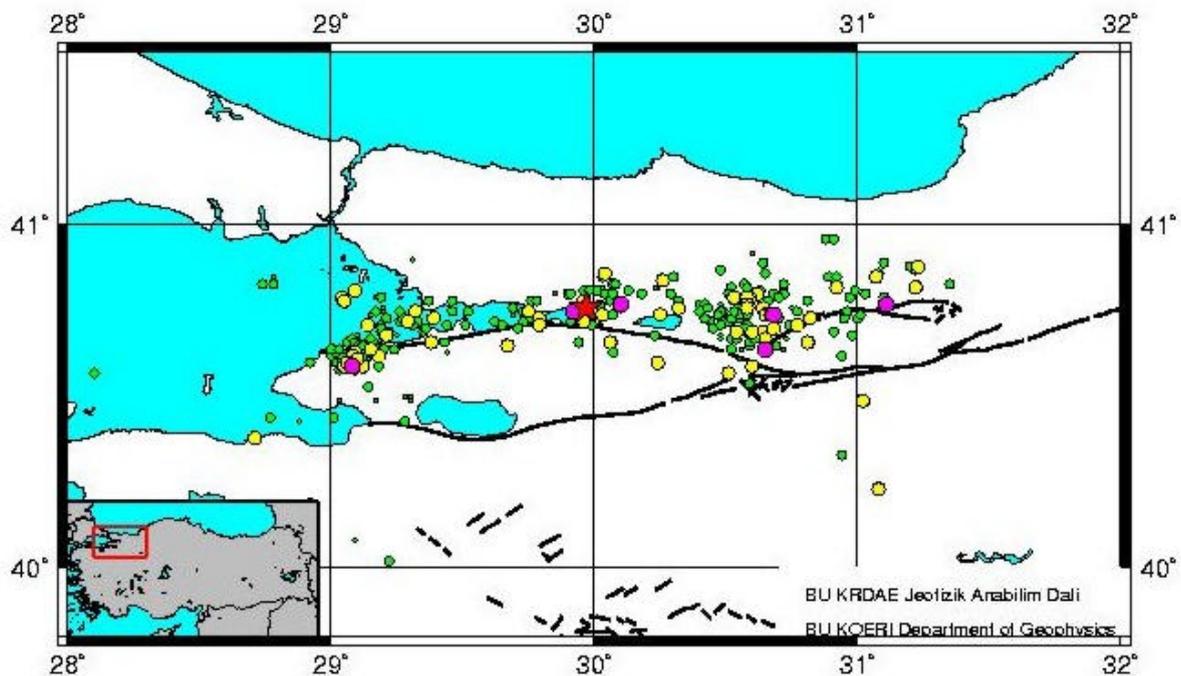
Figure 4.1 Aftershock distributions (after KOERI)

team. The fault displacement ranges between 2-4 meters. The western portion of the fault is considered to be in the sea of Marmara. The total length of the fault is estimated as 150km (see section 4.4). The spatial distribution of aftershocks for three weeks after the main shock is shown in Figure 4.1. The aftershocks concentrate especially around the epicenter, and at the ends of two segments, namely, Yalova, Akyaz and Gökaya from west to east, respectively.

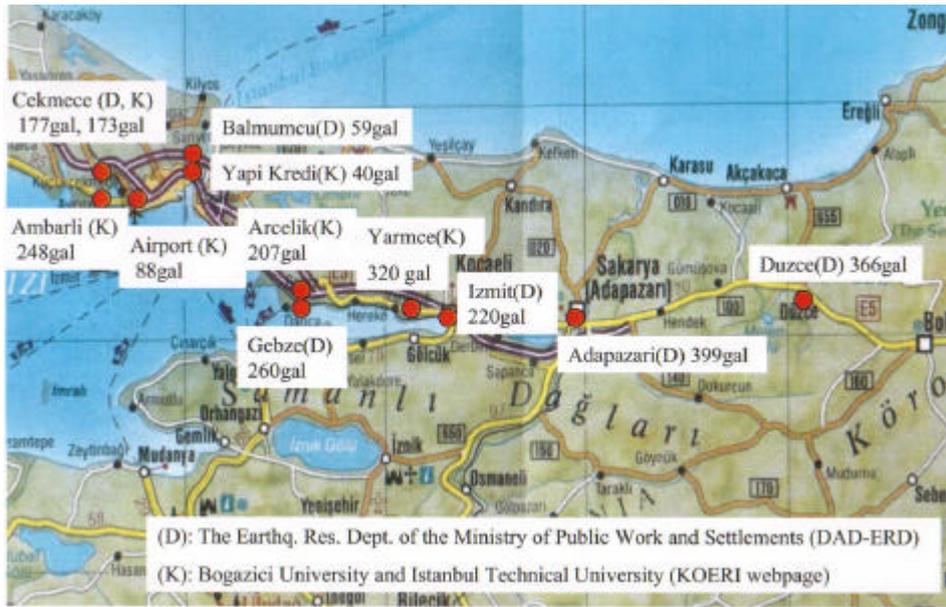
Figure 4.2 Maximum acceleration distribution (data from DAD-ERD-KOERI)

Three strong-motion observation networks are established in the region and are managed by the Earthquake Research Department (DAD-ERD) of the Ministry of Public Works and Settlements, Bogazici University and Istanbul Technical University (KOERI WebPages). Figure 4.2 shows the maximum horizontal accelerations recorded at the observation stations of DAD-ERD and Bogazici University. The peak acceleration of Duzce, the east end of the inferred fault, is 366gal. A peak ground acceleration of more than 300gal was also observed at Yarmca station of Bogazici University. The earthquake records observed at the Kobe Marine Observatory in the 1995 Kobe earthquake and at the DAD-ERD Sakarya observation station in the 1999 Kocaeli earthquake are shown in Figure 4.3. The peak ground accelerations are 817gal and 399gal respectively. A large pulse of the period of about 1sec is dominant in Kobe, while a long period component of 4-5sec is found in the wave at Sakarya station.

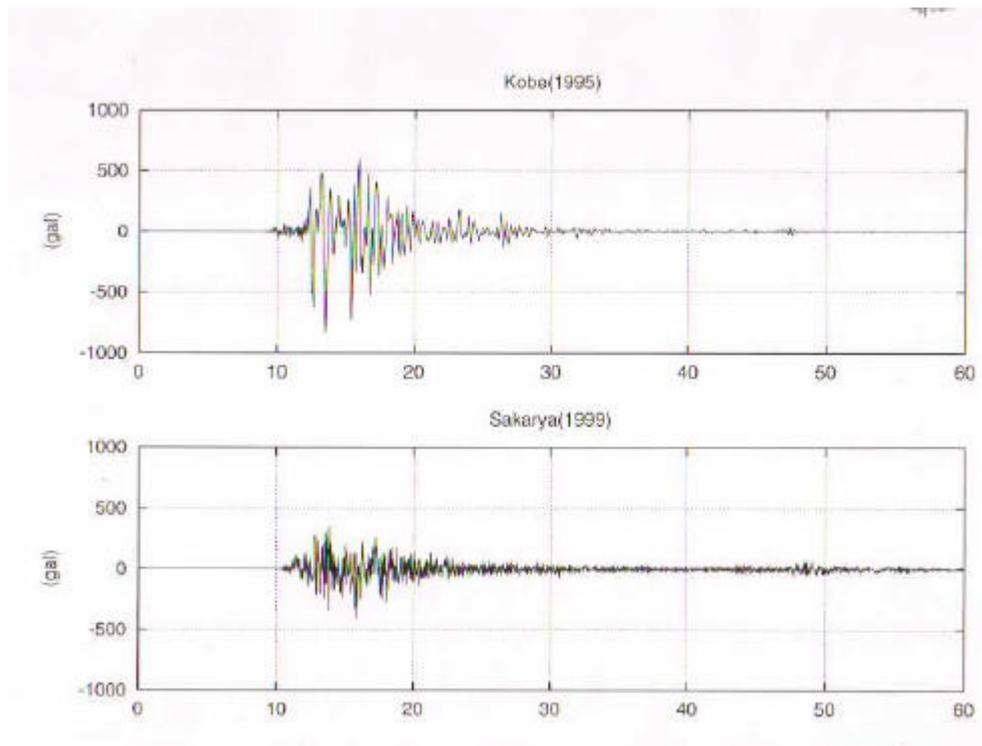
Figure 4.3 The earthquake records observed at Kobe and Sakarya

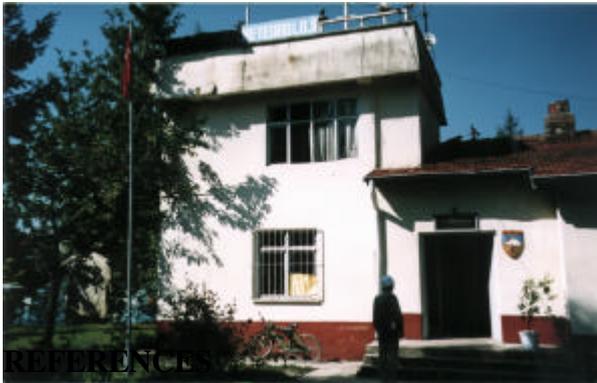
Figure 4.4 Düzce Station

The JSCE team members visited the DAD-ERD observation stations at Düzce (Figure 4.4) and Sakarya (Figure 4.5). Shear wave velocity characteristics of ground at each station were measured by using a portable elastic wave exploration device (Figure 4.6). Because of the capacity of the exploration device the horizontal distance of the measuring line was restricted to 10-15 meters. Therefore, shear wave velocities could be measured only for depths of several meters. Table 4.1 shows the results. The ground was generally hard and the S wave velocities at several stations were more than 300 m/s except the city center of Adapazarı. The strong motion observation station of Adapazarı is a few kilometers away from the city center and the surface ground there is much stiffer than that in the city center ($>300\text{m/sec}$). Therefore, the ground motion in the severely damaged area in the city center might be quite different from that at the Sakarya (Adapazarı) station. Most of the heavily damaged areas was situated on the soft soil (Figure 4.7). In the case of the 1995 Kobe earthquake in Japan, the irregularity of the geological structure resulted in a large amplification of ground motion, which was one of the causes for the heavy damage. In Avcılar, the west of Istanbul, the peak acceleration was unexpectedly high more than 200gal. More detailed study on the surface topography besides the ground conditions is necessary to clarify the cause of the amplification of the ground motion.

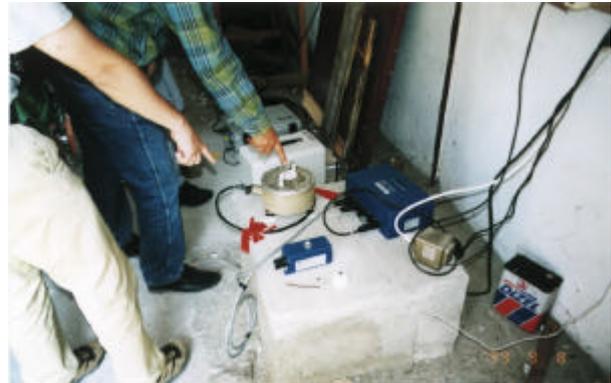
Figure 4.5 Sakarya station

| Location | Installation site of the seismometer | S-wave velocity (m/s) | Comment |
|---|---|---|---|
| Sakarya (SKR) | IIM Concrete foundation | 310 | Hill side (2-3 km SW of Adapazar) |

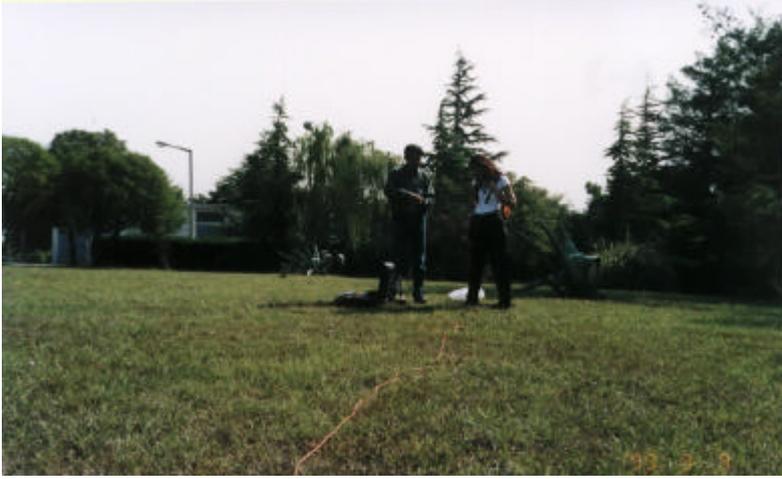
Figure 4.6 S- wave velocity exploration device

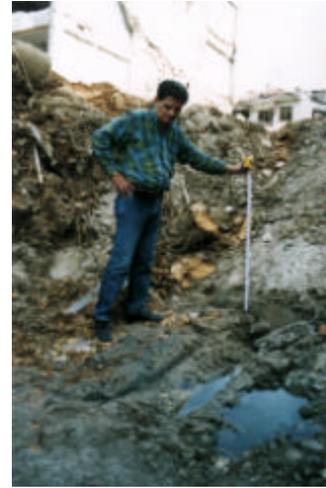
Figure 4.7 Ground conditions in the city center of Adapazar

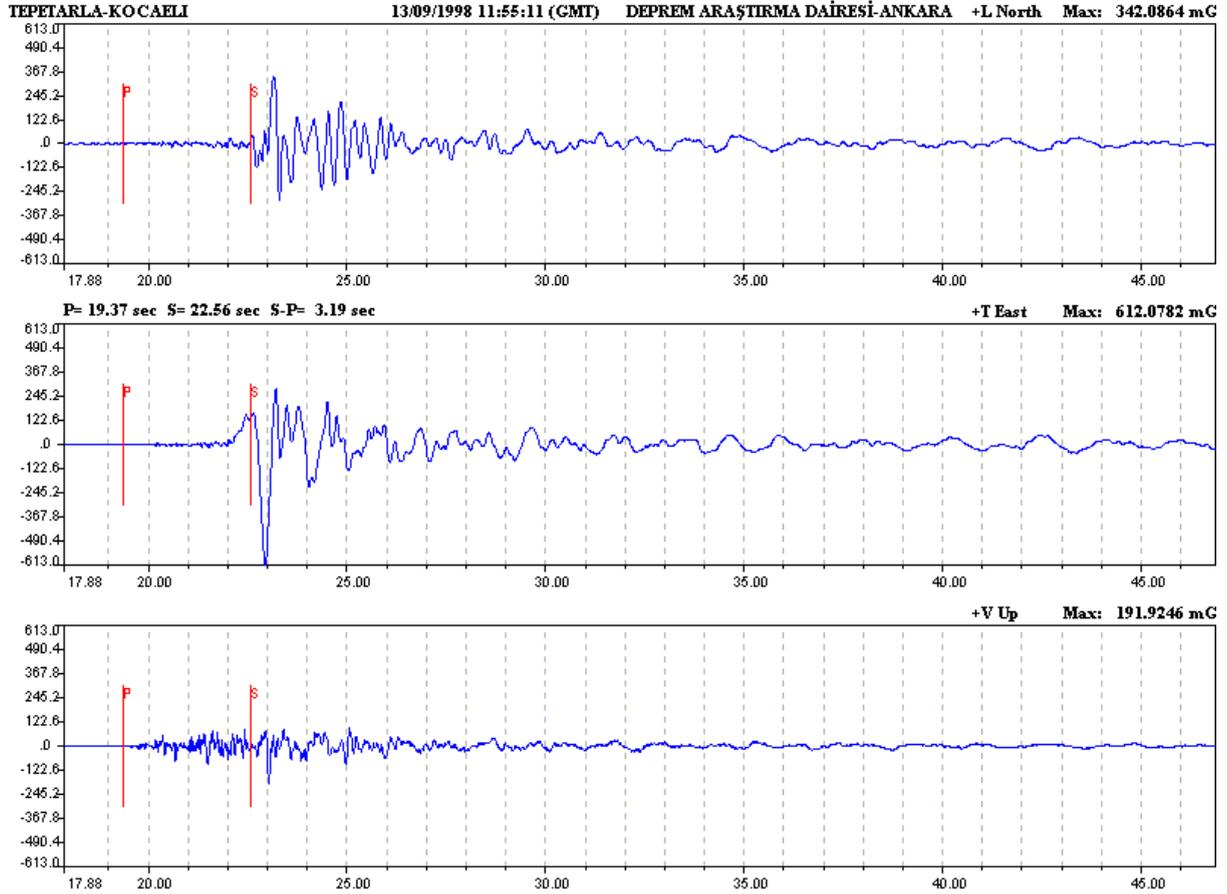
Figure 4.8 Acceleration records at Tepetarla station measured during 13.9.1999 aftershock by DAD-ERD

The recorded accelerations are published (<http://angora.deprem.gov.tr/sept13after.htm>). The maximum acceleration record is obtained at TPT(Tepetarla) temporary station. This station is about 3 m from the fault surface break. It is on the southern side of the fault and on a clayey soil. The accelerations are shown in Figure. 4.8. The maximum acceleration is over 612 cm/s^2 and predominant period is about 0.8 seconds. The maximum velocity is briefly estimated as 80 cm/s.

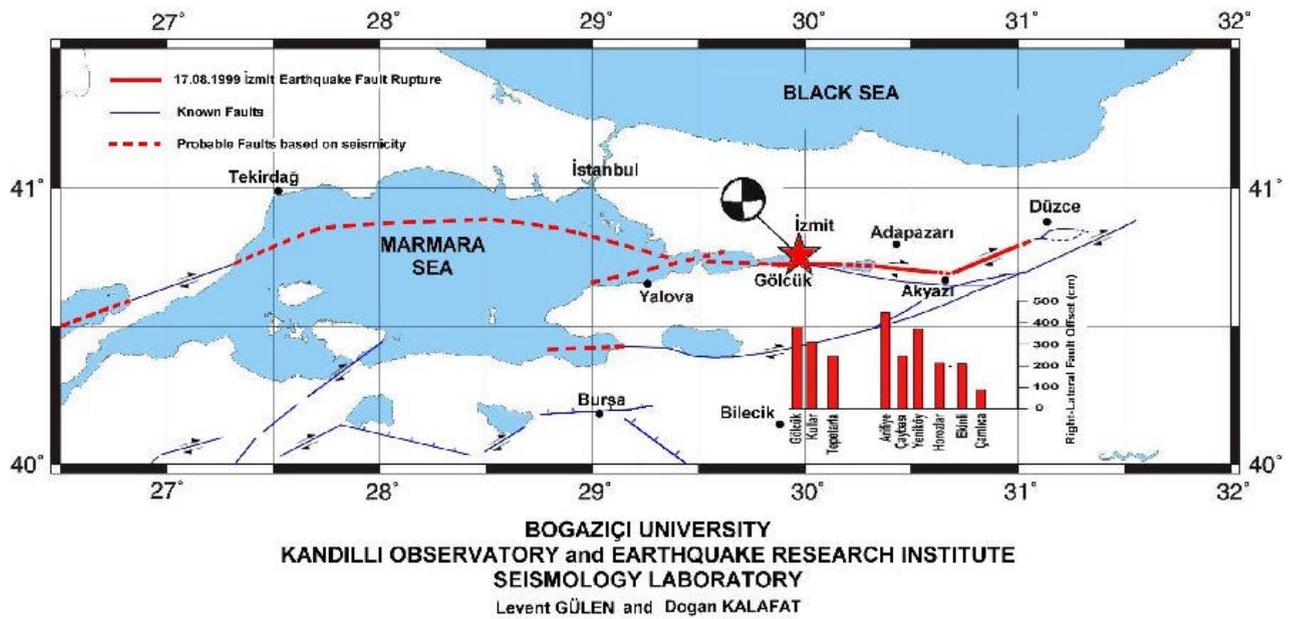
Figure 4.9 The main trend of fault breaks (after Gülen and Kalafat 1999)

Surface ruptures occurred close to known geological active faults. Figure 4.9 shows the main trend of the surface fault rupture traces (Gülen and Kalafat 1999 <http://kandilli.koc.net/rupture.htm>). The western end of the surface fault ruptures was observed in Gölçük. Figure 4.10 shows the right lateral strike-slip fault of more than 4m in Gölçük. The surface fault rupture extends to the Navy Base in Gölçük and goes into the Izmit Gulf. The fault passes through the sea from Gölçük and appears again on the land at Ba iskele and extends towards Sapanca Lake. Figure 4.11 shows about 2m right lateral displacement near Kullar village. A large displacement can be seen near the

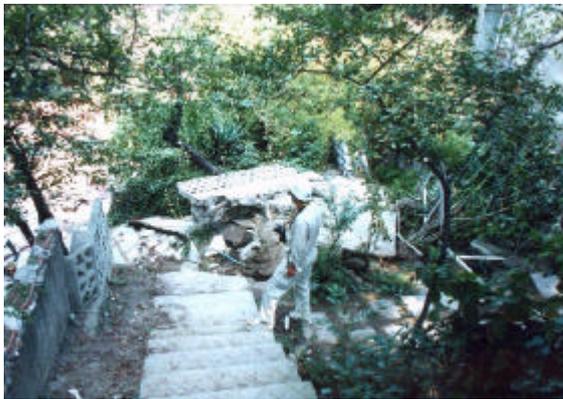
Figure 4.10 Faulting in Gölçük

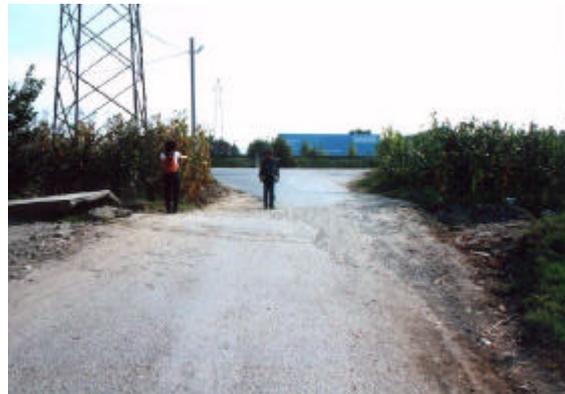
Figure 4.11 Faulting in Kullar village

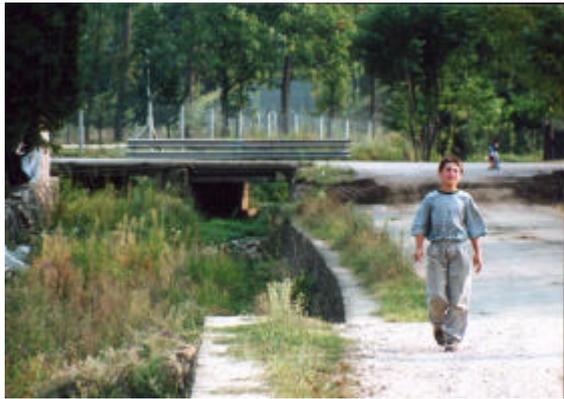
Figure 4.12 Faulting in Arifiye

TCDD Tepetarla station. Here, rails and embankment of a railway were deformed by the fault movement. The fault goes into the Sapanca Lake and appears in the land near Arifiye as shown in Figure 4.12. In Arifiye, an over the Trans-European Motorway (TEM) bridge collapsed due to the fault movement. The eastern end of the fault could be traced as far as the southwest of Duzce.

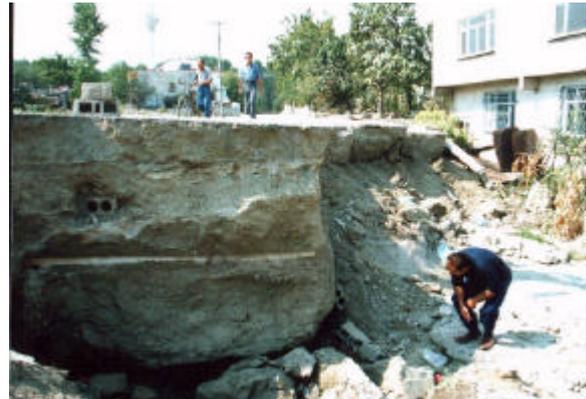
Figure 4.13 Normal faulting in Kavaklı (Gölcük)

In Gölçük, a large subsidence of the ground was observed in wide area. The maximum vertical displacement was more than 2m and it was caused by a normal fault which was secondarily caused by the main strike slip fault (Figure 4.13). This might be caused by tensile force caused two stepping strike-slip faults. However, the direction of the normal fault is varying and any strike slip fault was not found at the southern end of the normal fault. It is supposed that there may be a large graben structures in the Izmit Gulf and that the graben structure is further grew up by this earthquake. This

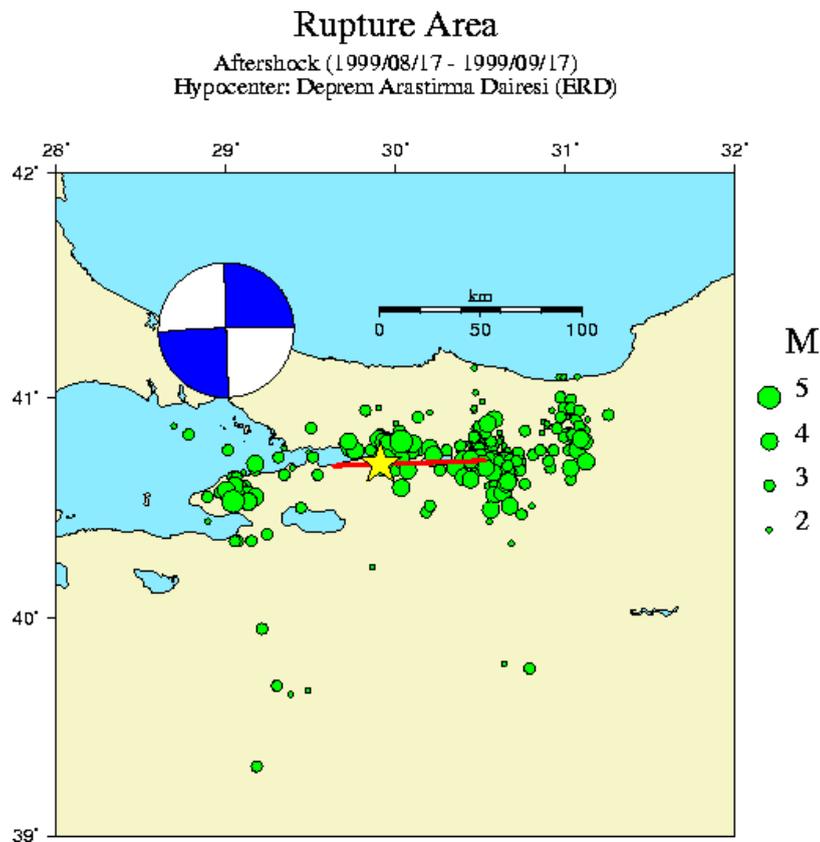
Figure 4.14 Rupture area assumed in Yagi & Kikuchi's solution

Yagi and Kikuchi(1999) have published waveform inversion results on their web site (<http://www.eri.u-tokyo.ac.jp/yuji/trk/izumit.html>). Figure 4.14 shows the fault plane location. The total length of the fault is 105km and strike is almost E-W direction. The fault slip distribution is shown in Figure 4.15. The figure shows that major slips are concentrated in deep portion 0-10km west from the hypocenter and in shallower portion 20-35km east from the hypocenter. The maximum slip was reported as about 7m. The slip duration is estimated about 15 seconds. The large slip area of this model seems to be correspond to the area where the surface ruptures were observed. However, this model was based on the earthquake ground motion record in far field. The details of fault rupture mechanism shall be carefully studied by using near field strong motion records.

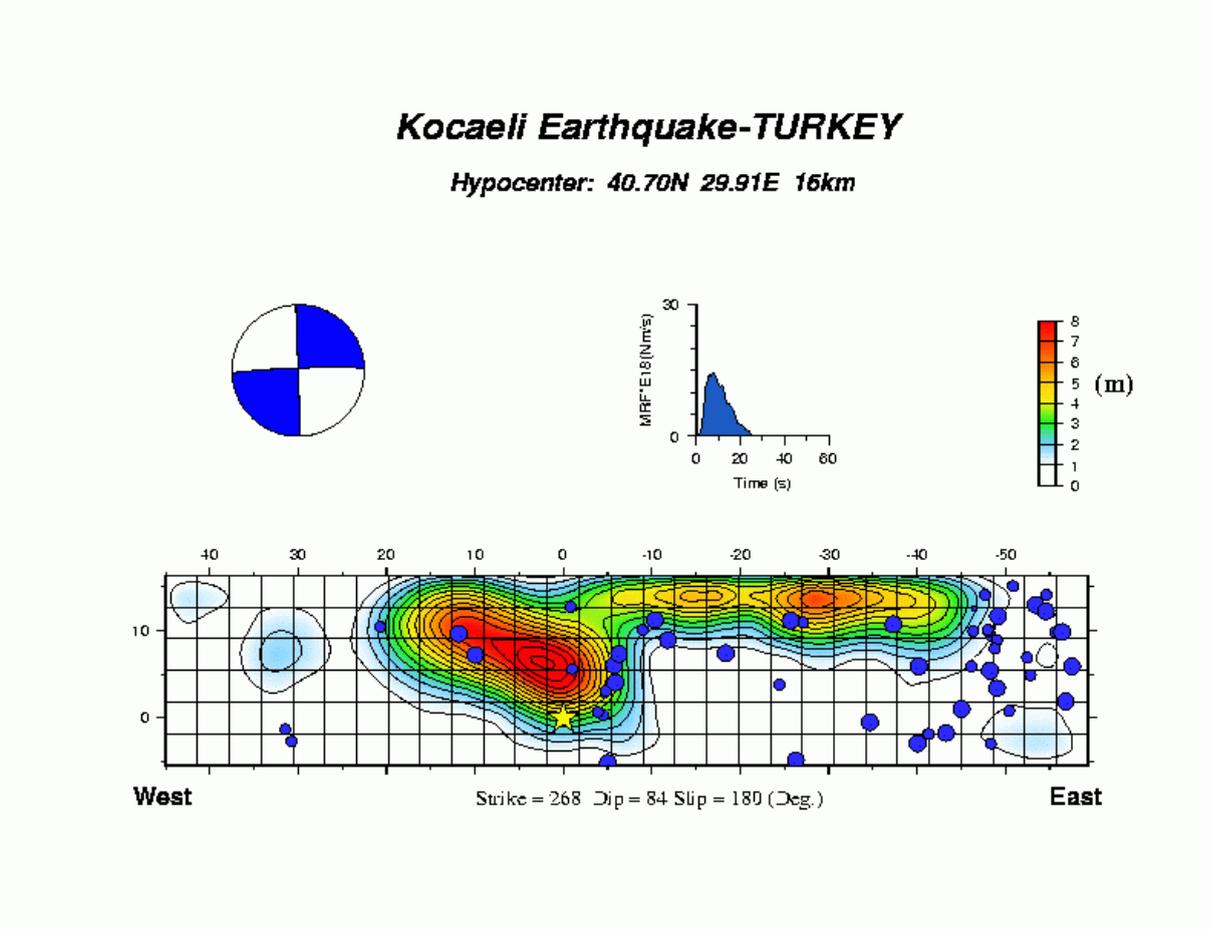
Figure 4.15 Slip distribution along the fault (Yagi and Kikuchi 1999)

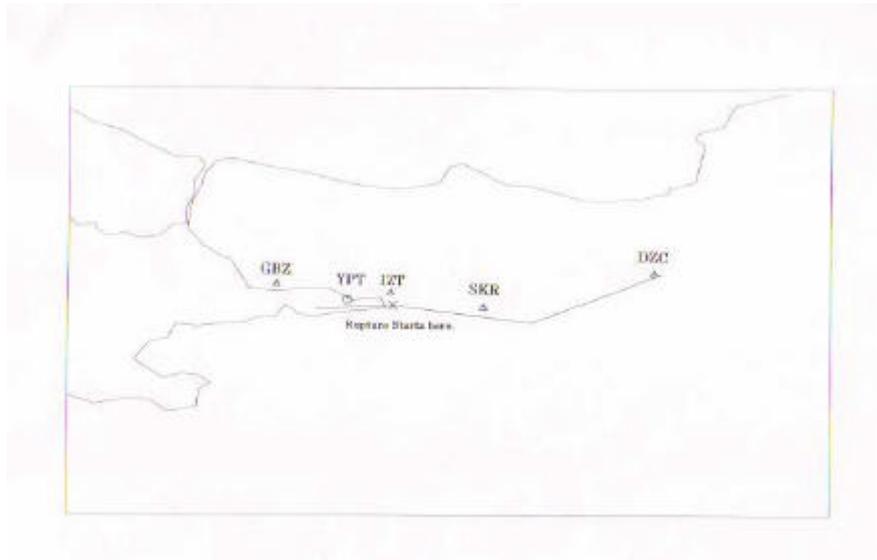
Figure 4.16 Sites for simulation of the ground motions

By using the fault rupture model by Yagi and Kikuchi (1999), a near field strong ground motion simulation was carried out. Figure 4.16 shows target sites and Figure 4.17 is the asperity model for the simulation. The asperity area is about 22% of total rupture area and slip contrast is assumed as 2.0(asperity) and 0.72(other). The rise time is set as 2.37sec. These values are the average rupture parameters for crust earthquakes given by Somerville et al. (1999). There is no enough information about sedimentary structure. The shear wave velocity was assumed as 3.5km/s for the rock sites and 1.5km/s with 1.0km thickness for the sediment sites.

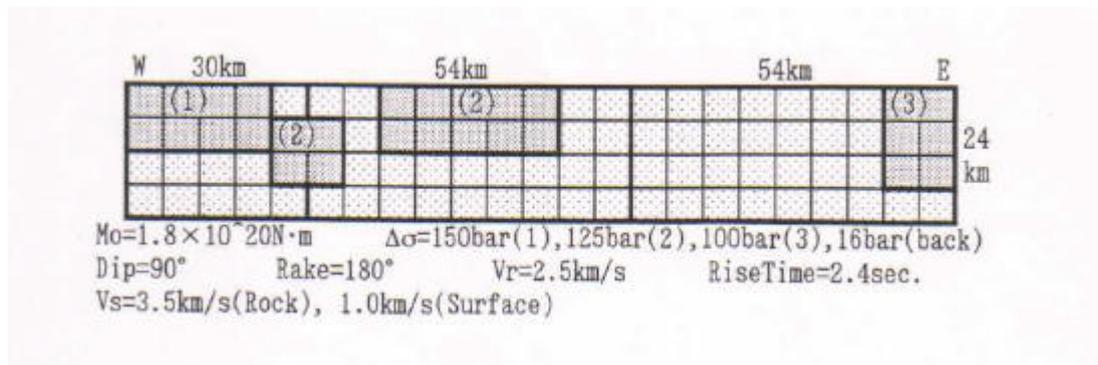
Figure 4.17 Asperity for Simulations of Ground Motion

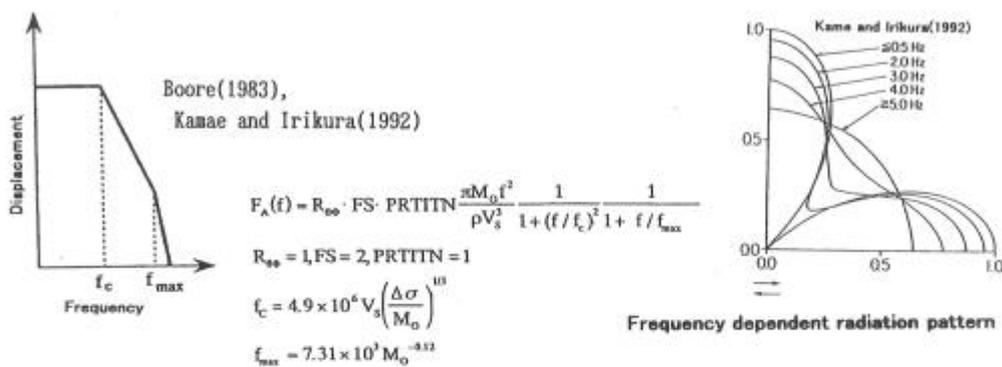
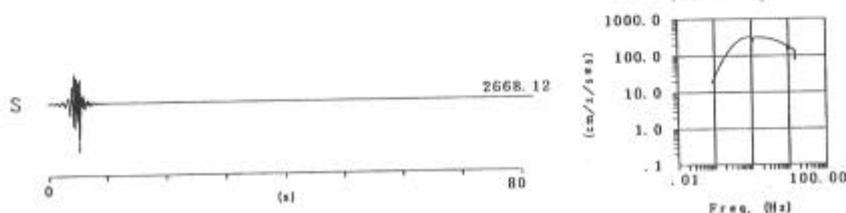
Making a small event trace at unit distance

Stochastic phase is used to make a trace.

Figure 4.18 Basic concept of the method for the simulation

The stochastic Green's function method was applied for the simulation. The basic concept of the method for the simulation is shown in Figure 4.18. First, stochastic wave traces that follow w^2 scaling law are generated with random phase characteristics [Boore(1983)]. Frequency dependent radiation patterns, path effects including Q-value, the effect of site responses with layered structures are taken into the consideration. Green's functions are summed up along the rupture propagation, to generate strong ground motion [Irikura(1983)].

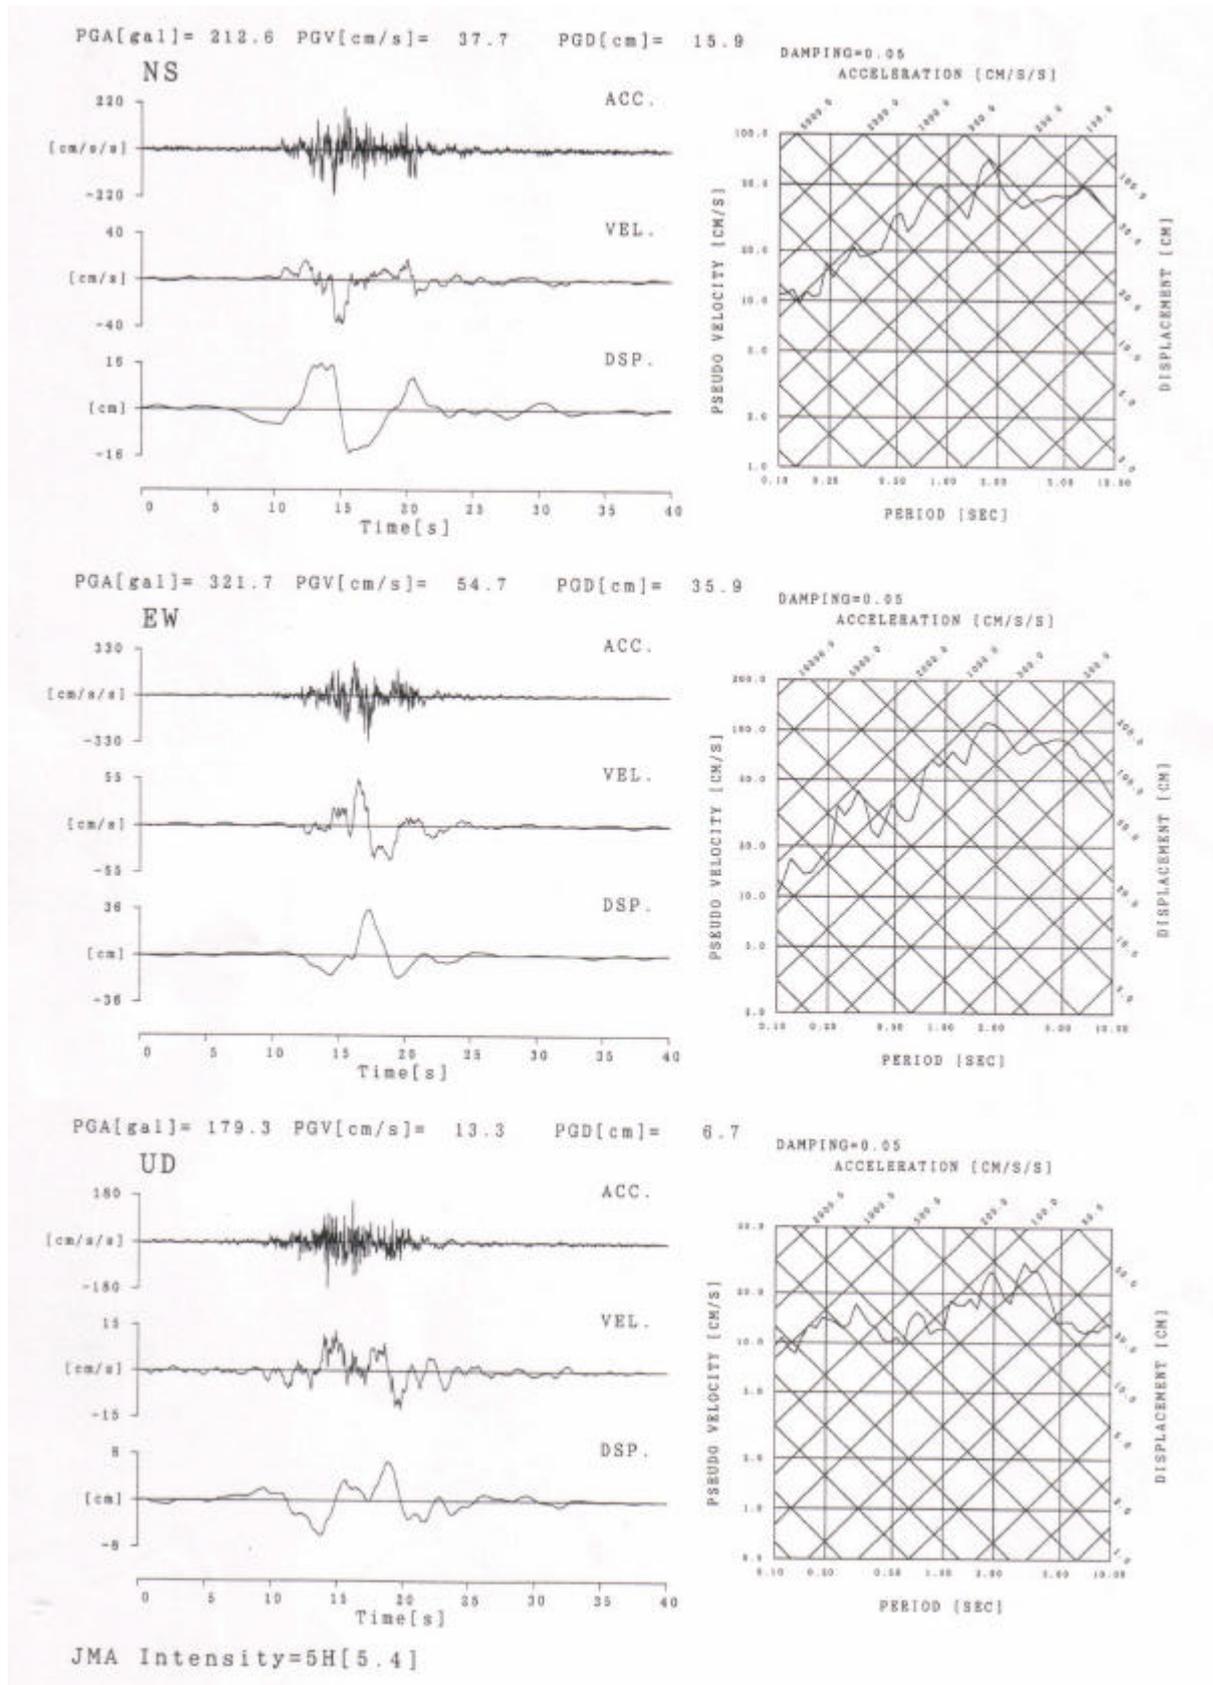
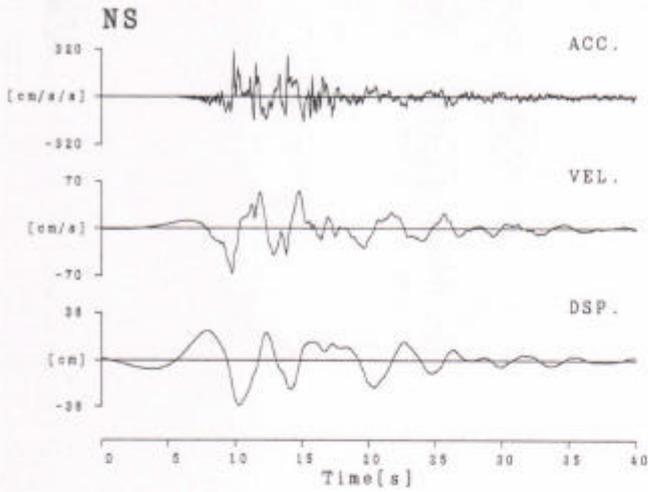
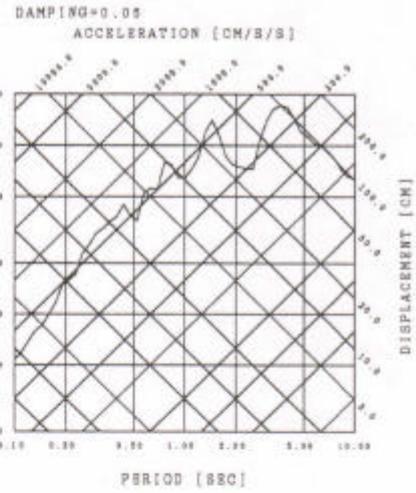
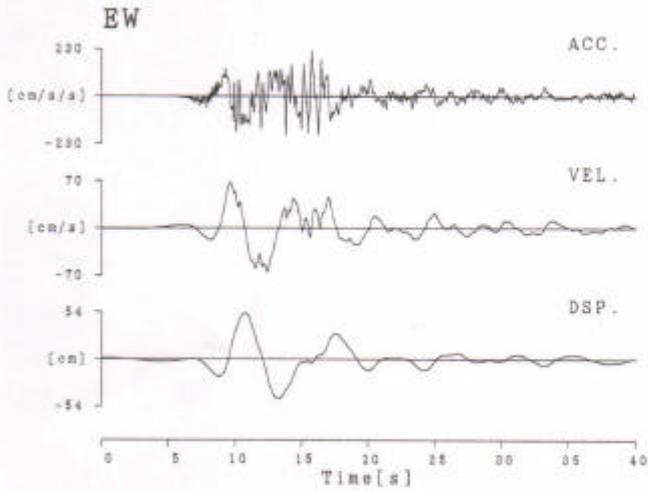
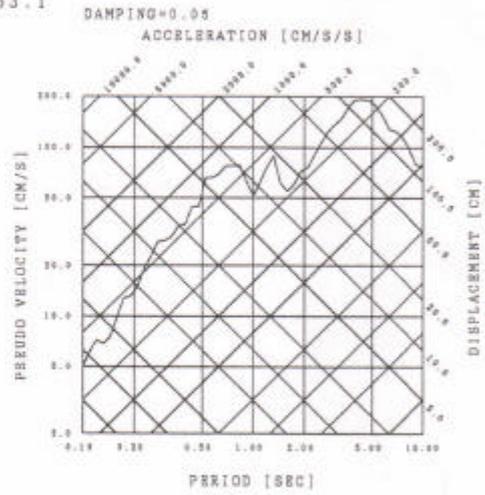
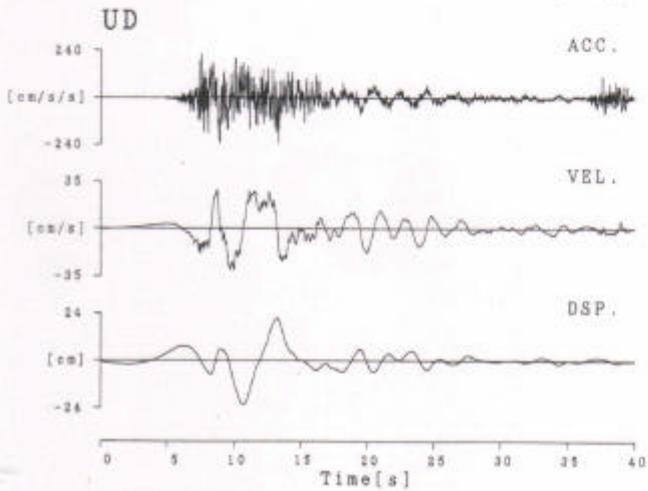
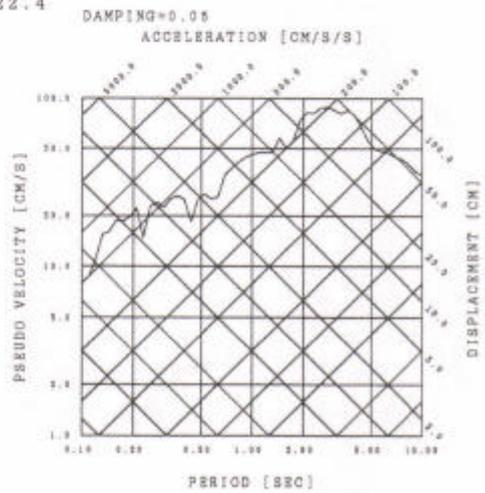
Fig. 4-19(a) Observed wave traces at SKR site

Fig. 4-19(b) Simulated wave traces at SKR site

PGA[gal]= 315.7 PGV[cm/s]= 87.0 PGD[cm]= 35.3

PGA[gal]= 225.1 PGV[cm/s]= 88.0 PGD[cm]= 53.1

PGA[gal]= 238.3 PGV[cm/s]= 30.4 PGD[cm]= 22.4

JMA Intensity=5H[5.4]

Figures 4.19 to 4.23 show the simulated earthquake ground motions in comparison with the observed ones. The amplitudes of the simulated ground motions are rather smaller than the observed ones. This may result from the lack of the data about the sedimentary structure. However, the simulated ground motions can mostly explain major characteristics of the observed records. This result shows that the strong ground motions can be explained by the average fault rupture model.

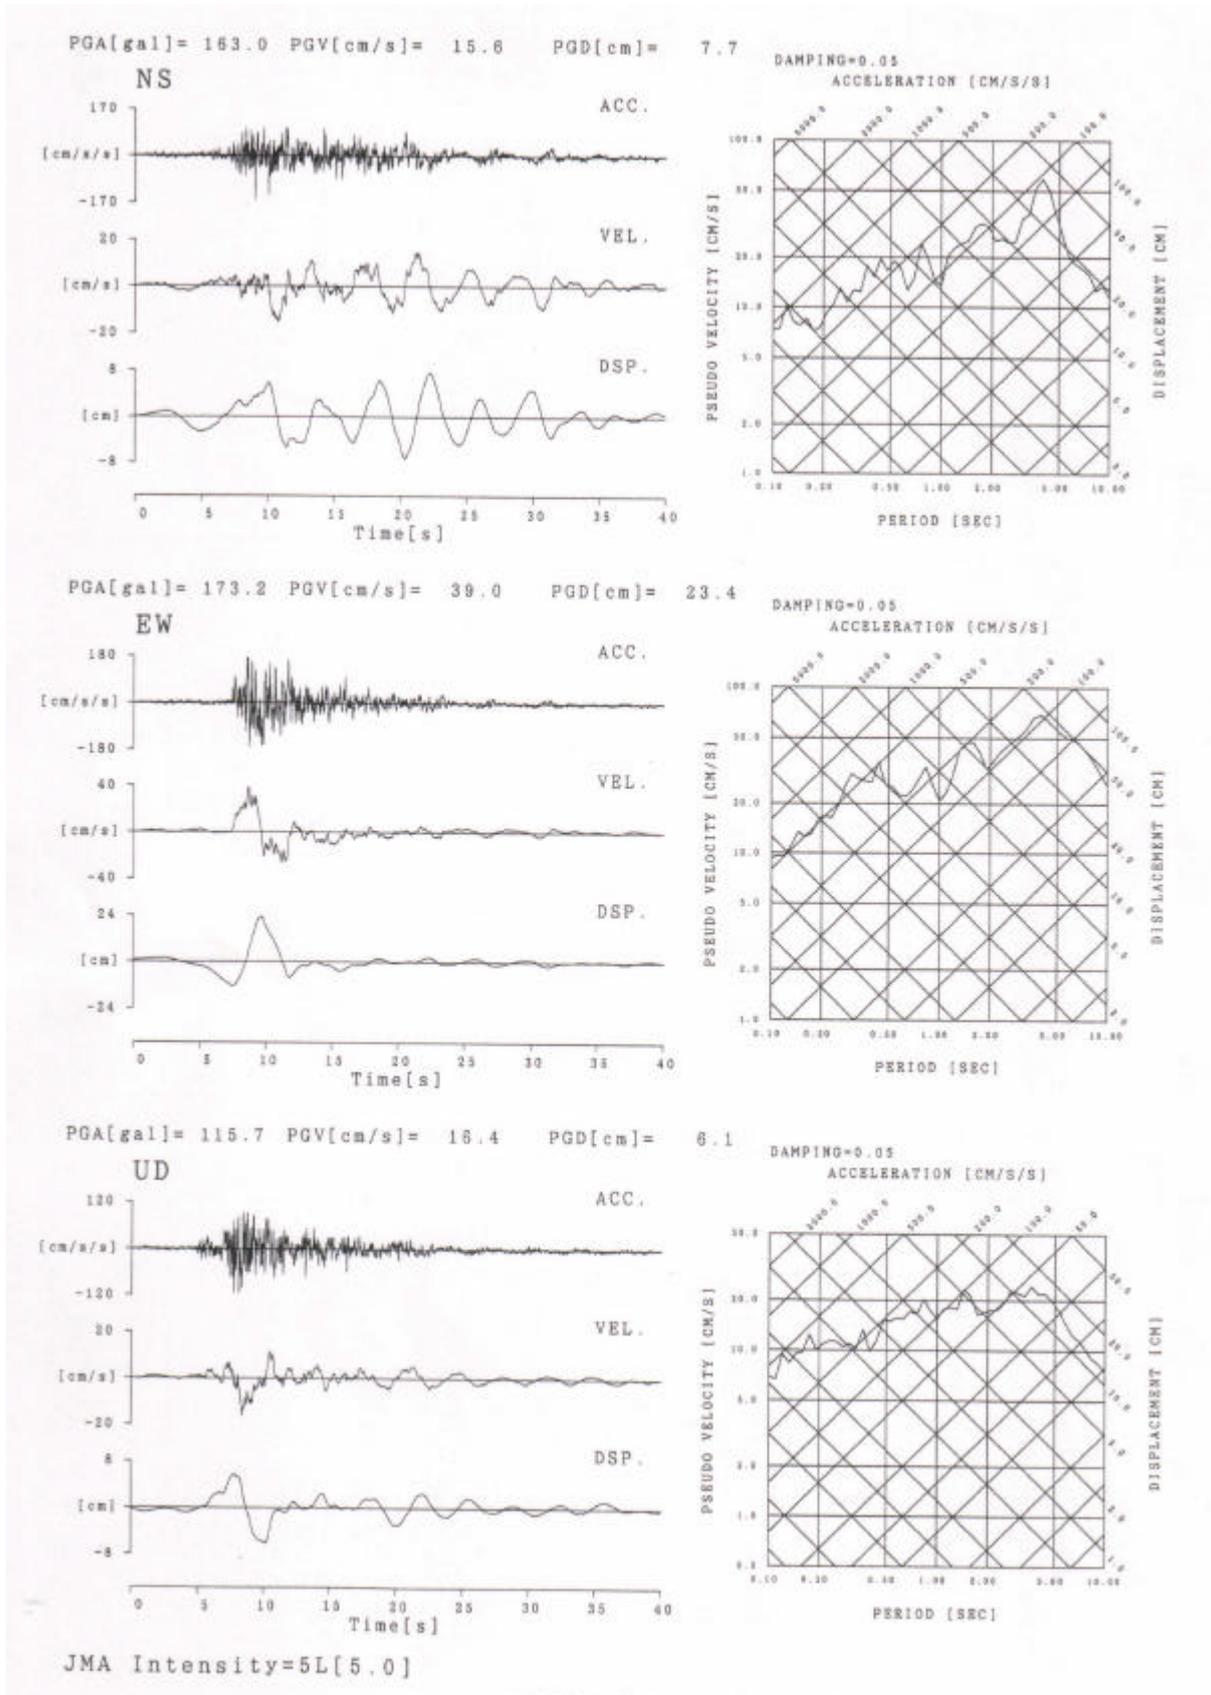
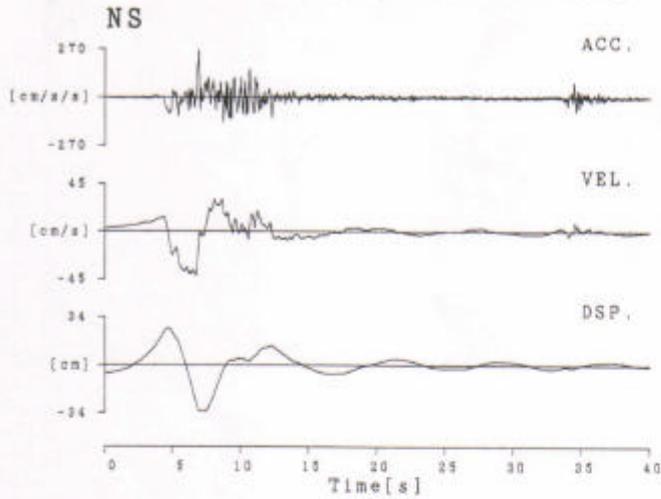
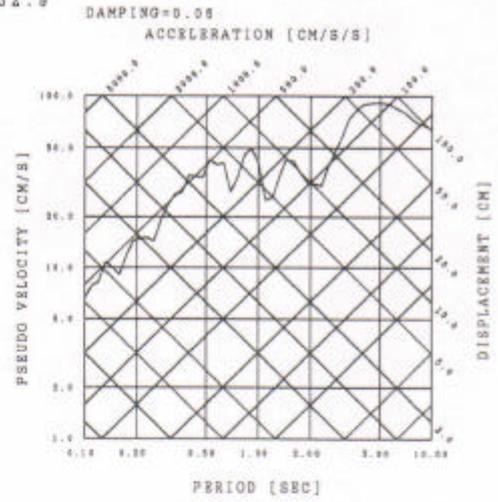
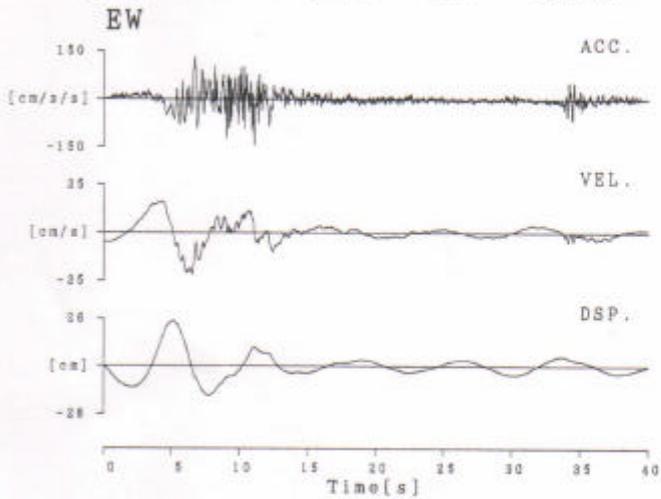
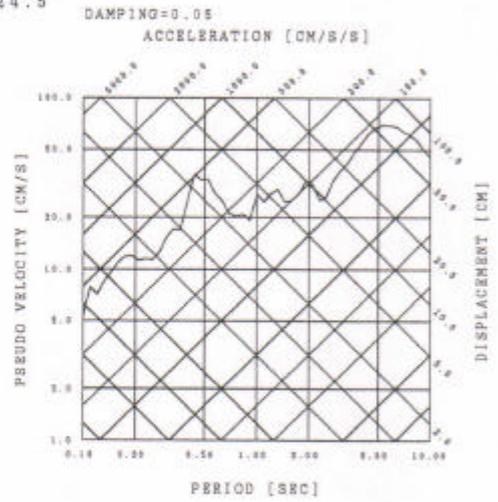
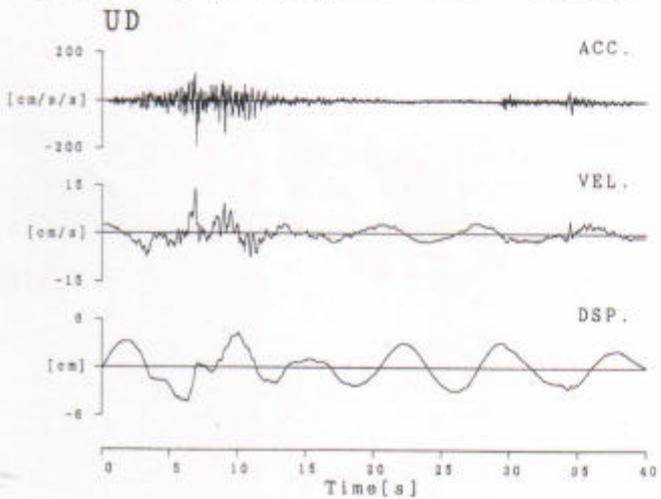
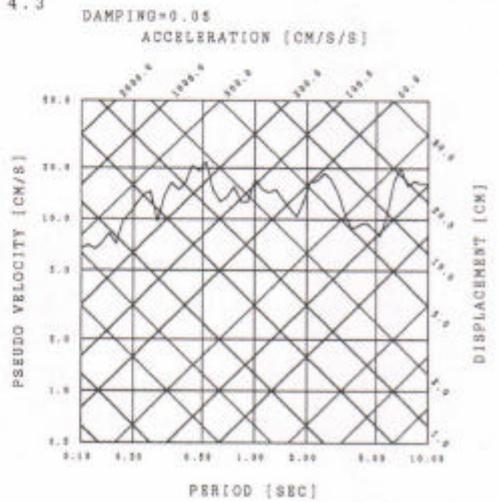
Fig. 4-22(a) Observed wave traces at IZT site

Fig. 4-22(b) Simulated wave traces at IZT site

PGA[gal]= 266.9 PGV[cm/s]= 41.4 PGD[cm]= 32.9

PGA[gal]= 144.1 PGV[cm/s]= 30.7 PGD[cm]= 24.5

PGA[gal]= 196.3 PGV[cm/s]= 14.1 PGD[cm]= 4.3

JMA Intensity=5H[5.0]
