Waterworks damage

Yasuko Kuwata
Dept. of Civil Eng., Kobe University

Damage to water supply facility Miyagi pref.

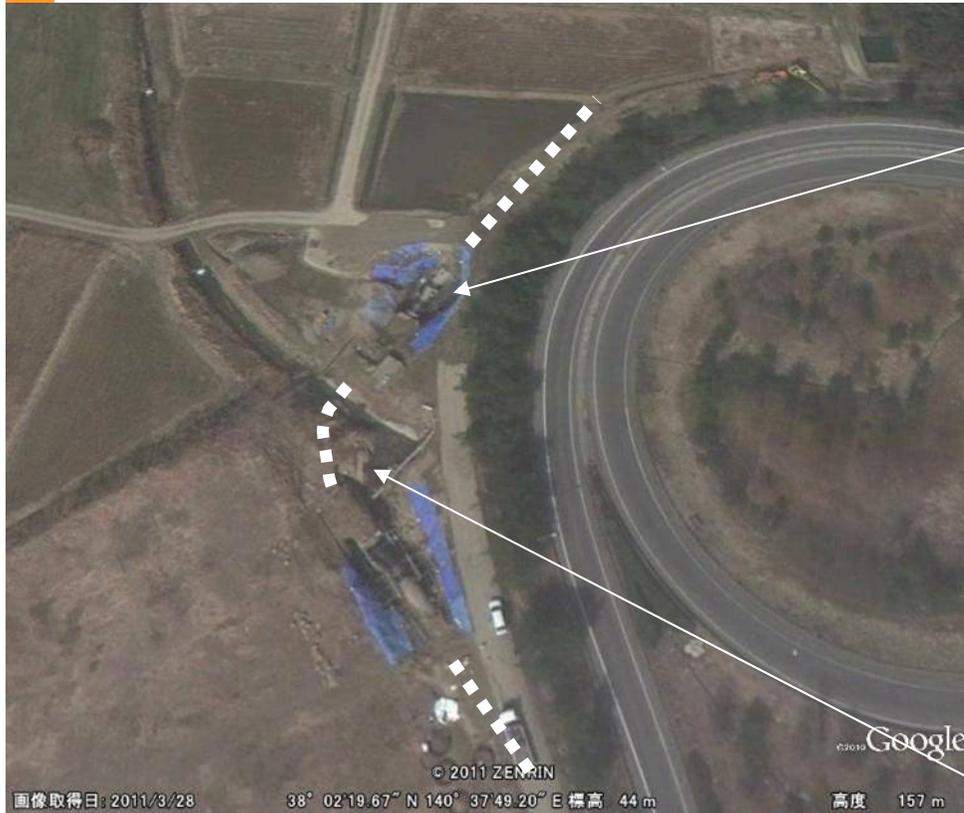
(March 28, Google Earth)

Large diameter pipe damage/ Shiraishi

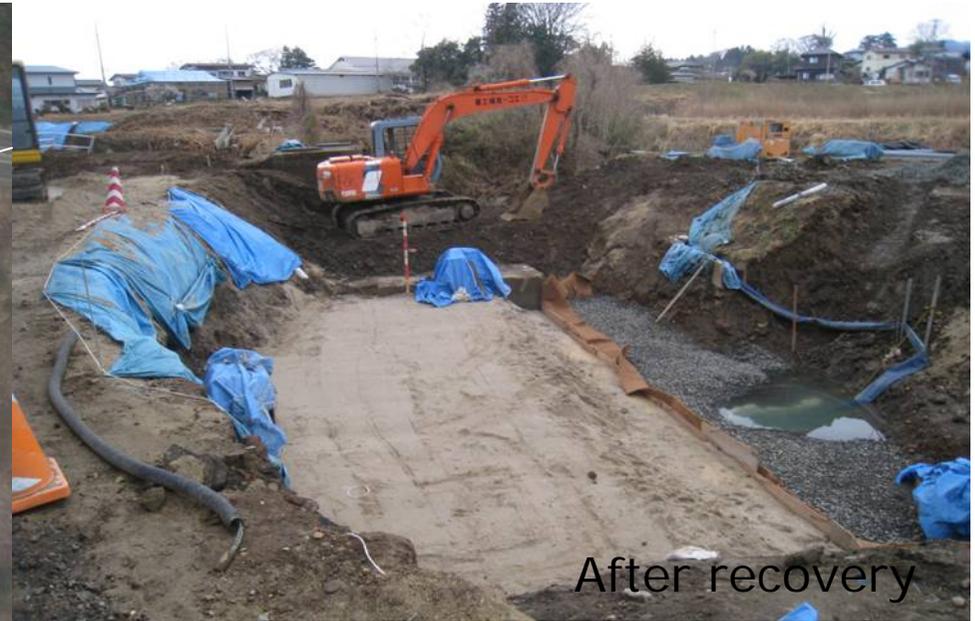
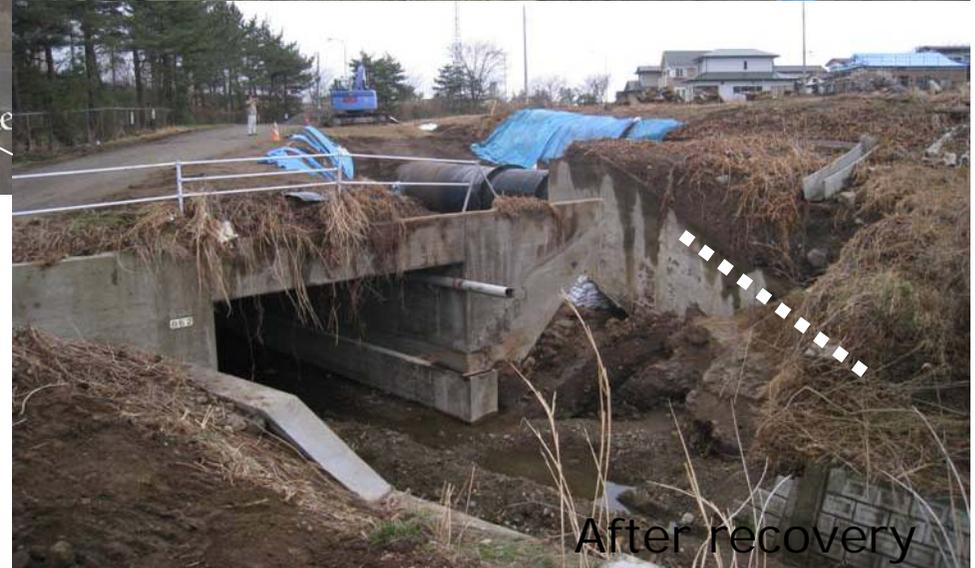
River under-passing
transmission pipeline SP ϕ 2400

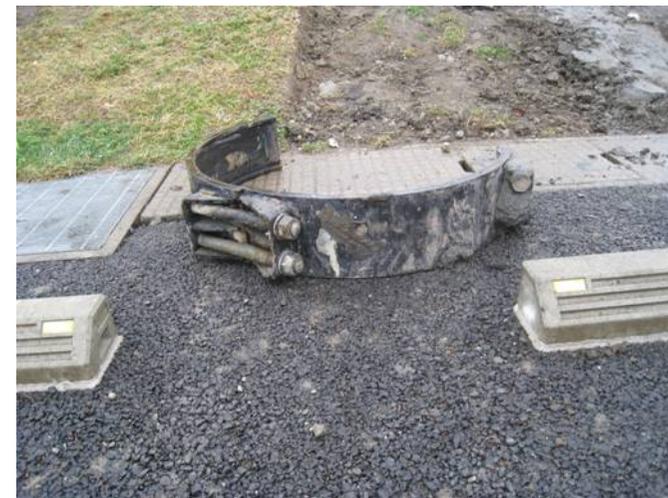
Water leak at welded part of steel pipe,
Sendai: SP ϕ 700 damaged by April 7,
aftershock

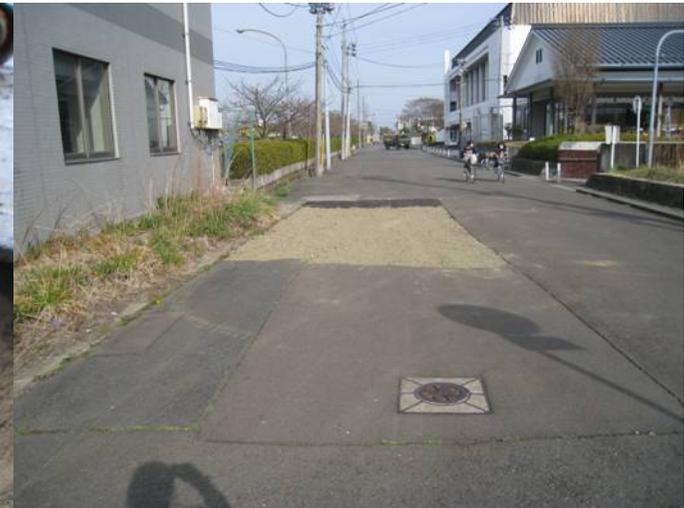
Before April 7

DIP ϕ 300, damaged by April 7 aftershock

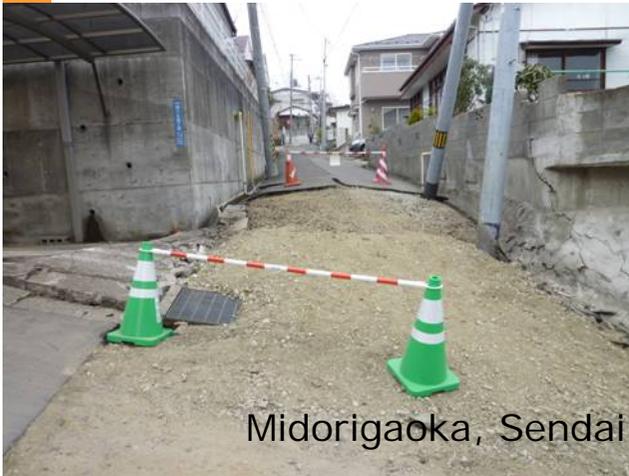
Midorigaoka, Sendai

Pipeline damage due to ground deformation

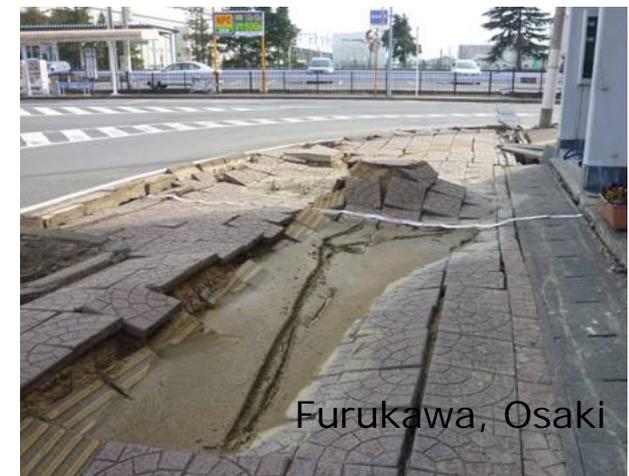
Furukawa, Osaki

Land deformation at hill-side land development

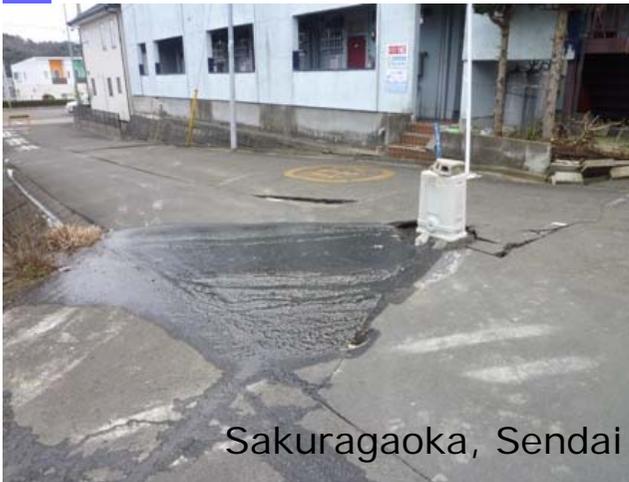
Sakuragaoka, Sendai

Liquefaction

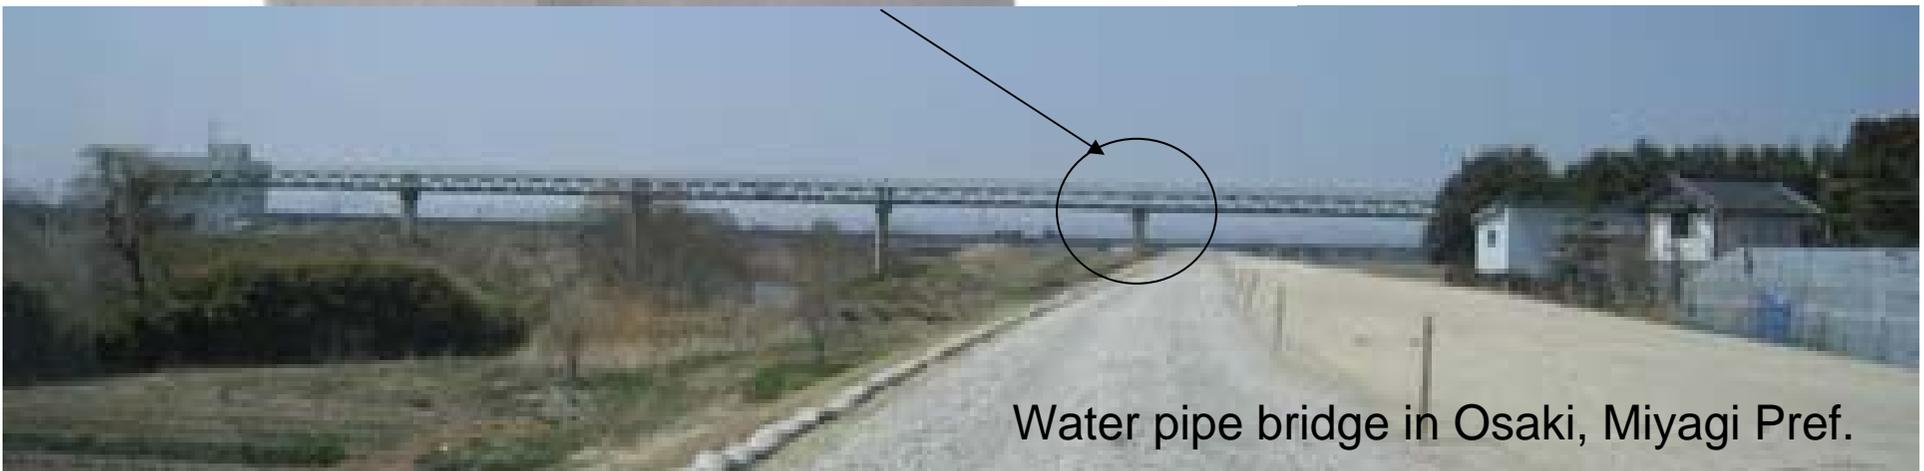
Water pipe bridge in Osaki, Miyagi Pref.

Temporal repair of water pipe bridge.

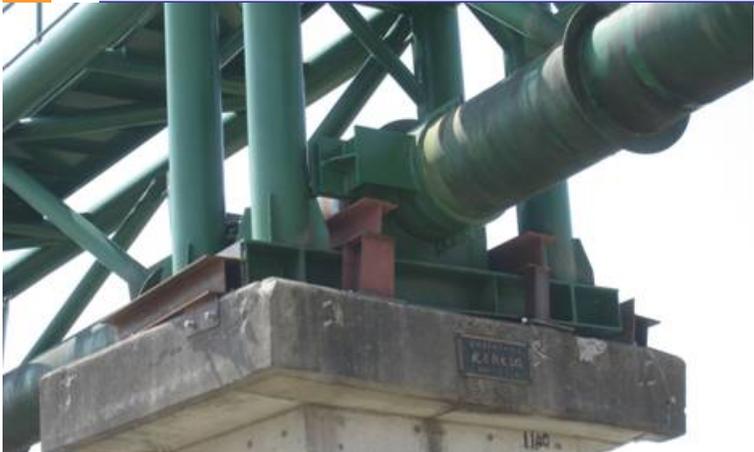
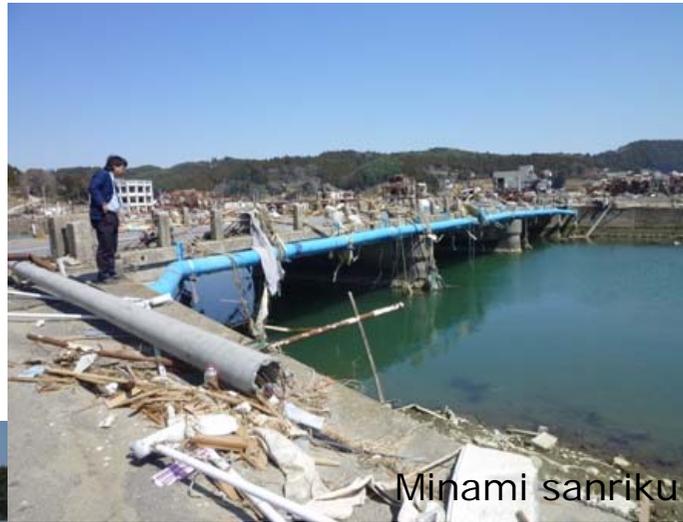
Minami sanriku

Water pipe bridge/ adjusted pipe

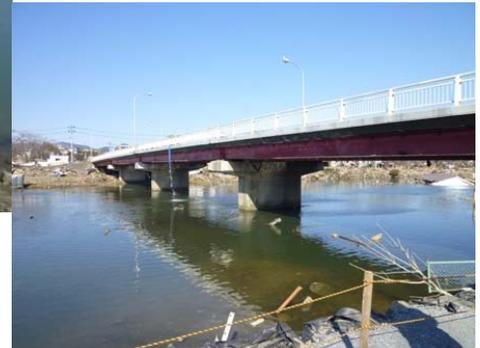
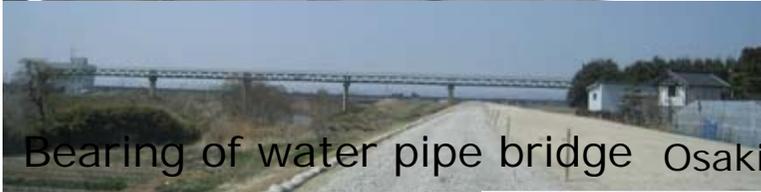
Bearing of water pipe bridge Osaki

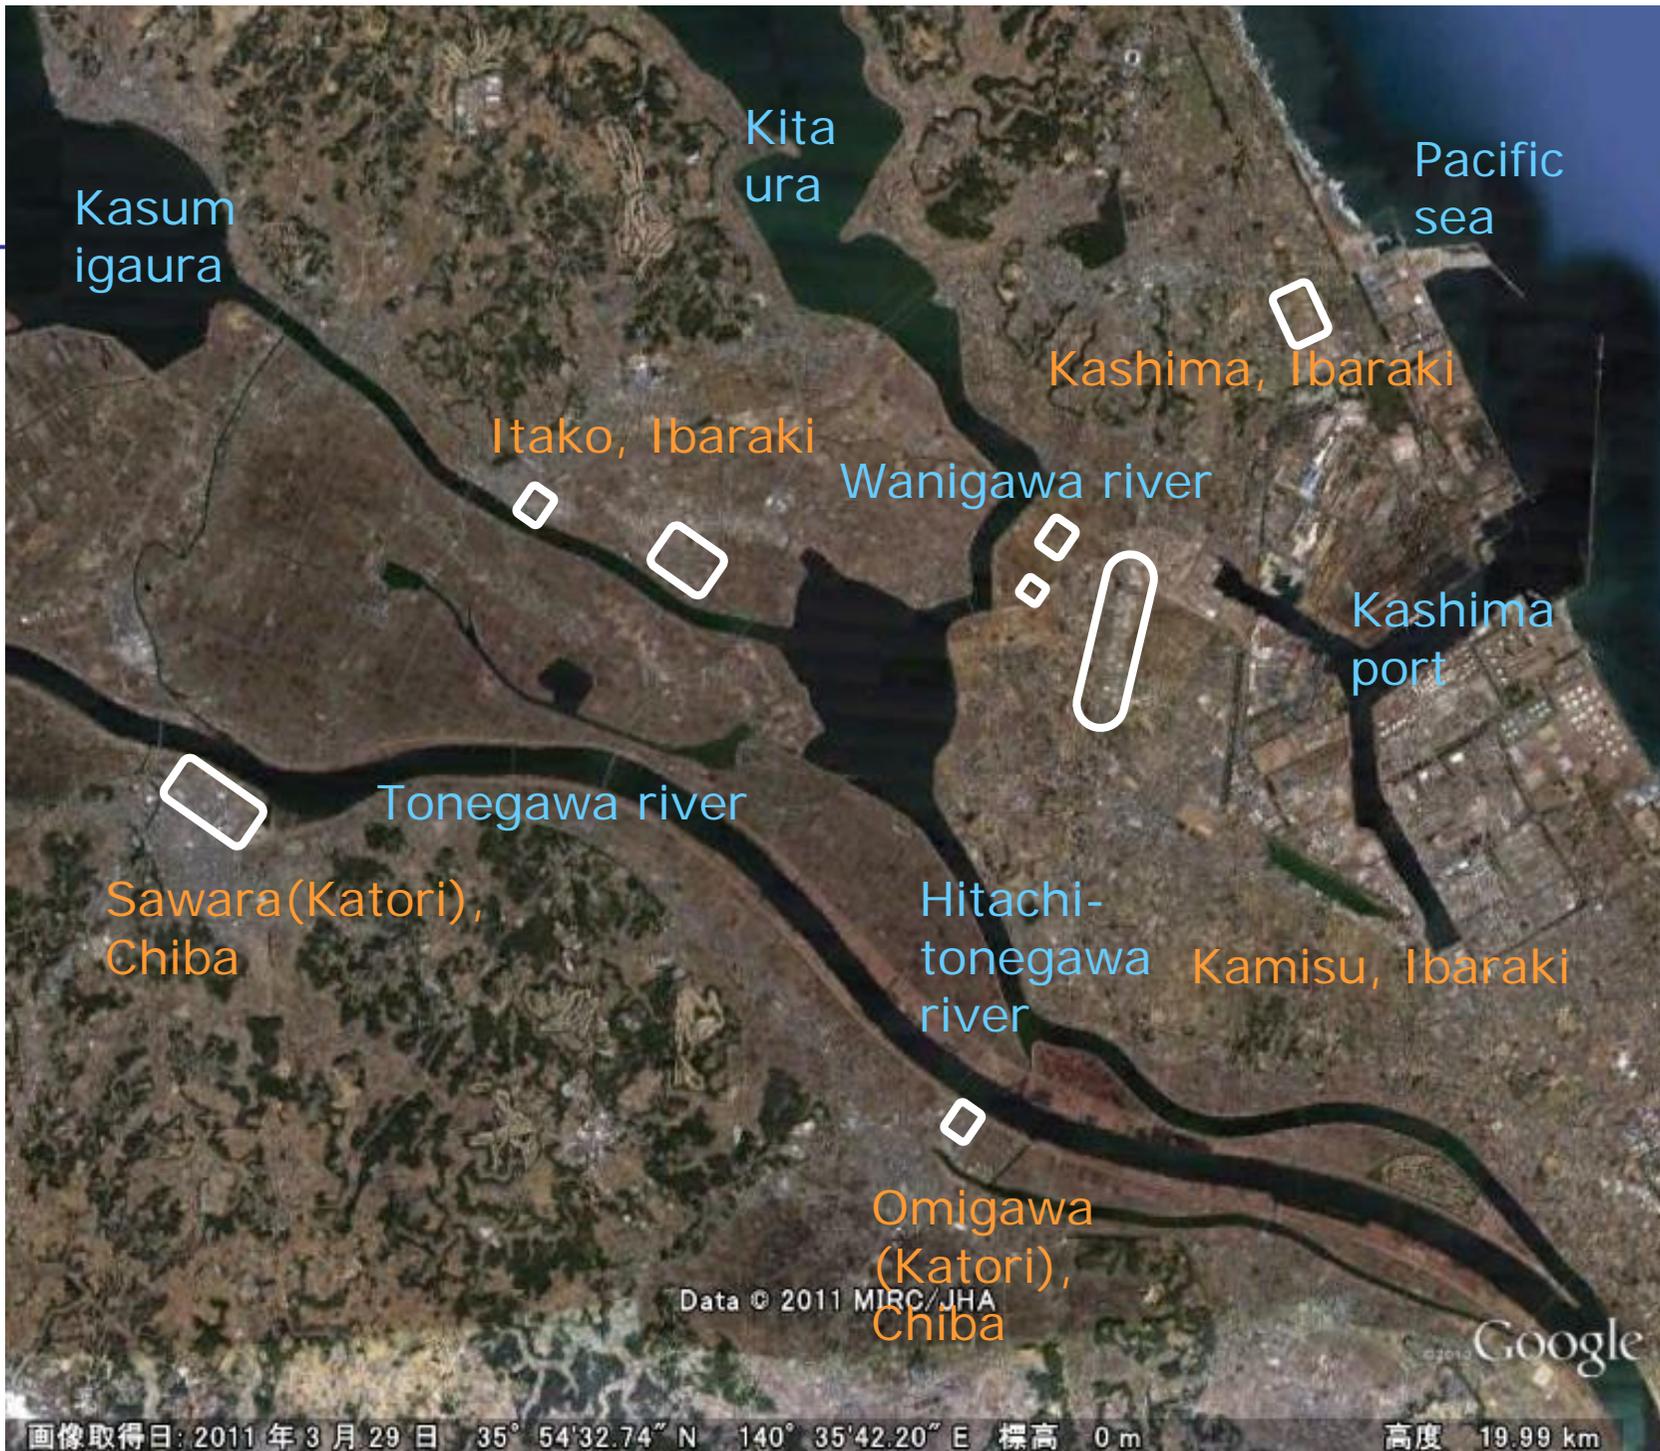
Liquefied area around Kamisu/ Kashima

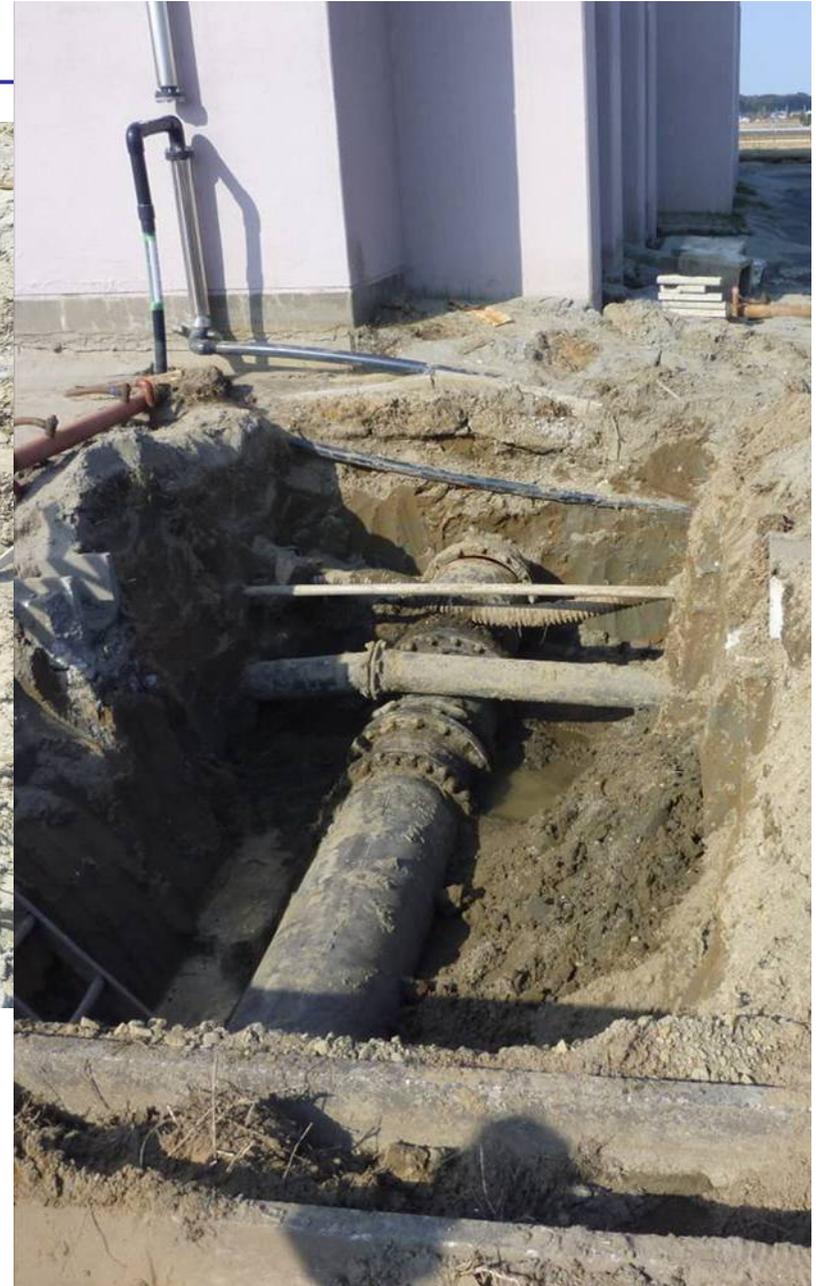
Subsidence/ No subsidence

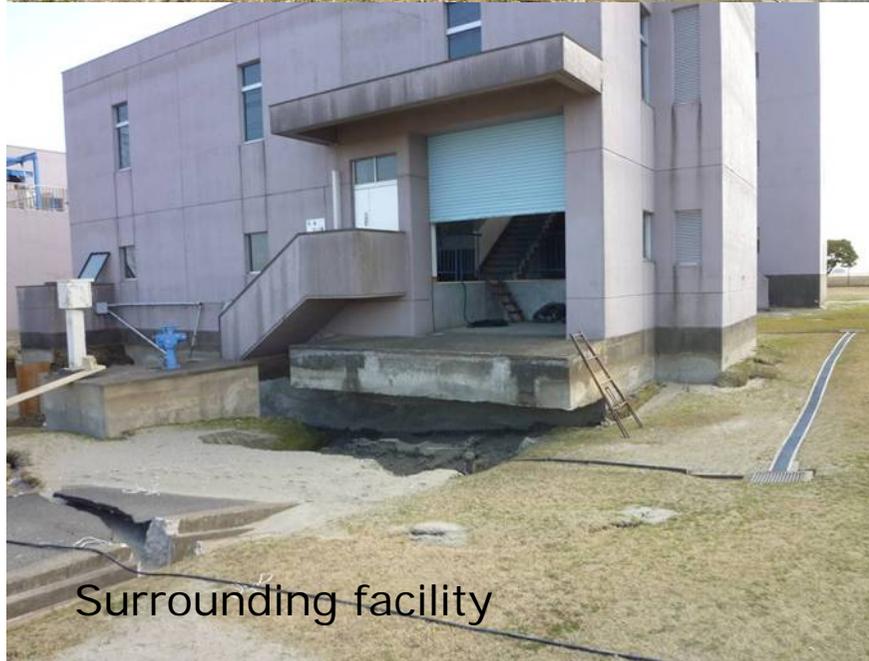
Distribution reservoir

Later leak at joint of DIP(K) ϕ 300

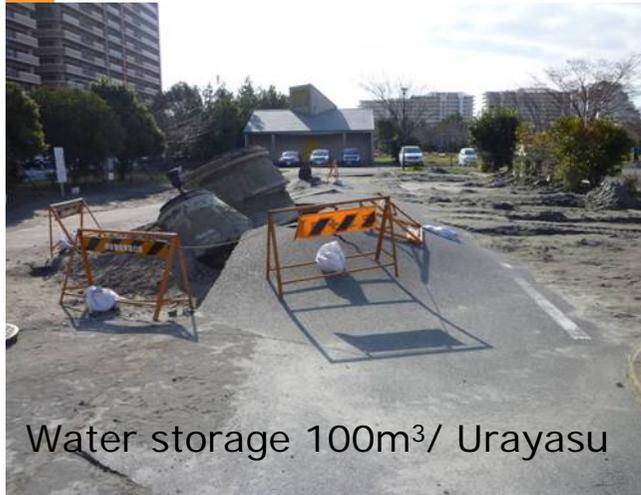
Water storage 100m³/ Urayasu

Uplifted tanks in liquefied ground

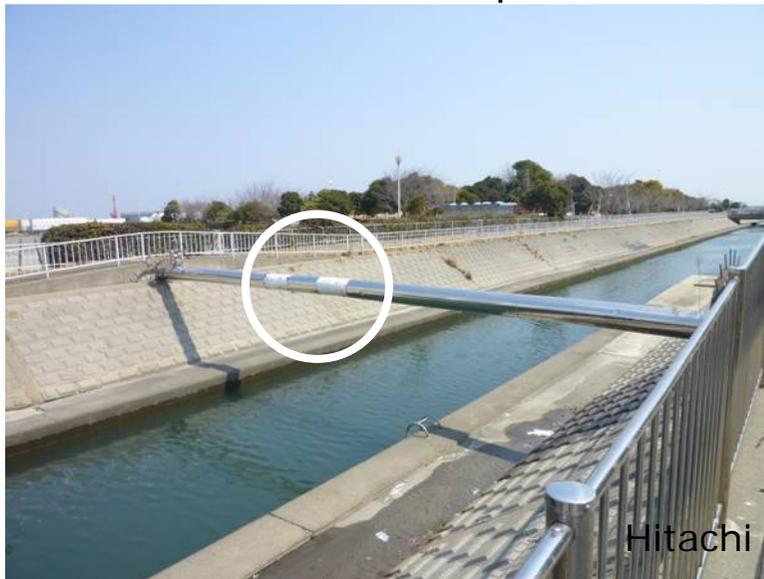
Hitachi

Leak of SP φ 250
