BOUMERDES EARTHQUAKE

May 21, 2003

Japanese Reconnaissance Team

OCTOBER 2004

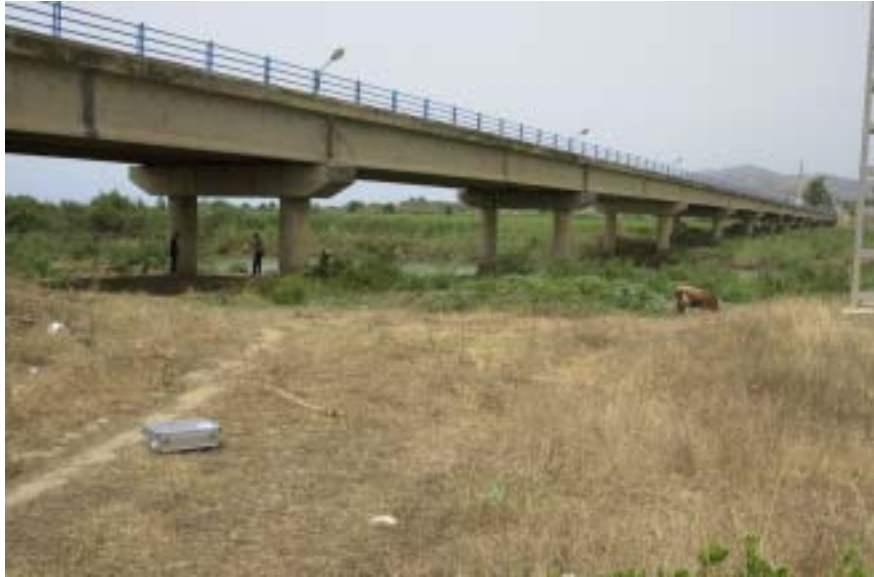
The lateral flow induced by the liquefaction occurred at the bridge of the National Road No.24 crossing over the Isser River at the Point 1 shown in Figure 3.1. The bridge is 454 m in length and consists of thirteen concrete girder spans supported on twelve concrete piers as shown in Figure 3.3.

Figure 3.3: Overview of the bridge crossing over the Isser River.

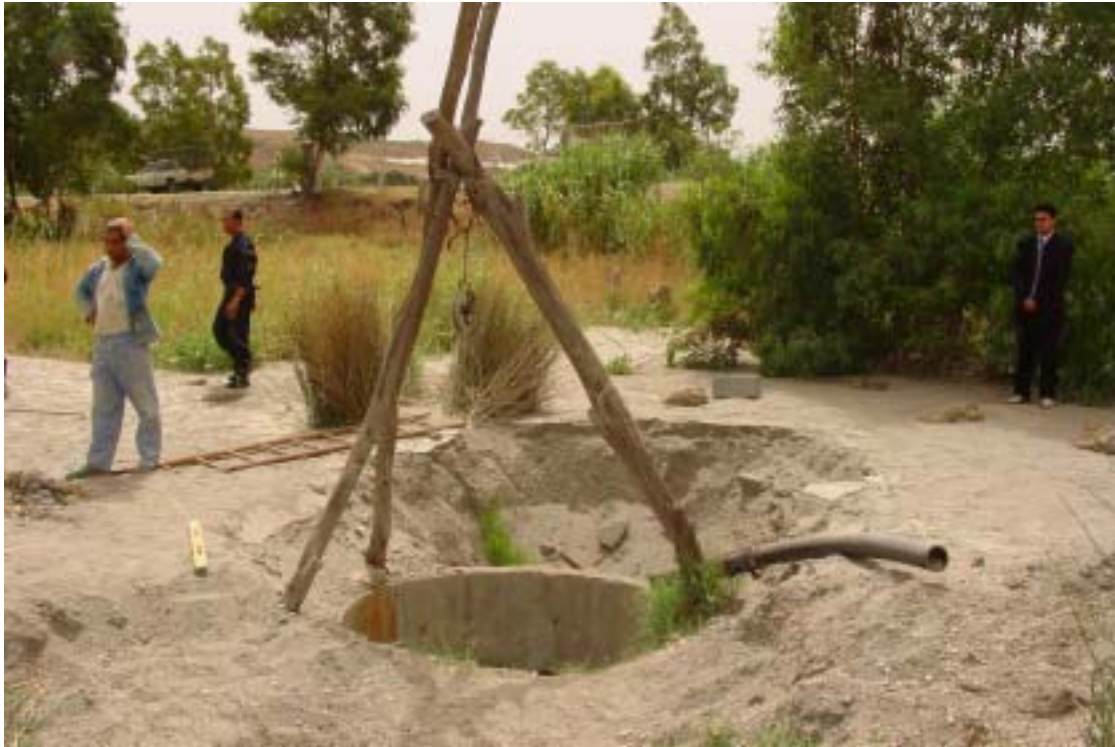
Figure 3.19 shows a well in a vineyard and the ejected sands from the well due to soil liquefaction at the right bank of the Sebaou River. It is located at Point 3 as shown in Figure 3.1. The well was made of concrete rings of diameter 0.7 m and of depth of 12 m approximately. According to witnesses, the sand and water spouted out from this well to several ten meters of height just after the earthquake and consequently the well dried up. The sands spouted out of the well were distributed like a concentric circle of diameter over 10 m. The maximum thickness of the sand deposit was over 1 m.

Figure 3.19: Ejected sand around the well in a vineyard.

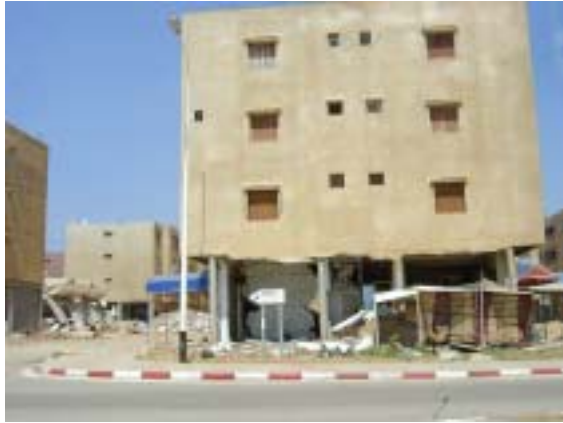
□ RC frame with infill brick wall (Figures 4.2-4.19)

Figure 4.2: Collapse of brick walls at the ground floor

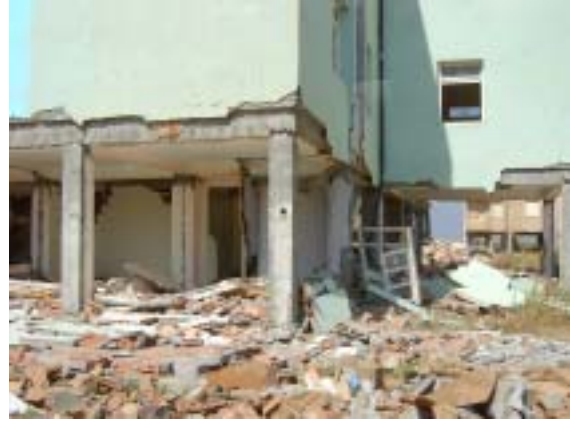
Figure 4.3: Collapse of brick walls at the ground floor

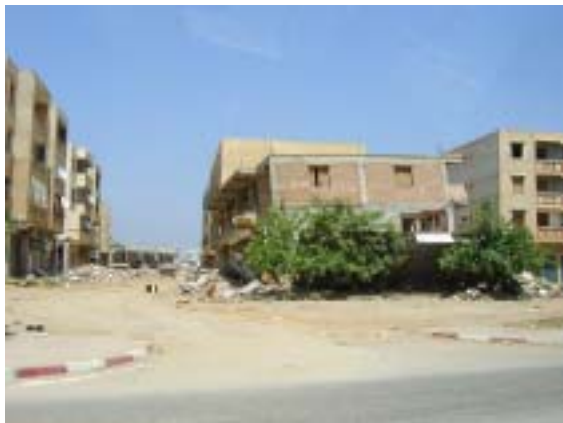
Figure 4.4: Building collapse in Zemmouri

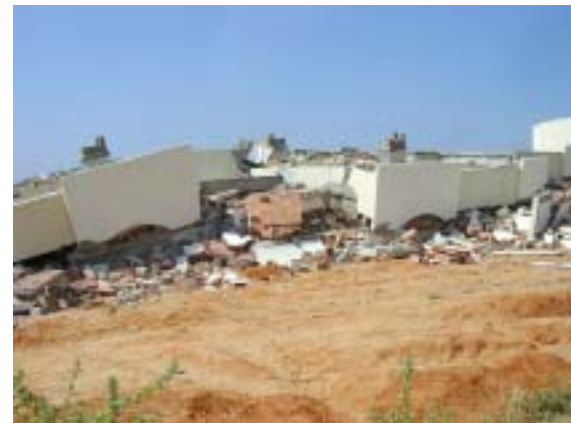
Figure 4.5: Pancake shape collapse

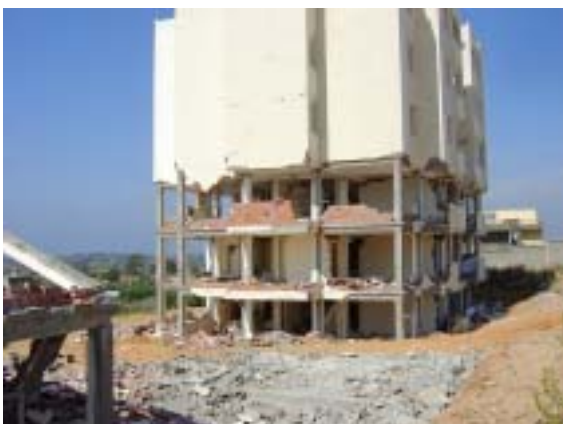
Figure 4.6: Severe damage of a building

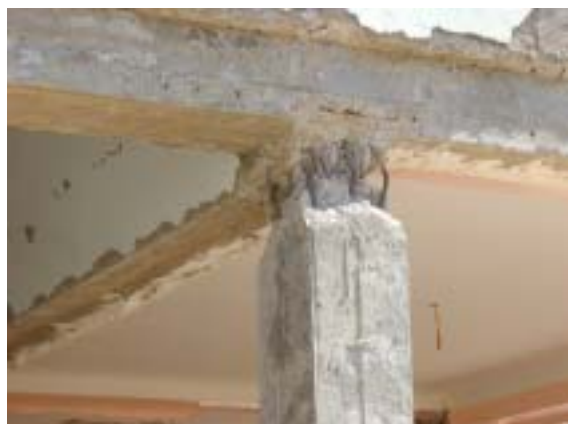
thermal insulation might increase the inertia force during earthquake and aggravate the damage. In most cases, the damage to the columns was found in the cold joint area at the top of the columns and in the connection area with the beams. Also, the evidences of bad construction practice, such as severe rust of reinforcement steel bars inside concrete, low quality of concrete material, lack of stirrup in connection area, were observed.

Figure 4.7: Failure at the column top

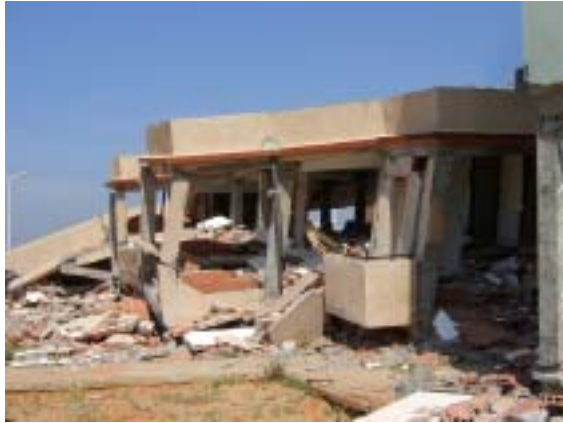
Figure 4.8: Story collapse of a building

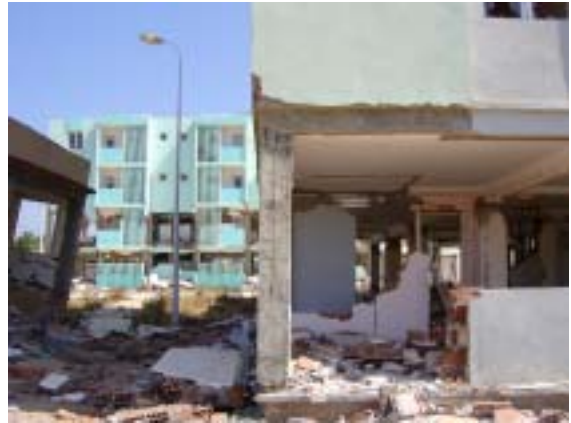
Figure 4.9: Failure of walls and columns at the ground story

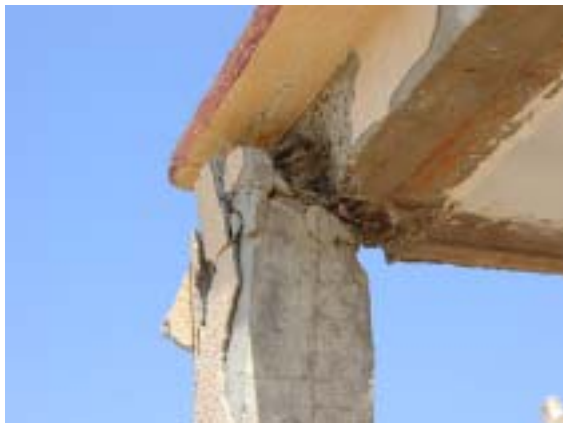
Figure 4.10: Failure of a joint between column and beam elements

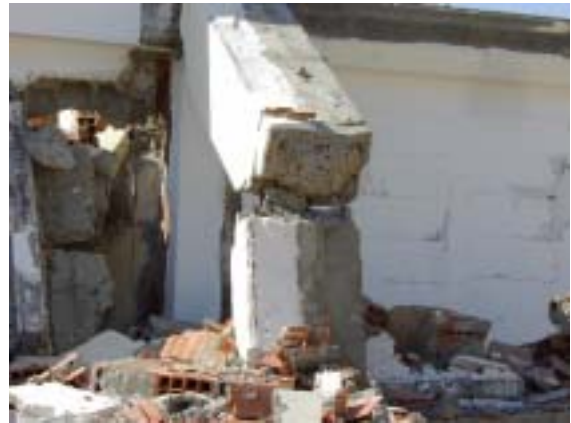
Figure 4.11: Break of reinforcement bars inside a column

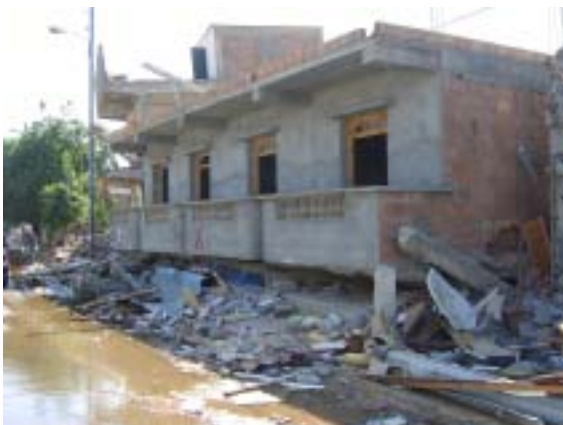
Figure 4.12: Soft first story collapse of a private house

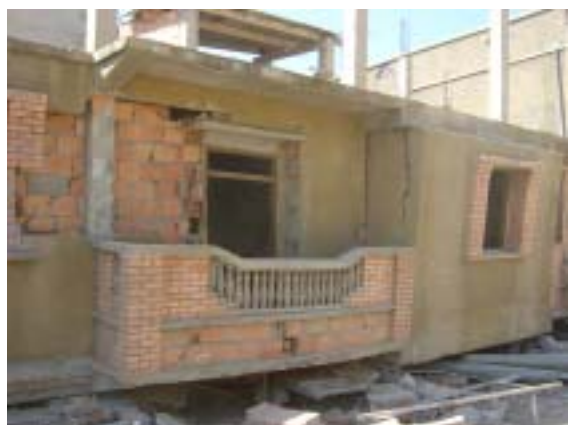
Figure 4.13: Soft first story collapse of a private house

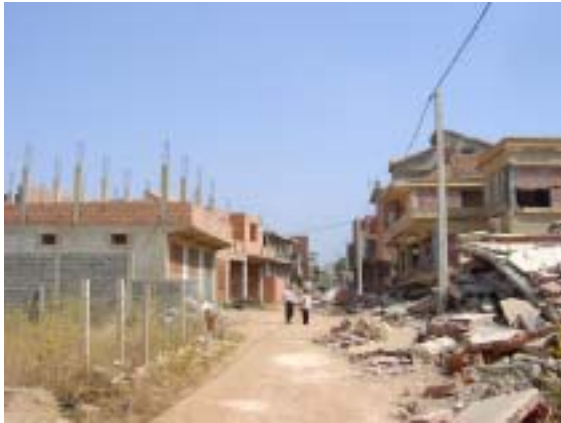
Figure 4.14: Building damage in a new residential area

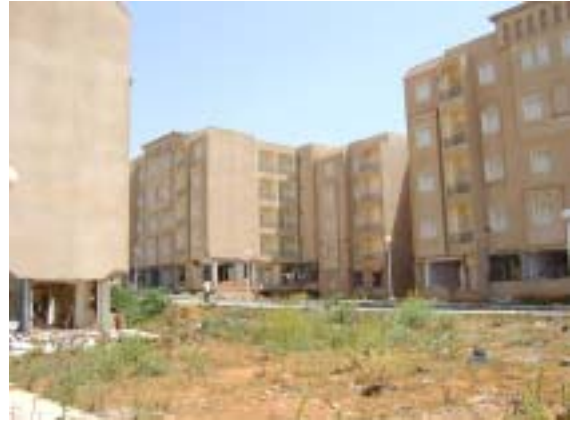
Figure 4.15: Damage of new buildings

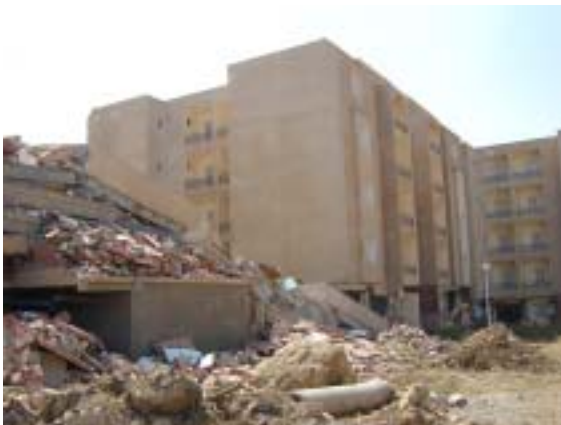
Figure 4.16: Collapsed buildings and survived buildings

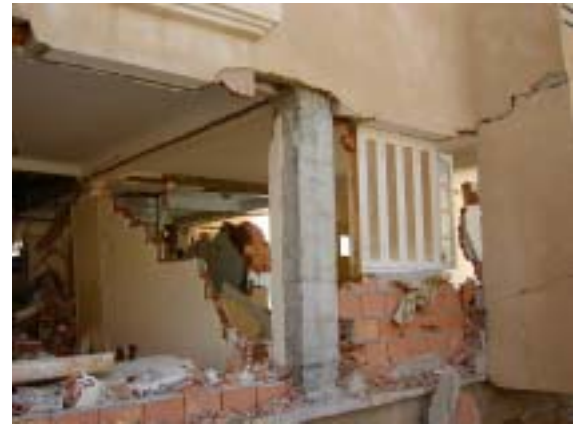
Figure 4.17: damage inside a building

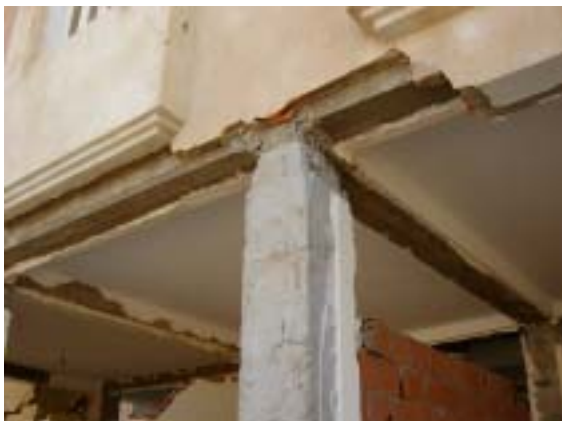
Figure 4.18: Damage around the cold joint of a column

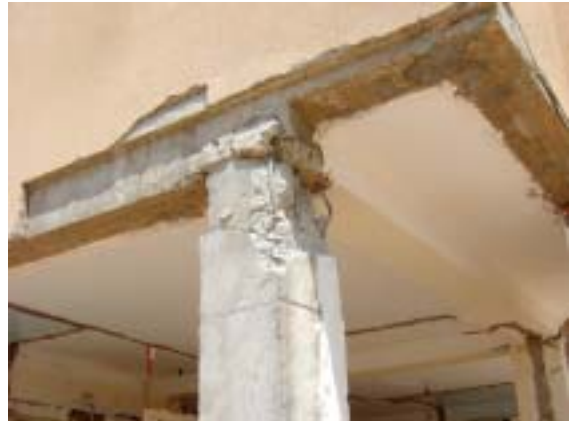
Figure 4.19: Damage around the cold joint of a column

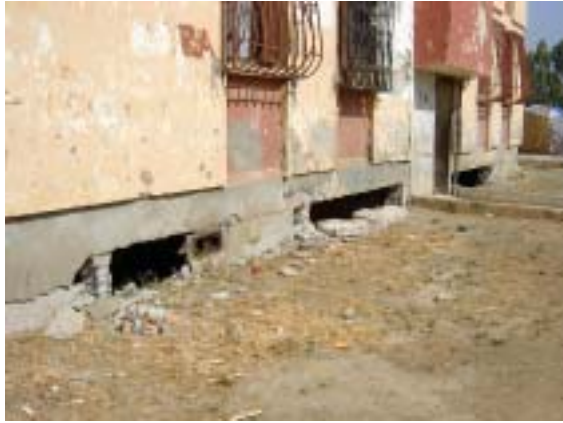
This structural system is widely adopted for medium story apartment buildings in Algeria. It has a sanitary space in the underground level, and the upper structure with residential space is supported by short columns less than 50 cm tall from the ground level. It constitutes a soft story at the level of short columns; therefore, the earthquake damage generally concentrate to this level with severe shear failure at the short columns.

Figure 4.20: Damage of the building with sanitary space

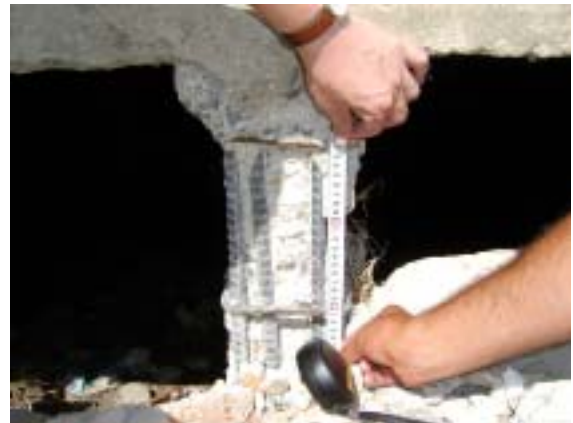
Figure 4.21: Damage of a short column

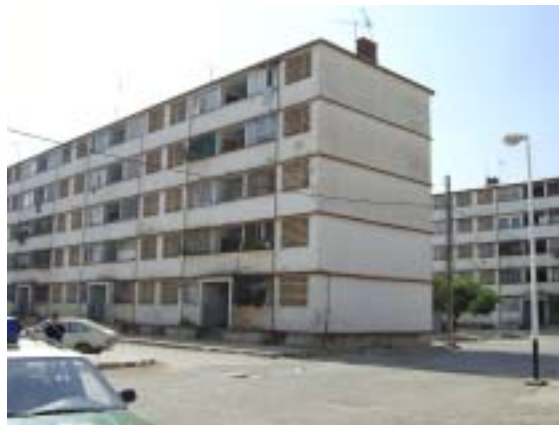
The adoption of reinforced concrete shear wall system is not common for the buildings in Algeria. However, it is apparent that the shear wall is a quite effective element to provide large lateral resistance against earthquake force. Several apartment buildings near Alger constructed by pre-cast reinforced concrete walls demonstrated the effectiveness of shear wall system by showing good performance without any structural damage.

Figure 4.22: Buildings with RC shear walls (no damage)

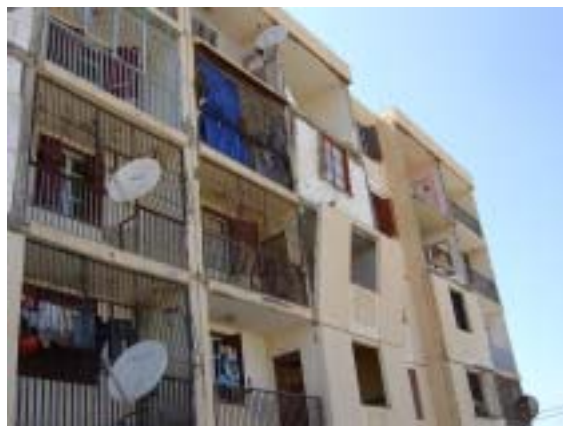
In a new apartment complex in Zemmouri area, a large number of pre-cast concrete panels which attached to the main structures were broken or fell down on the ground because of the break of small steel joints. Apparently the strength of joints was not enough to resist a large inertia force induced by the earthquake. Even the main structure did not suffer severe damage, failure and collapse of these heavy non-structural elements might cause serious human losses.

Figure 4.23: Damage of pre-cast concrete panels

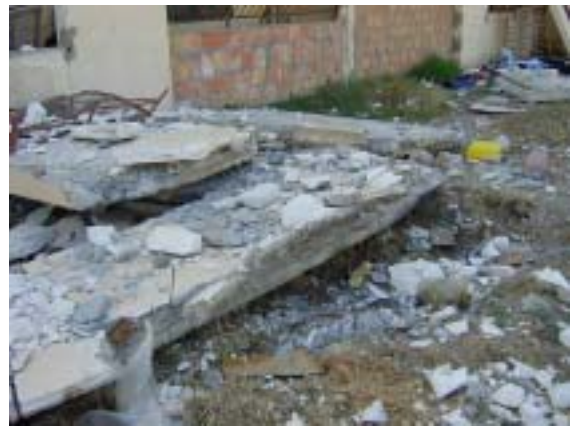
Figure 4.24: Pre-cast concrete panels dropped on the ground

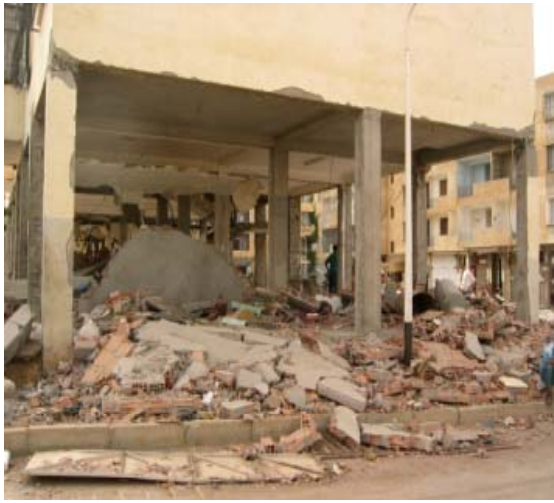
Figure 4.27: Collapse of the facades

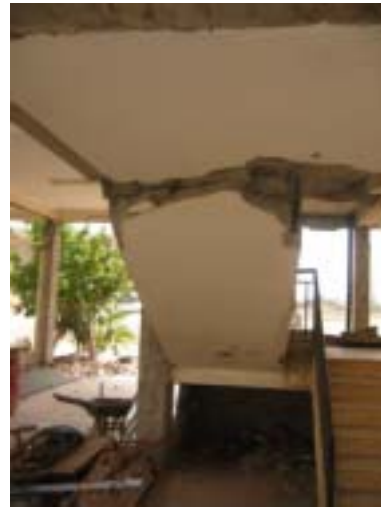
Figure 4.28: Collapse of the stairs

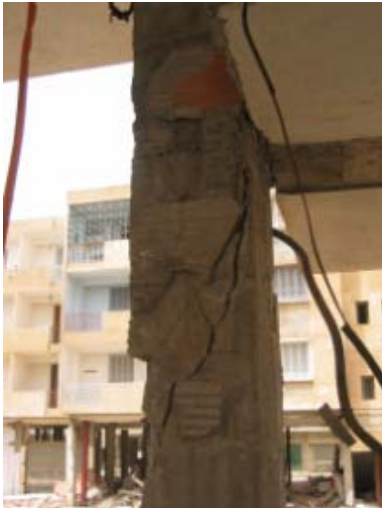
Figure 4.29: Short column failure

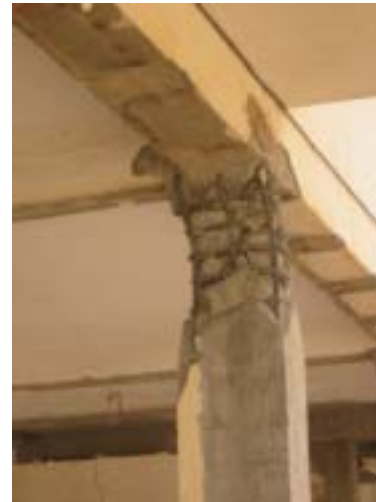
Figure 4.30: Top end column failure

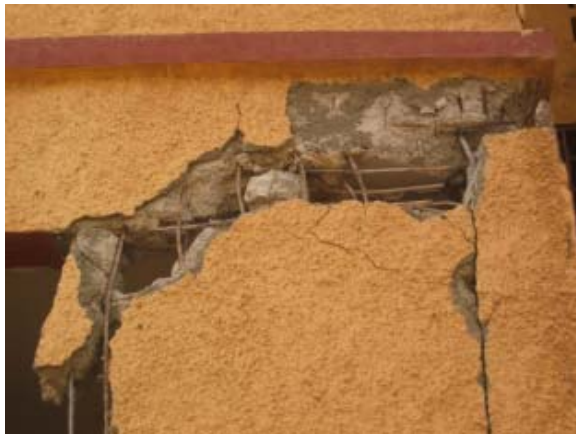
Figure 4.32: Failure at the column's top level

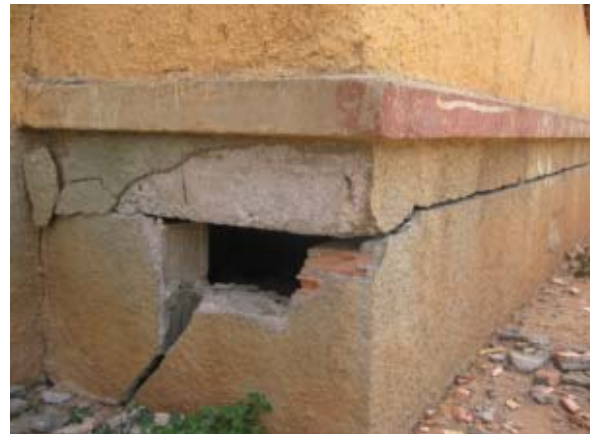
Figure 4.33: Failure at the sanitary level

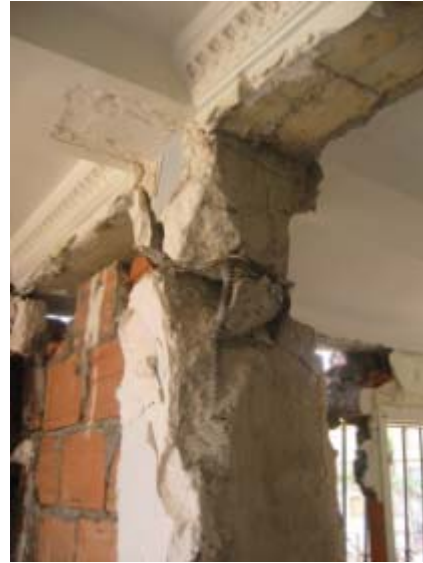
Figure 4.35: Lack of reinforcement bars causing failure at the column's top level

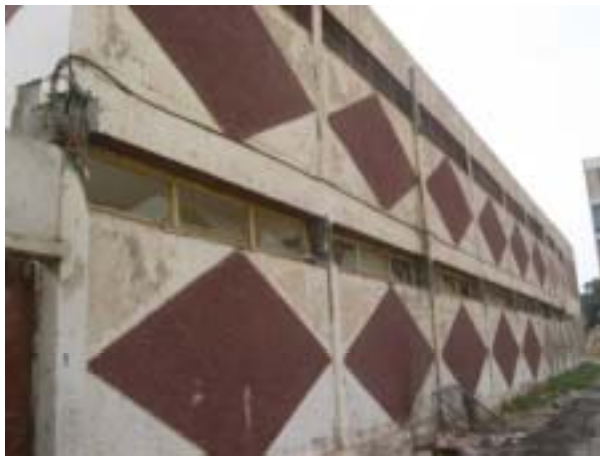
Figure 4.38: Short columns failures

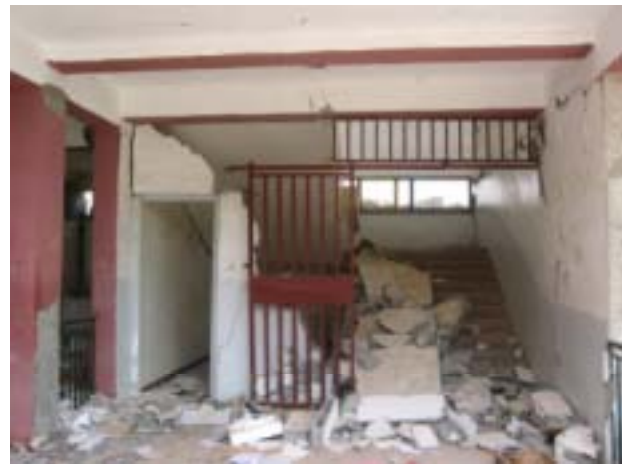
Figure 4.39: Failure of stair's landing

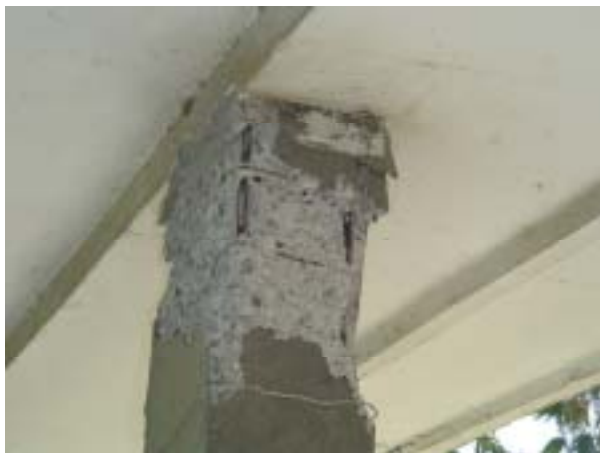
Figure 4.43: Weak reinforcement in both directions

From the sclerometric tests, which were led on a small sample (10 tests) of columns and beams at the ground floor, one can conclude that the used concrete presents a good compression resistance ($> 270 \text{ kg/cm}^2$). However, since the structure is not earthquake-resistant following the code (1960), it underwent structural and non-structural damages as shown in the Figure 4.43 to 4.46.

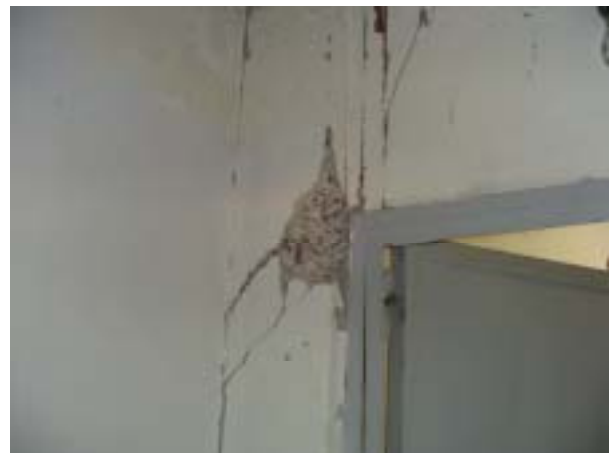
Figure 4.44: Column severely damaged due to stiff frame of the door

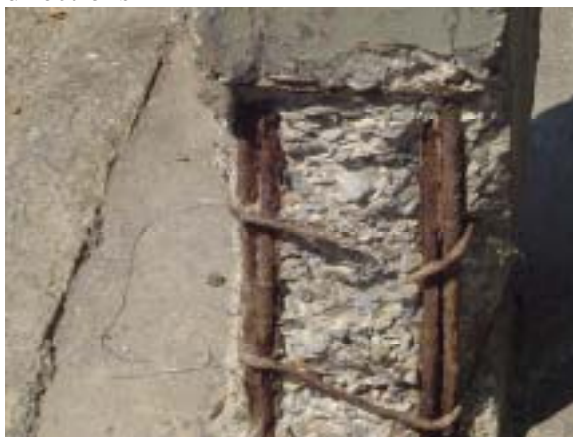
Figure 4.45: Pulling of the cover and weak reinforcement at the bottom of the column

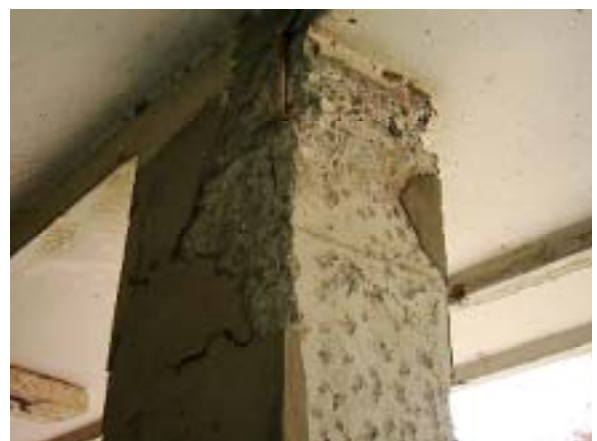
Figure 4.46: Pulling of the cover and damage at the top of the column

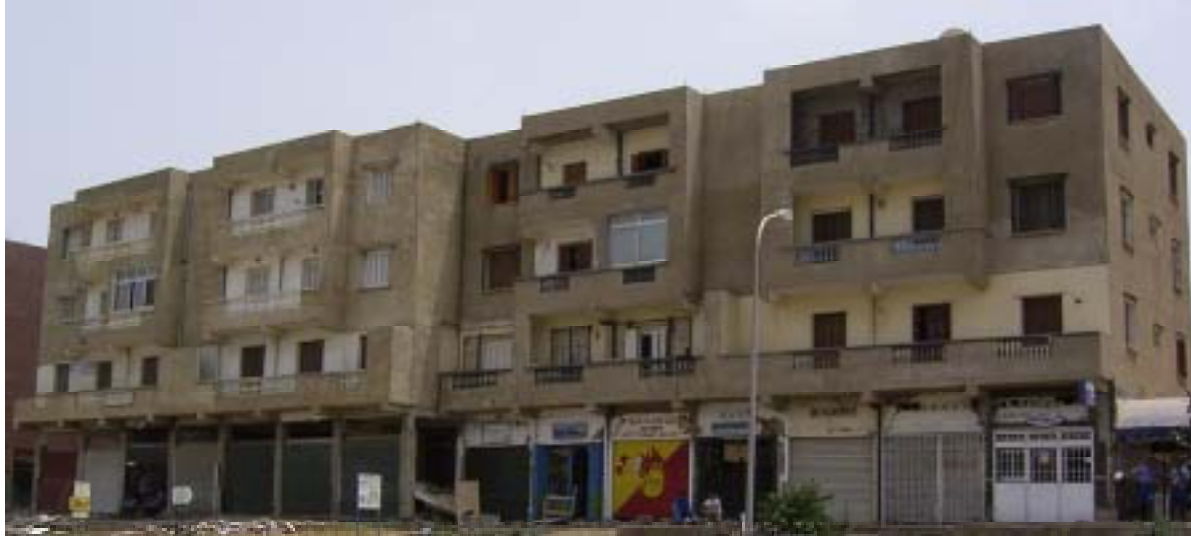
that were in operation near to the observation area might have affected the measurements. It should also be reported that the first observed structure was a four-story buildings with “soft story” type of damage. From Table 4.2 it is clear that the fundamental period for that structure increased due to the high seismic damage. The microtremor measurements can be used to identify damage by recognizing changes in the fundamental period.

(a) Structure 1 (4-story RC structure with soft floor type of damage)

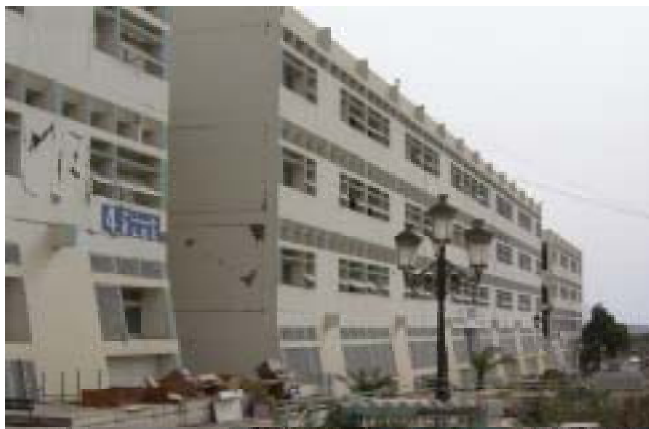
(b) Structure 2 (Boumerdes University)

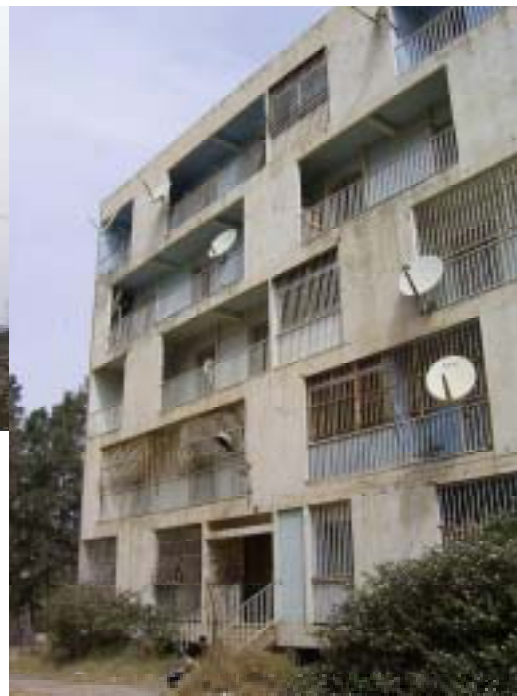
(c) Structure 3 (5-story RC building)

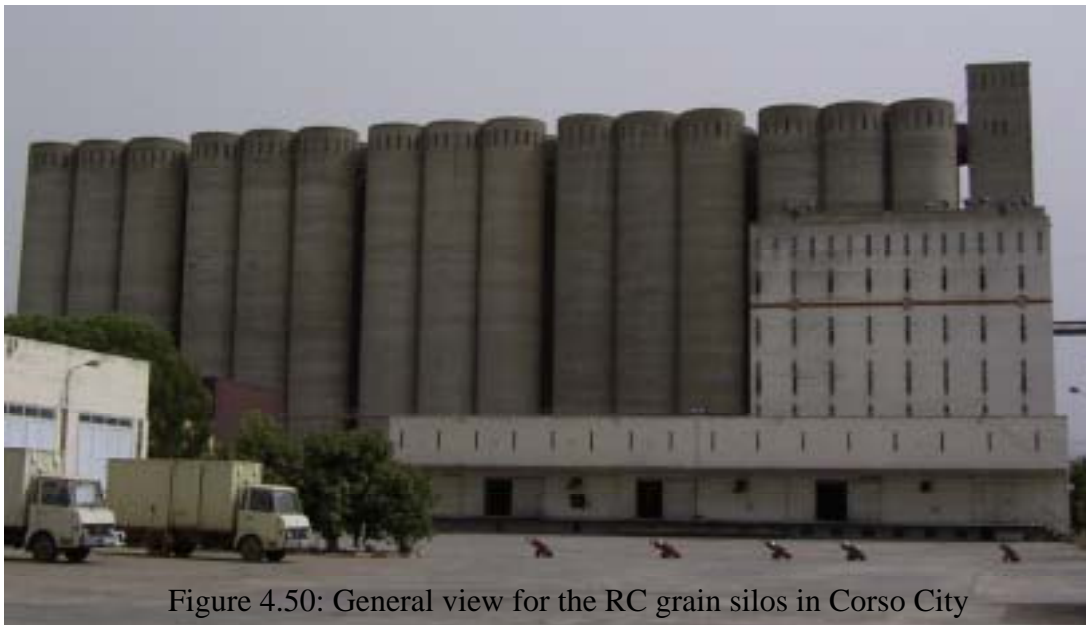
- 45 reinforced concrete Silos for storing wheat, of cylindrical shafts composed of 5 blocks
- Each block has 9 circular cells of diameter of 8.4 m, about 18 cm of thickness and height of 66 m
- Dimension of each block is 25.96 x 29.28 m
- Each block lays on 72 piles of 24 m
- Poor soil is of clay
- The structure is earthquake-resistant
- Constructed using sliding formwork
- The design concrete strength was supposed to vary between 210 and 290 kg/cm². But hardly reached 200 kg/cm²

Figure 4.50: General view for the RC grain silos in Corso City

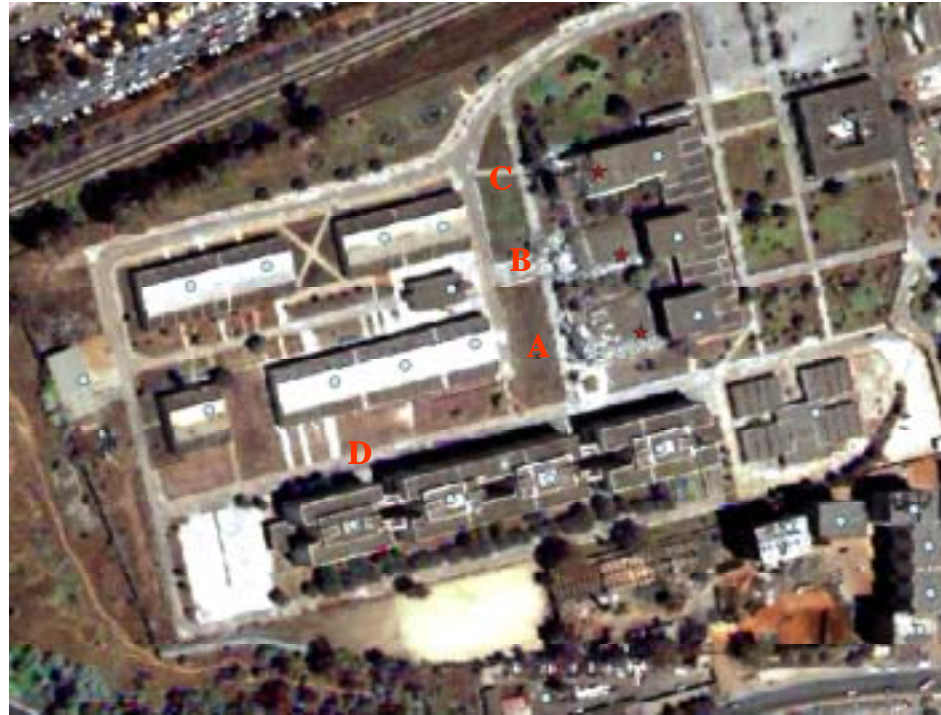
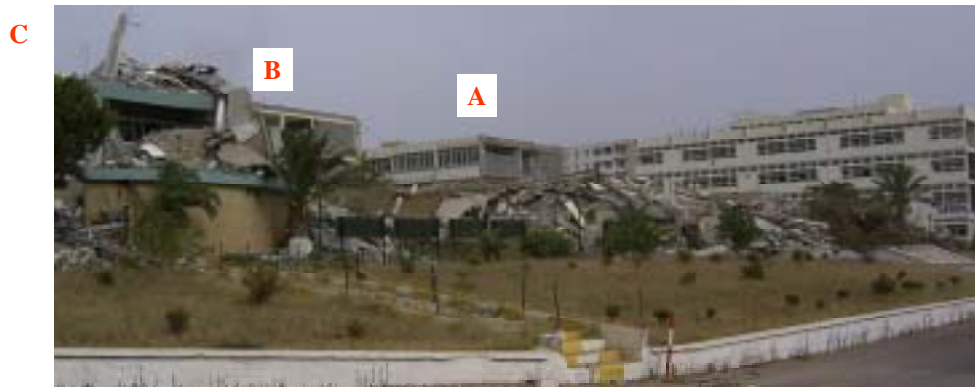
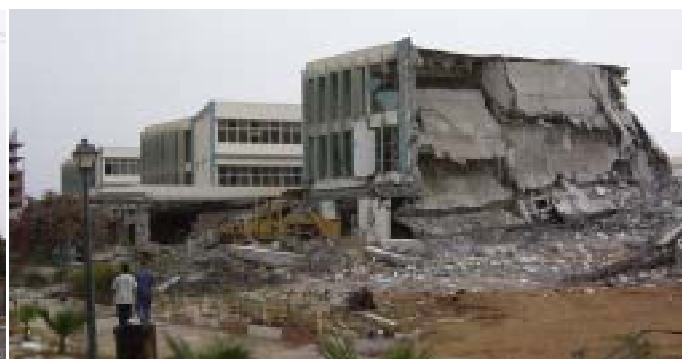
Figure 5.13 shows QuickBird image on May 23, 2003 and photographs taken from the ground for the buildings in the south campus of Boumerdes University. Buildings A, B, and C in the image are judged as Grade 5 and all the other buildings as Grade 1 or 2 based on visual interpretation. The ground photographs verify the accuracy of the judgment for buildings A, B, C since their damages are apparent even from the vertical direction. Although building D was judged as no to moderate damage (Grade 1 or 2), the ground photograph indicates that it suffered from some damage (may be Grade 2 or 3), especially inside the building. The field observation revealed that the debris seen in the photo was gathered between the buildings in the stage of clearing works.

Figure 5.13: QuickBird image on May 23, 2003 and photographs take from the ground for the buildings in the south campus of Boumerdes University. Buildings A, B, and C are judged as Grade 5 and all the other buildings as Grade 1 or 2 based on visual interpretation.

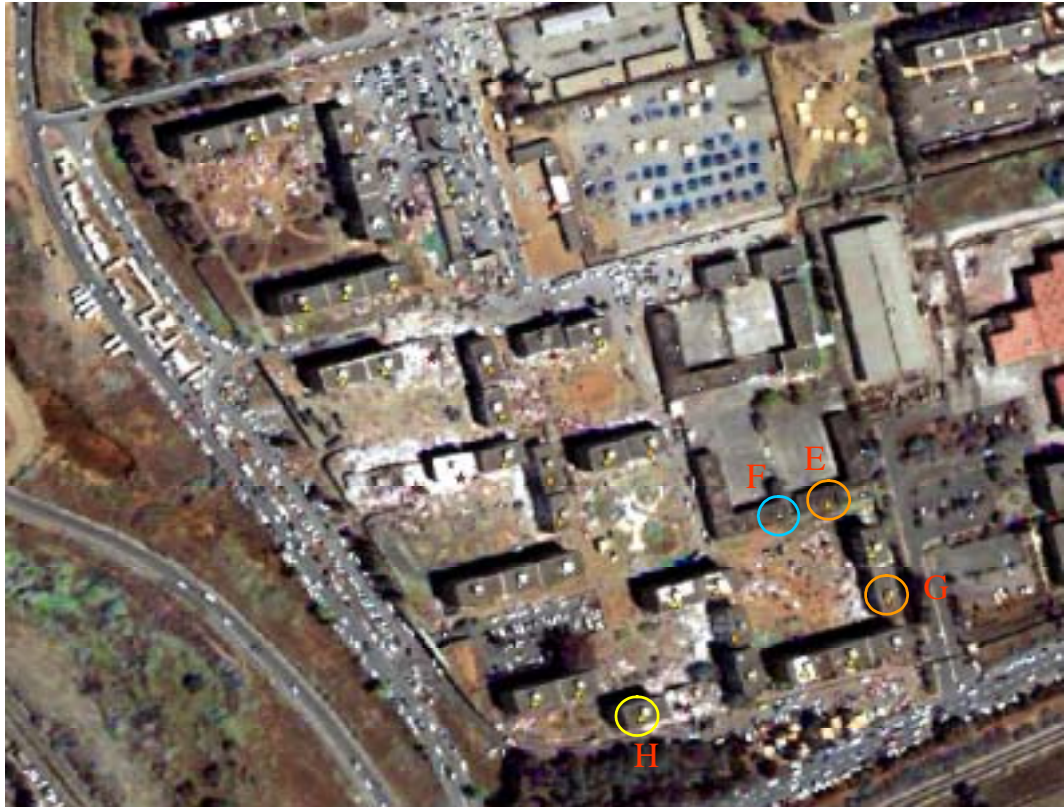
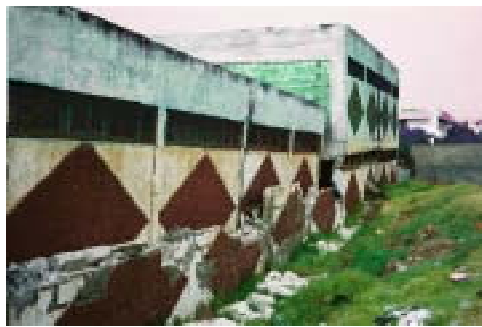
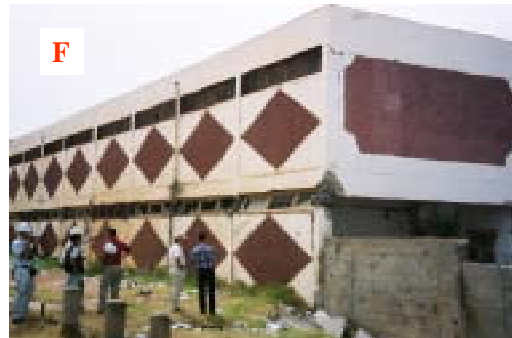
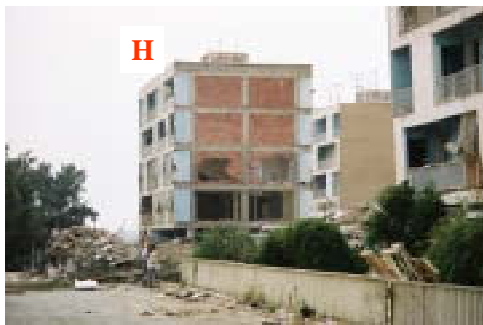
Figure 5.14 shows another example for a high damage area. Building E is judged as Grade 4, building F as Grade 1 or 2, building G as Grade 4, and building H as Grade 3 based on visual interpretation. Compared with the ground photographs, it is observed that story collapses, like buildings E and G, are not so easy to judge with confidence from the vertical image because the settlements are mostly to the vertical direction. A similar observation was obtained in case of vertical aerial photographs as demonstrated before (Ogawa & Yamazaki 2000). The short-column collapse of building F was almost impossible to detect from the vertical image because the settlement is only about 10-20cm and the spread of debris is not so much. Compared with the ground photograph, building H seems to be judged correctly, but its interpretation was not so easy because its debris mostly spread in the shadow and the adjacent building collapsed completely.

Figure 5.14: QuickBird image on May 23, 2003 and photographs take from the ground for a high damage area. Building E is judged as Grade 4, building F as Grade 1 or 2, building G as Grade 4, and building H as Grade 3 based on visual interpretation

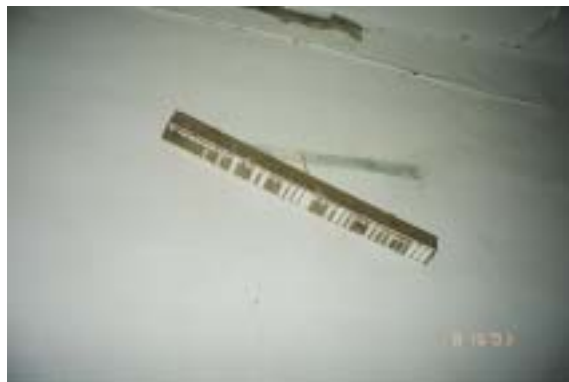
The electricity and telecommunications were cut for more than 12 hours. The staff stated that the commercial electric power was replaced by alternative sources. However telecommunication was cut in many buildings until the day of our visit, almost two months after the occurrence of the event; there were no alternative sources that could be used. Some personnel stated that they were trying to use their own mobile phones. The water supply and gas were cut in some areas, and alternative sources were used. Other staff, stated that some equipment including medical equipment had fallen down, which caused their damage or their un-operability. The radiology service stopped functioning due to the damage to its equipment. Figure 6.2 shows an example of the equipment that fell because of weak attachment to its support; two months after the earthquake and the equipment was not fixed and therefore it was unused.

Figure 6.2: Damage to electric equipment, CHU Hospital

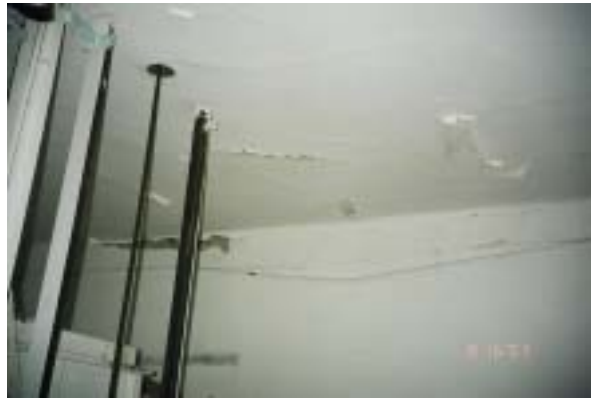
The facility suffered slight structural damage. Some cracks in the walls were noticed during the visit, see Figure 6.3. Some of the interviewed staff stated that they had spotted some structural damage, which had an impact on their tasks by making the areas inaccessible.

Figure 6.3: Cracks in the structure, CHU Hospital

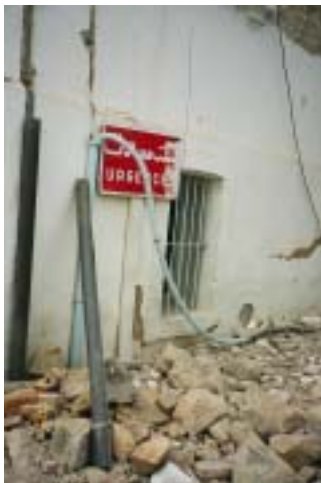
Figure 4: Damage to the emergency wing

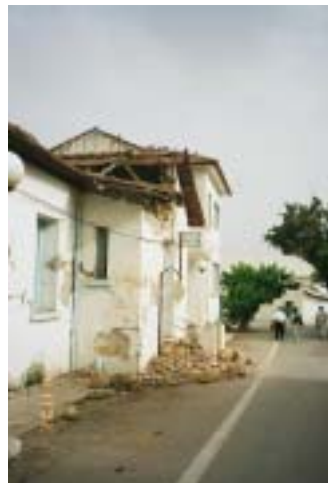
Figure 5: Collapsed roof of another wing

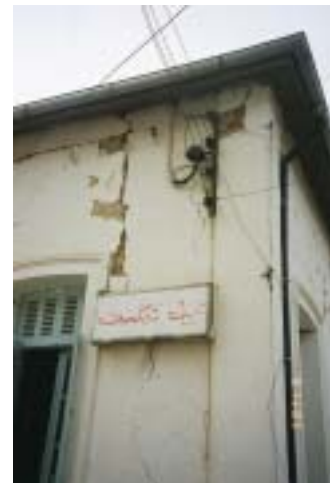
Figure 6: Cracks in the walls of the emergency wing

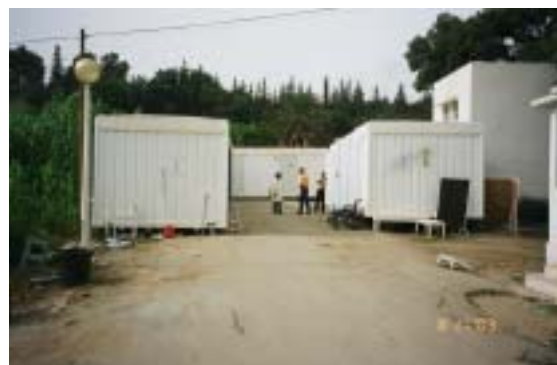
Figure 6.8: Prefabricated buildings used instead of the actual building, Thenia Hospital

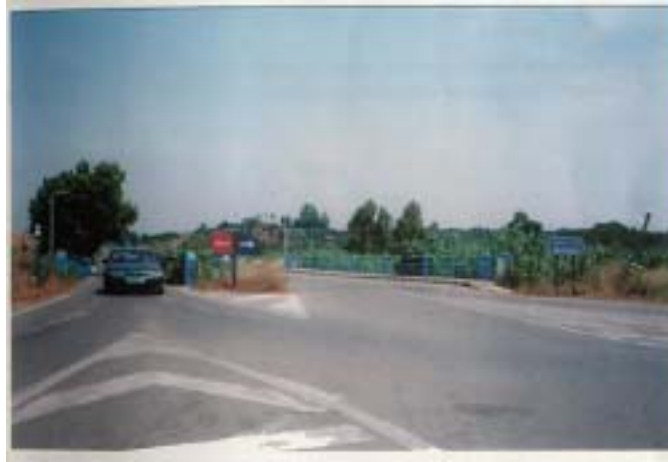
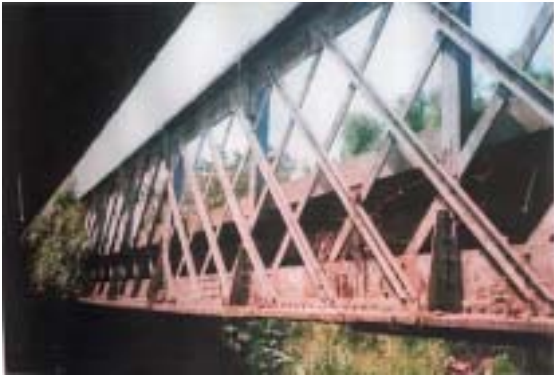
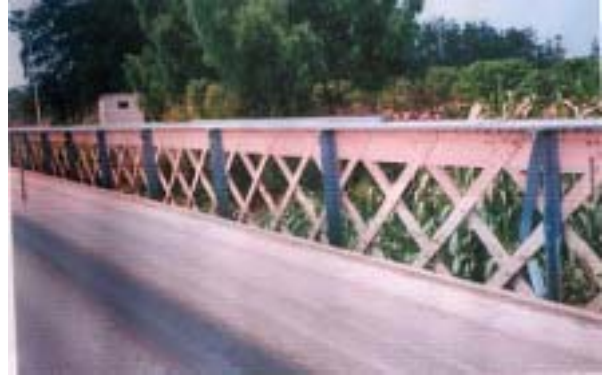
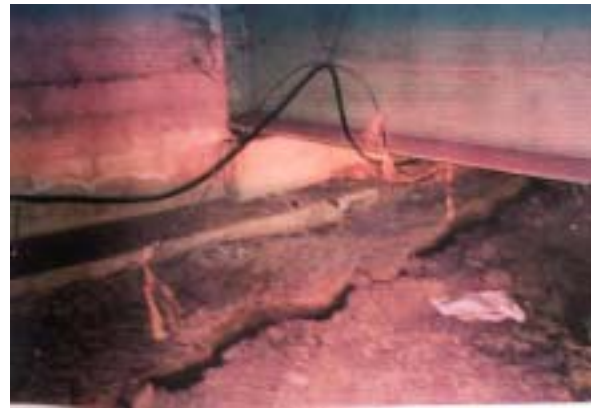
Bridge No 1
“RN24 Bridge of Boudouaou River”

The roadway and the abutments are in good state. No degradation was noticed. There is one transversal crack in the soil near the abutment. The crack is the only effect due to the earthquake.

- a- In both bridges no transversal displacement was noticed. The evidence is that the masonry under the transversal beams is still adequate. However the crack in the soil shows that the seismic motion was predominant in the longitudinal direction.
- b- The truss structure needs maintenance (cleaning, painting...) as well as the uprights of the principal beams. The mixed structure does not need any repair.
- c- The two bridges do not need any particular action.

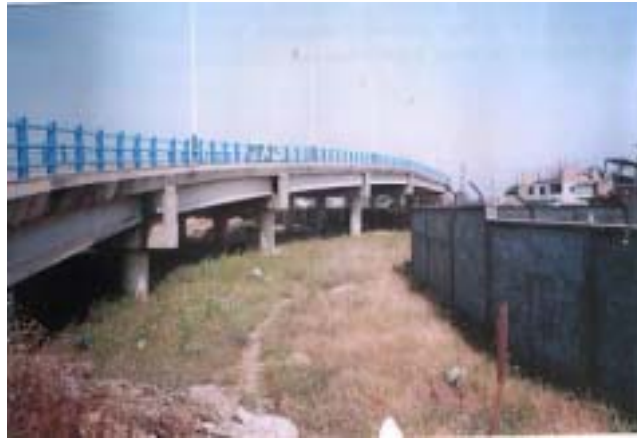
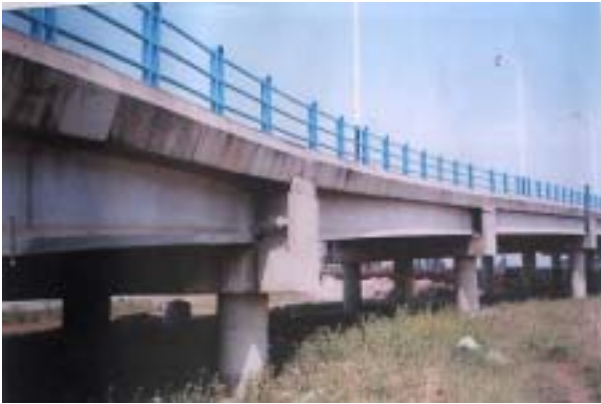
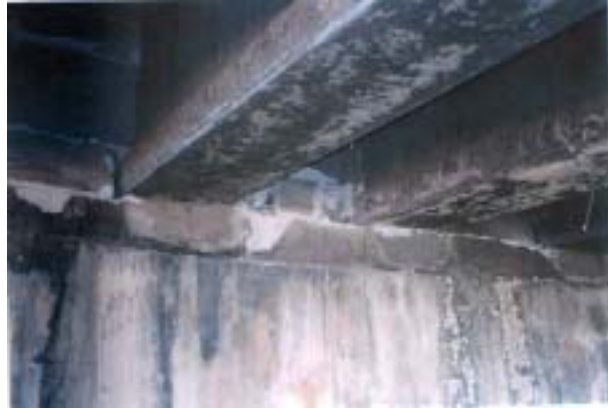
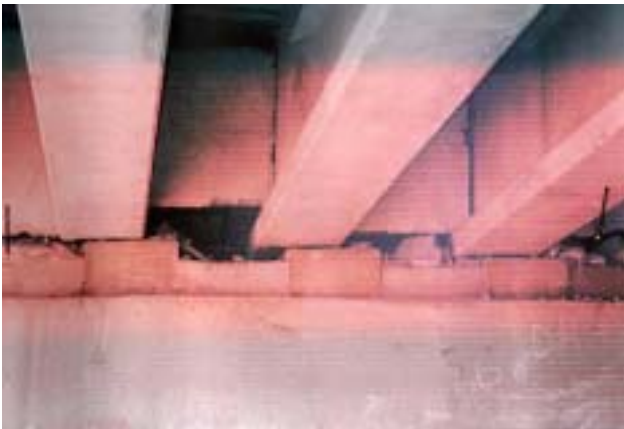
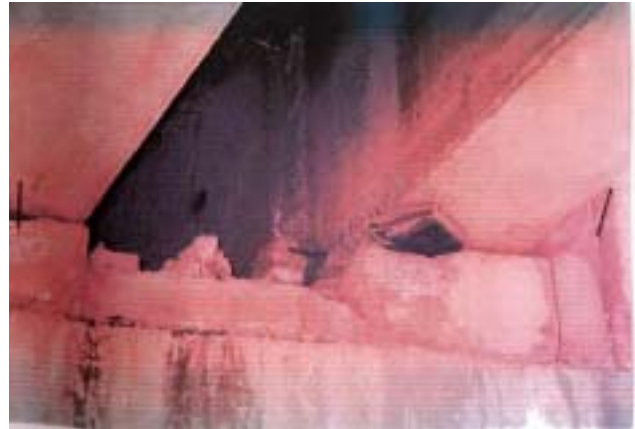
Bridge No 2
“RN24 Bridge of the railways in Corso”

- Shearing of the walls of the transversal beams (supported by the piles),
- Cracks in the joint of the roadway on the abutment side of Algiers.
- Bursting of the supports (RC elements supporting the girders) in the last two spans.
- Some beams fell from their initial supports.
- The 2nd, 3rd and the 4th spans moved in the direction Corso→Algiers.
- The extremity of one beam supported by the 2nd pile burst (direction Algiers→Corso); one of the inferior cables of the pre-stress became uncovered.

- a- The height of the supports is sufficient therefore there was a direct contact between the main girders and the horizontal beams (built on the piles), the problem is clear under the spans that have steep longitudinal slope.
- b- As result of the earthquake some girders moved and destroyed some of the supports. The burst concrete could be clearly seen.
- c- The bridge should be inspected to decide on the reparation that should be carried out:
 - Restoration of the roadway (horizontal movement)
 - Reparation and even retrofitting of the damaged girders
 - Re-design and re-building of the supports
 - Modification of the girders' supports
 - Design and positioning of the anti-seismic elements.
 - Reparation of the roadway joints.
- d- No decision will be taken before the reparation.

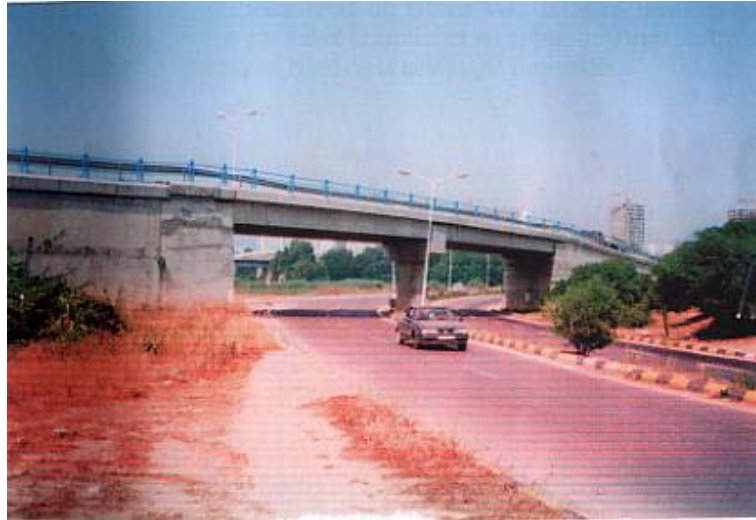
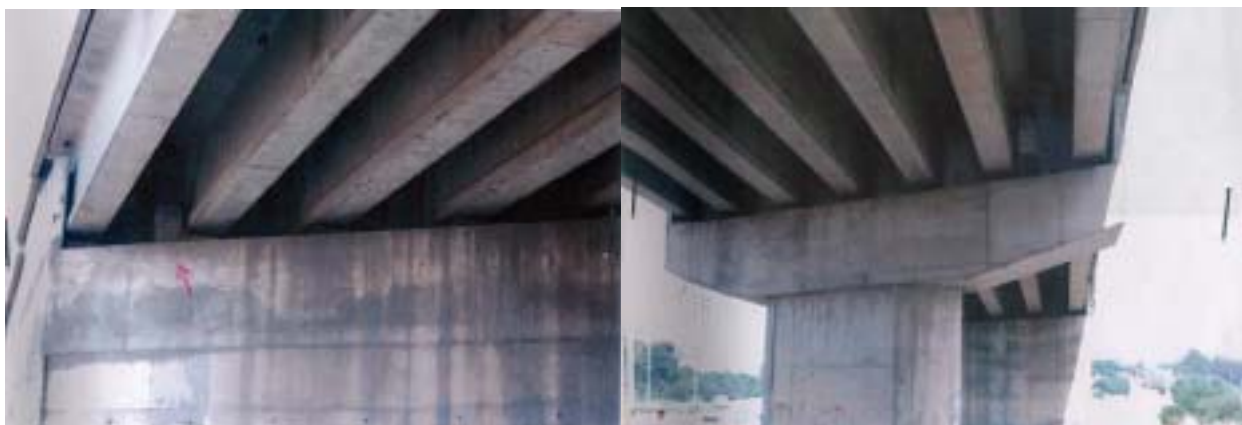
Bridge No 3
“RN24 Bridge over the expressway”

No anterior degradation is observed as a result of the earthquake. The structure experienced a transversal movement of the roadway towards the North; however the anti-seismic elements saved the bridge and the support elements. One of the anti-seismic element fractured: it is located in the north of the abutment in Bouverdes side.

- a- The fractured anti-seismic element has to be re-built: demolition of the concrete with preservation of the reinforcement (steel bars), re-building the new element using a high strength concrete quality (450Kg CPA).
- b- No particular action will be taken for the structure.
