BOUMERDES EARTHQUAKE

May 21, 2003

Japanese Reconnaissance Team

OCTOBER 2004

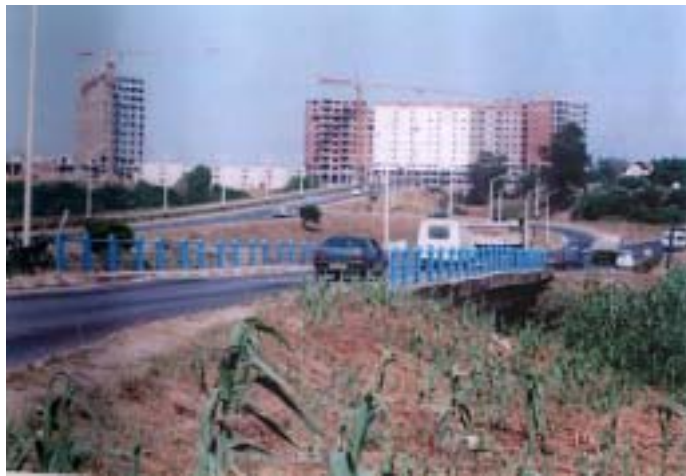
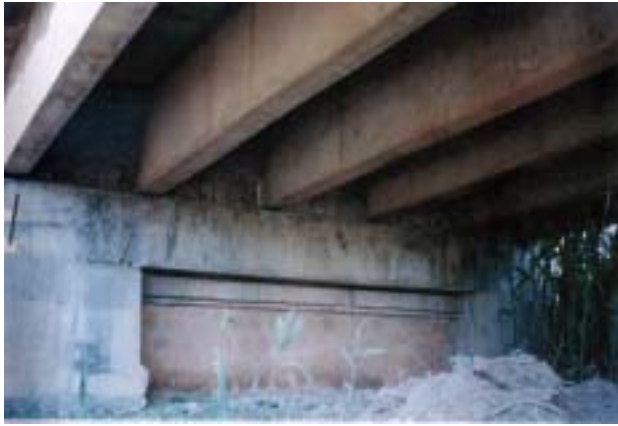
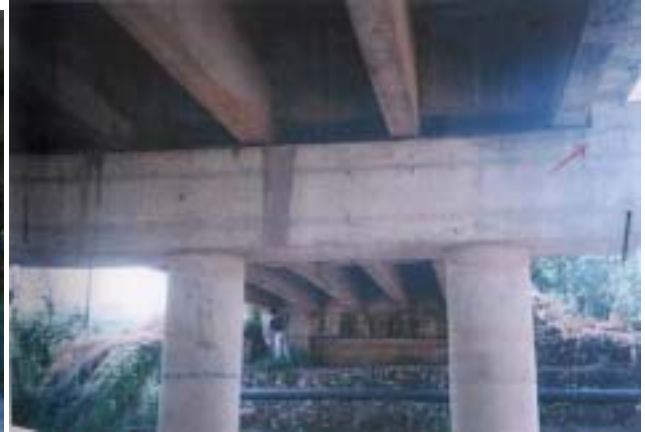
Bridge No 4 “RN24 Bridge over Corso River”

The bridge did not suffer action from the earthquake. The girders moved slightly from the supports, but no damage to the anti-shocks elements was observed. This setback is a result from non-correct placement during the construction of the bridge. The bridge is still intact, the girders still supported correctly by the abutments.

- a- The impenetrability should be re-done.
- b- No particular action will be taken for the structure.

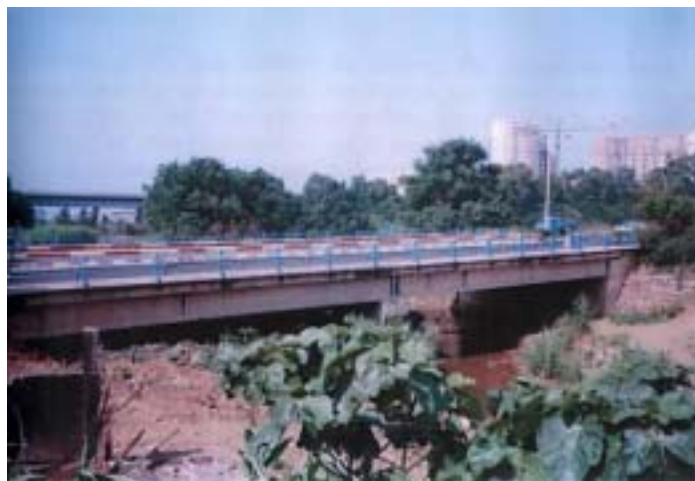
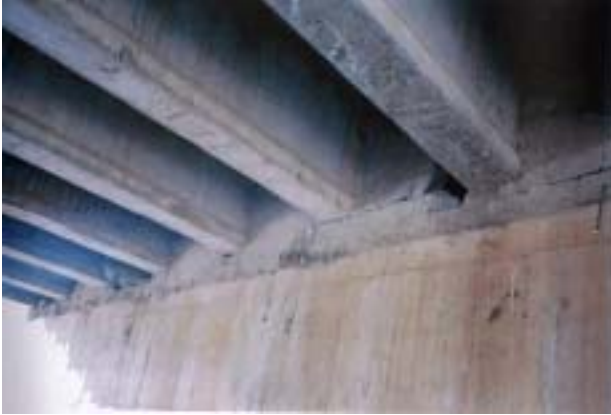
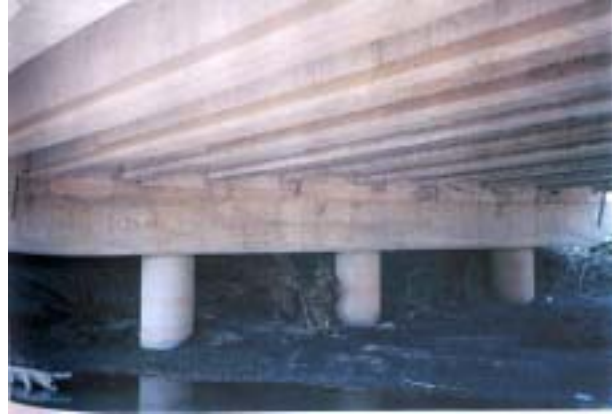
Bridge No 5 **“Expressway over Corso River”**

The earthquake did not affect the bridge. Some bursts were noticed in some concrete blocks near the abutments; however the roadway did not displaced. The anti-seismic elements did not let the roadway move. No other degradation was noticed in the bridge.

- a- It is recommended to obliterate the concrete blocks to be able to check thoroughly the anti-seismic elements.
- b- No particular action will be taken for the structure.

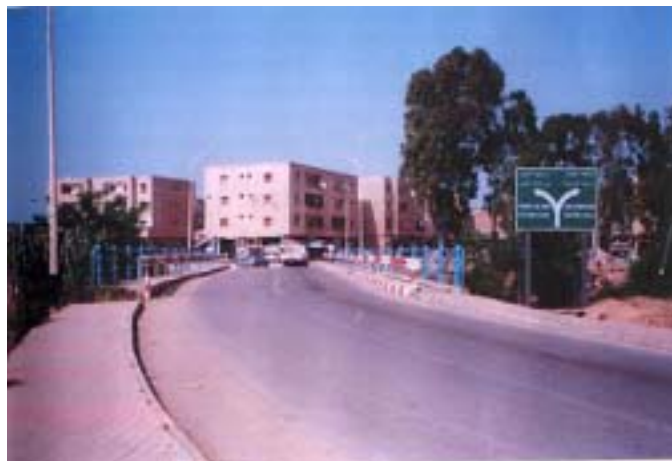
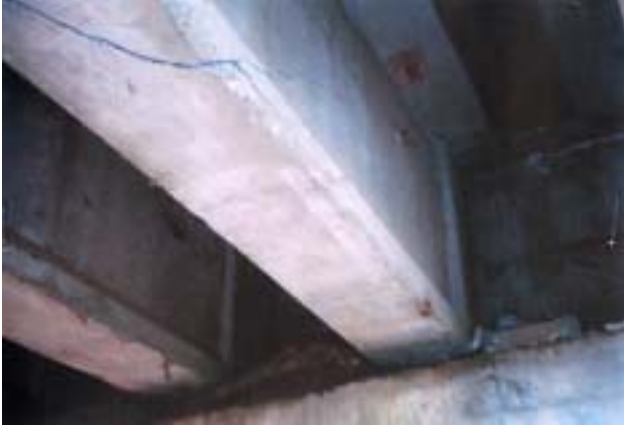
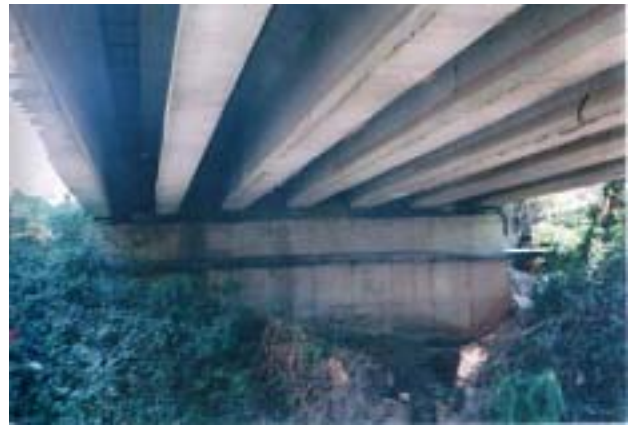
Connection RN24-Express way “Bridge of the railway”

Inclined cracks in some girders were observed. As result of the earthquake the roadway went down and made contact with the West element causing a great damage to the East element. The cracks in the beam can be explained by the result of the vertical reaction. This damage is probable since the height of the anti-seismic should be at least twice the supports.

- a- The structure must be inspected and visited to make decision on the kind of reparation that must be carried out.
- b- No decision will be taken for the bridge.

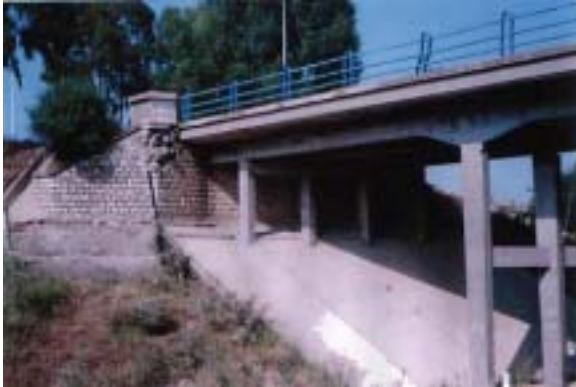
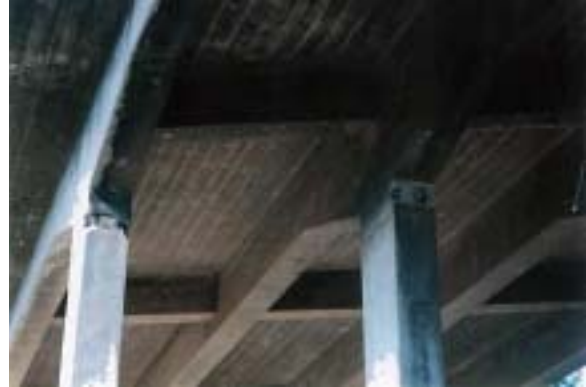
The concrete of the slab was burst near the intermediate support side of Boumerdes, as well as the last two piers. Also The junction beam-column of the abutment, side Boumerdes, was burst. Un-stabilization and damage of the masonries that support the embankment was observed. These were the damages resulted from the earthquake.

- a- Bursting of the concrete on the top of the columns shows that the elements were subjected to compression and bending + compression action.
- b- The bridge must be assessed.
- c- No decision will be taken before the conclusion of the assessment.

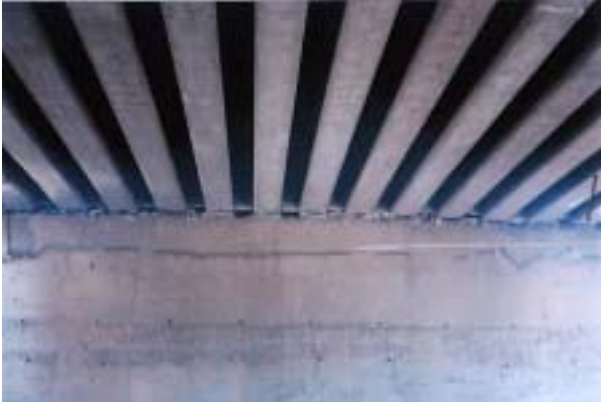
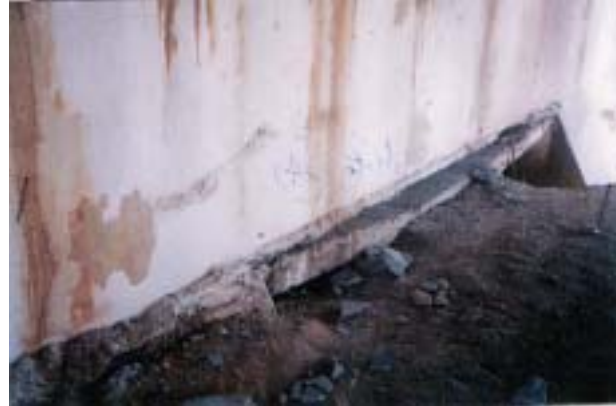
The earthquake caused damage to the non-reinforced concrete that used as a fill around the supports (for protection of the bridge). The anti-seismic elements resisted well the earthquake.

- a- All the concrete that was used for filling around the supports must be removed. The ones of the pile should be done as soon as possible to not damage the cars using lane 3.
- b- The embankment should be protected by using weak concrete; if not possible there is a risk that the embankment will sink and it can cause the destruction of the roadway.
- c- No decision will be taken until testing the concrete (that was used for filling) of the pile.

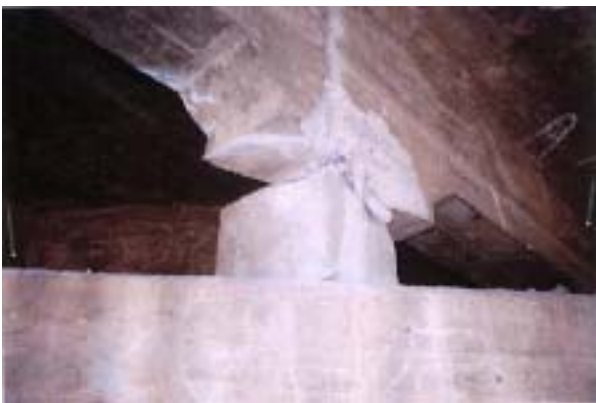
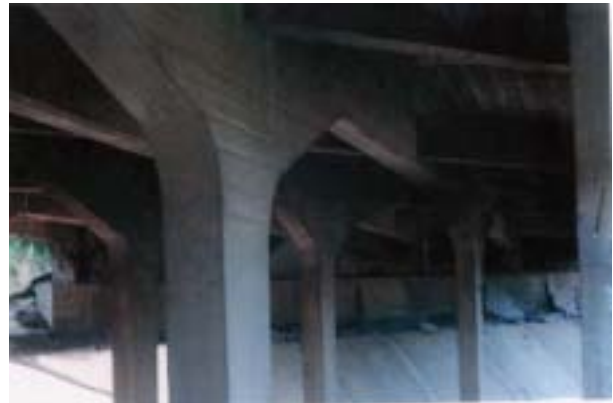
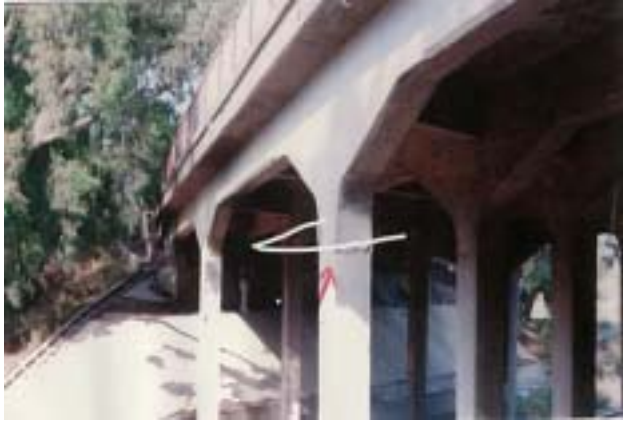
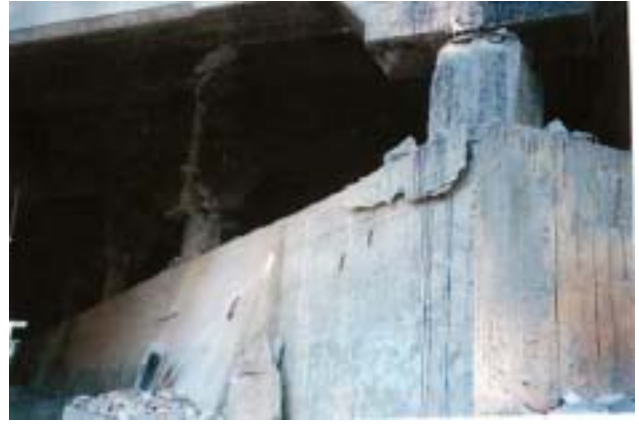
Degradation of the head of the lateral column side Boumerdes, and in pile side Algiers.

The coating of the roadway near the joints was raised and pulled out.

- a- The bridge should be assessed in order to fix the mode of repair of the support on abutment and the head of the column.
- b- Steel holds should be placed beside the destroyed RC supports. The retrofitting of the roadway (near the joints) must be repaired using special material “enrobé a chaud”.

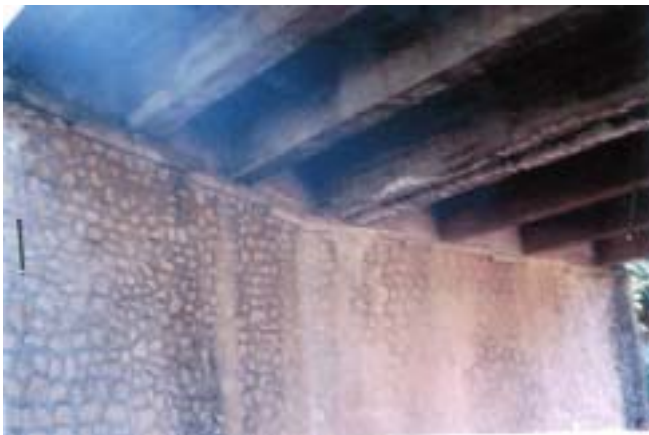
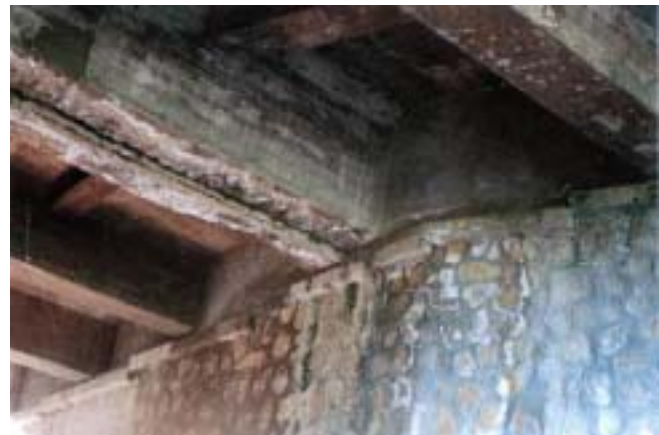
The structure did not suffer any damage as result of the earthquake. Unsound construction methods caused the degradation at start for the two beams.

- a- The joint will be repaired in the next retrofitting operation.
- b- No specific measures will be taken.

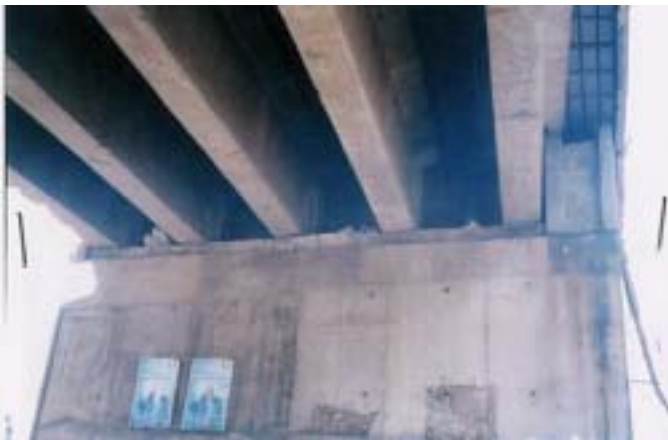
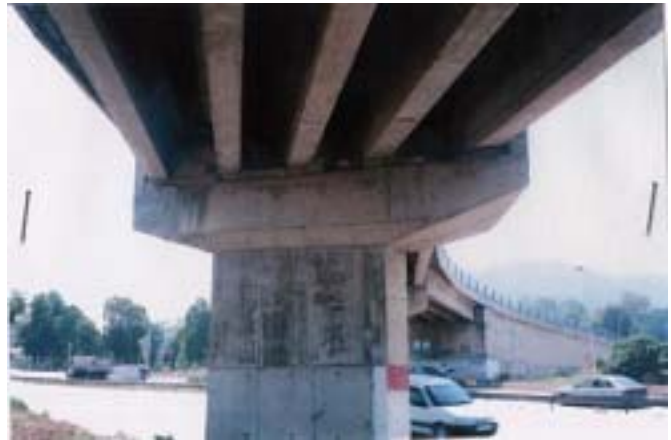
The earthquake caused the dislocation of the supports used as protection, but slightly moved the roadway.

The geometry of the bridge helped the bridge to resist against the transversal effort coming from the roadway.

- a- The structure resisted well and does not show any degradation.
- b- Only rubbles (placed on the horizontal beam, upside the piles) need to be removed as soon as possible.

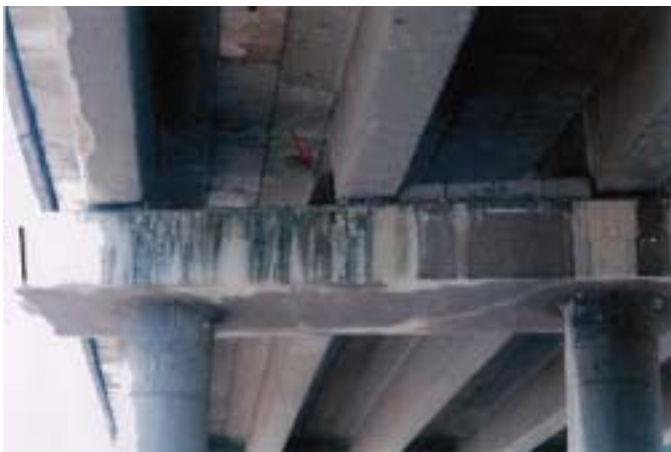
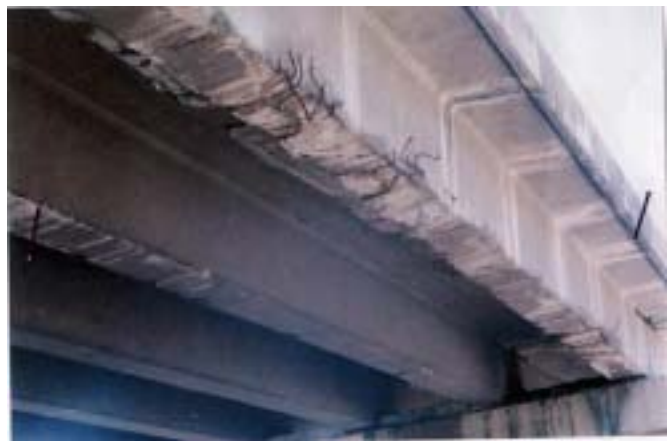
The structure did not suffer any damage as result of the earthquake. However deterioration of the structure was observed after the earthquake: problem of watertight of the roadway. Some bursts in the two extreme beams side of the span of Algiers-Bouira direction were seen.

- a- An expert opinion is necessary to determine the way of retrofitting of the damaged beams, and define the necessary work for repairing the structure.

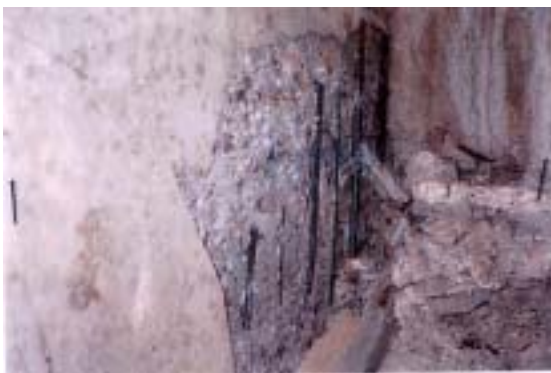
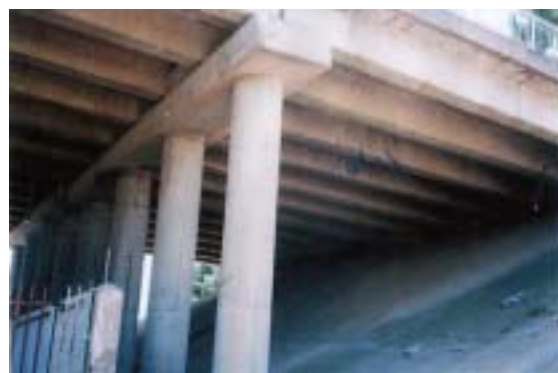
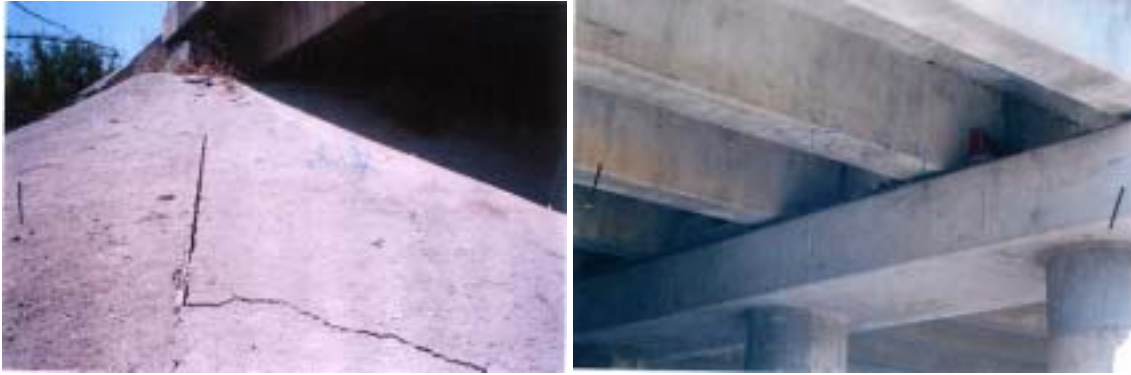
The structure resisted well the earthquake. Only the concrete protecting the embankment cracked (abutment side Algiers). The concrete of the end of the beam burst and caused the steel to be bareness.

- a- The degradation affected the concrete protecting the embankment without any consequences.
- b- The foot of the fragmented beam must be repaired.
- c- No special measurement will be taken except the cleaning the rubble residues over the piles.

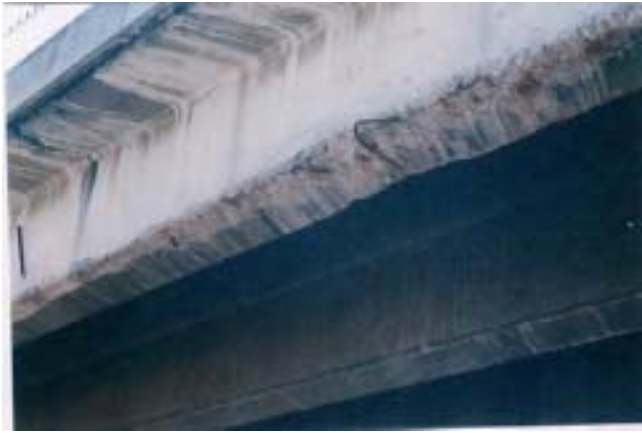
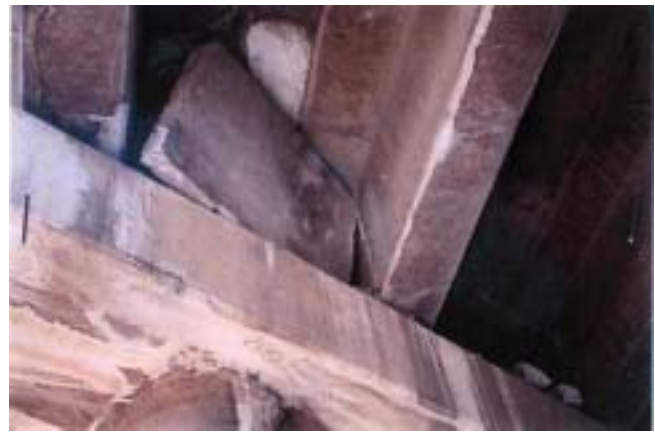
The structure did not suffer damage related to the earthquake. However there was a problem related to the watertight that can be seen in feet of some beams. A beam in the last span (direction Bouira-Algiers) was much damaged.

- a- The structure resisted well the earthquake.
- b- An expert opinion must determine the type of the retrofitting of the damaged beam and the required maintenance.
- c- No special measurement will be taken, excepting the rubble that fills the spaces between the beams.

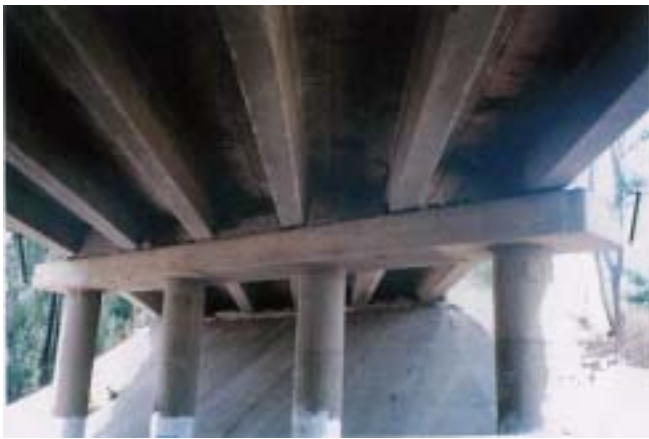
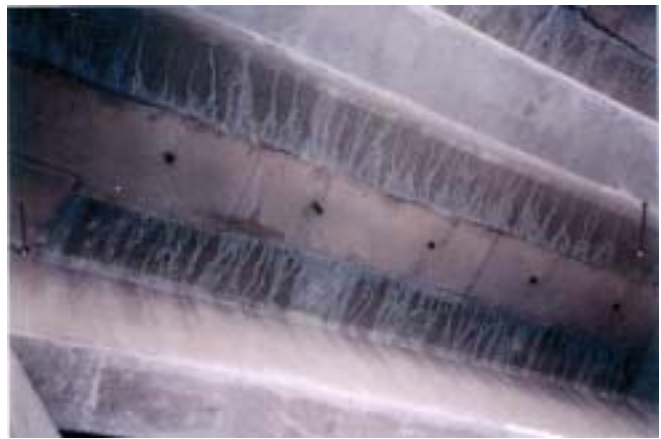
The structure resisted well the earthquake. However it suffered a nuisance of watertight in the slab of the roadway.

- a- The slab for the watertight must be reconstructed.
- b- No special measures will be taken except cleaning the rubbles (problem of safety for the users).

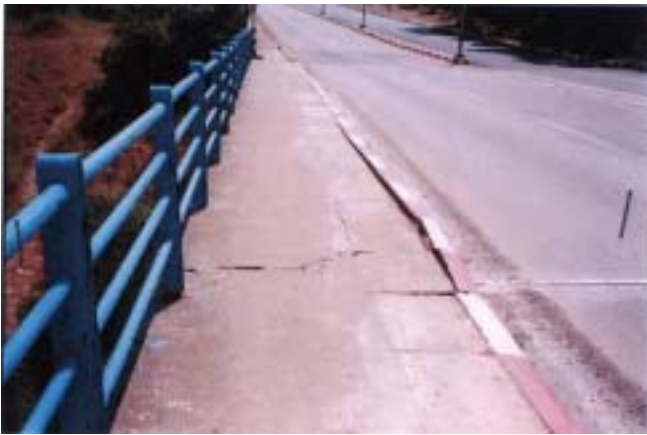
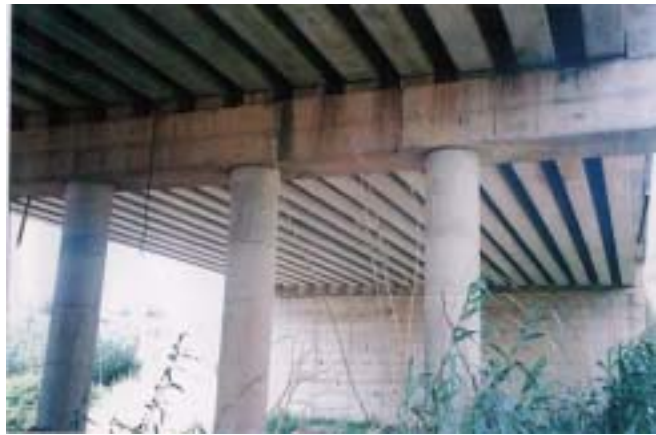
The slab (roadway) did not move in the transversal direction. One crack was seen on the sidewalk over the pile (direction Boumerdes-Dellys). The crack is due to the continuity of sidewalk (the roadway is divided by a joint).

- a- The sidewalk needs to be repaired.
- b- No measure will be taken for the structure.

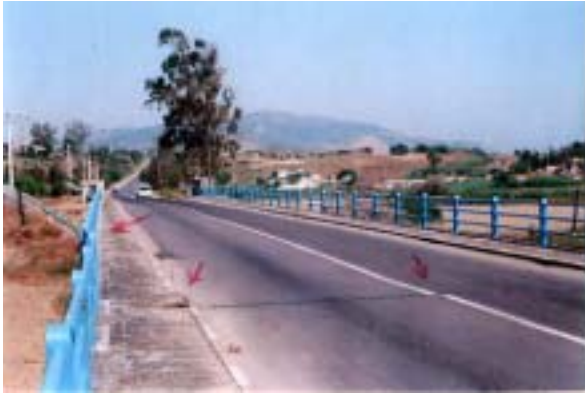
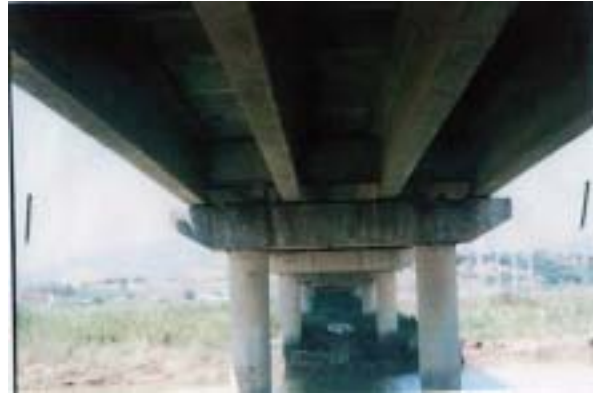
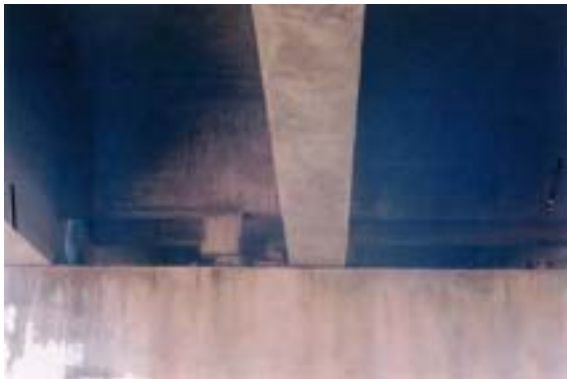
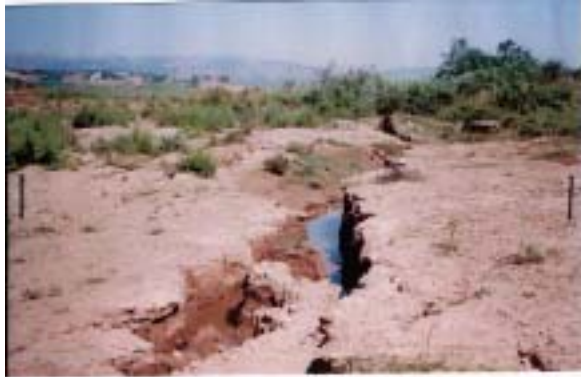
The bridge suffered transversal displacement towards the downstream water (toward the sea) after the destruction of the anti-seismic components. The beams moved from their initial supports and became resting on the horizontal beam in the piles P3, P4, P5, P6 and P7 (direction Dellys→Boumerdes).

- a- The structure must be inspected to define the method of repairing the roadway and the supports and the anti-seismic elements.
- b- Nothing will be done before the conclusion of the assessment.

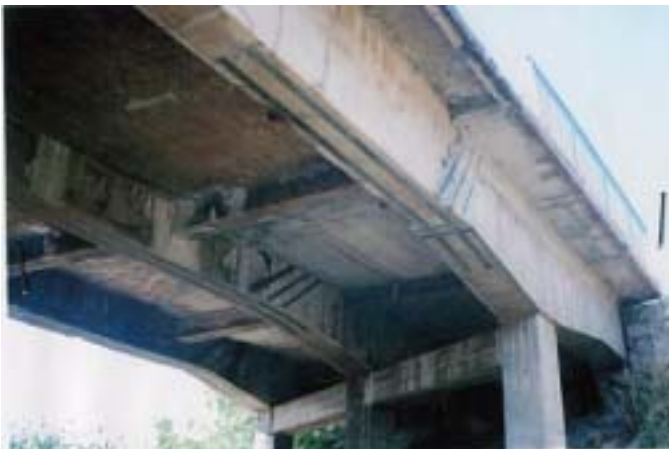
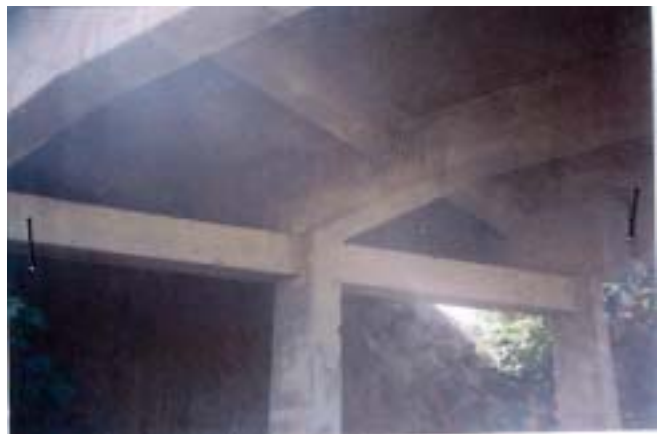
No degradation was been noticed. The reinforcement using the carbon fibre has well resisted.

- a- The handrail of the road must be repaired.
- b- The structure resisted well the earthquake.

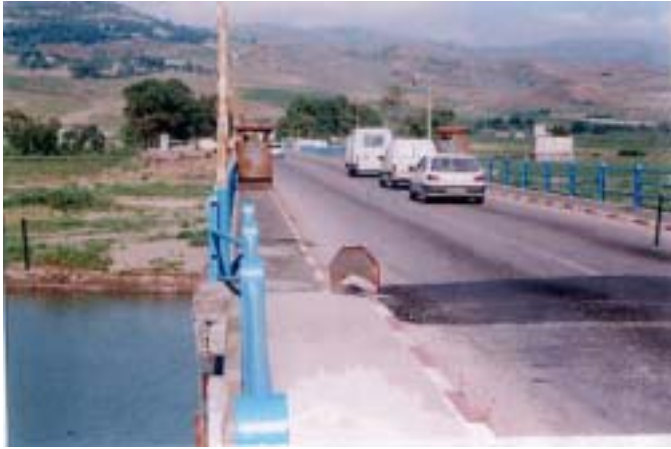
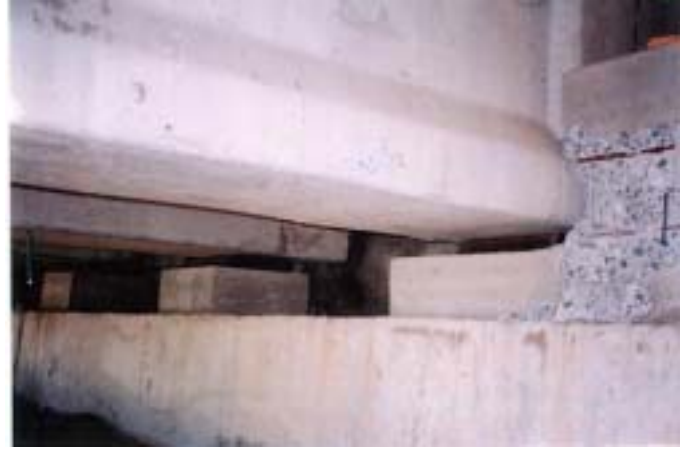
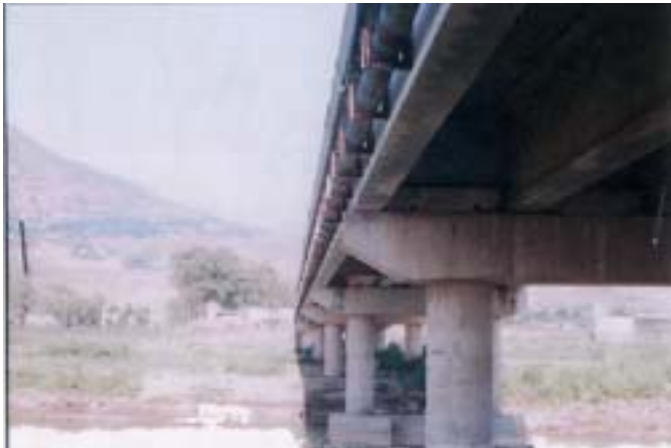
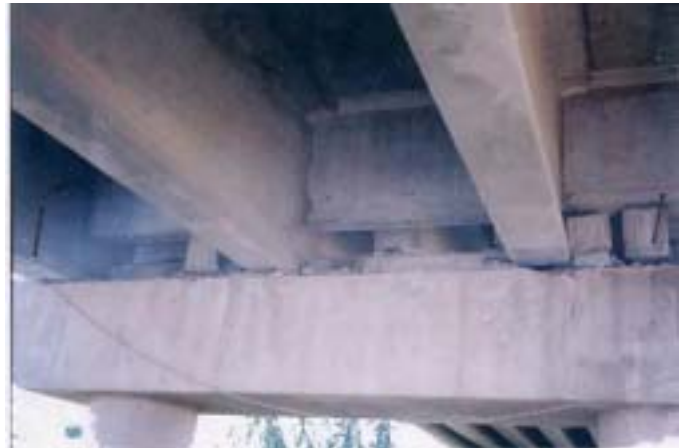
Most of the girders moved toward the downstream water, except the first girders in Boumerdes side did not move. The girders left their supports and rested on the horizontal beam. The last span in Dellys side, which did not show any movement, suffered a light damage. The anti-seismic components in the median spans were completely crushed.

- a- The bridge needs to be inspected in order to decide on the method of reparation.
- b- Nothing will be done before the conclusion of the assessment.
