# **INDONESIA-JAPAN JOINT SEMINAR ON MAPPING-OUT STRATEGIES FOR BETTER SEISMIC DISASTER MITIGATION**

**February 2007**

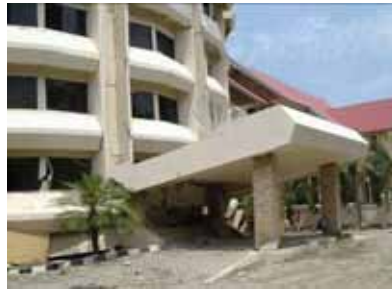
(b) Kuala Tripa Hotel

The earthquake caused significant damages to structures, especially multi-story structures (structures with relatively long natural period). Examples are shown in Figure 4. Five-story Balai Gading Hall was significantly damaged, although nearby one-story wooden house was intact. Five-story Kuala Tripa Hotel was pancaking at the first story. Governor-office Annex which was under construction went down with soft-story mechanism of failure (see Figure 4).

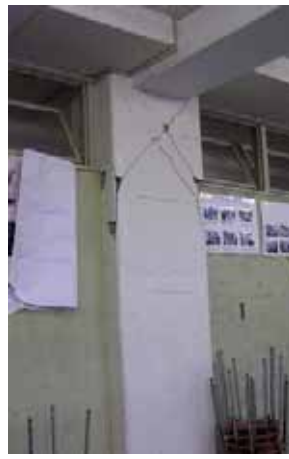
2004 Chuetsu EQ (Japan)

Photo 3 Contribution of nonstructural elements to column shortening and damage

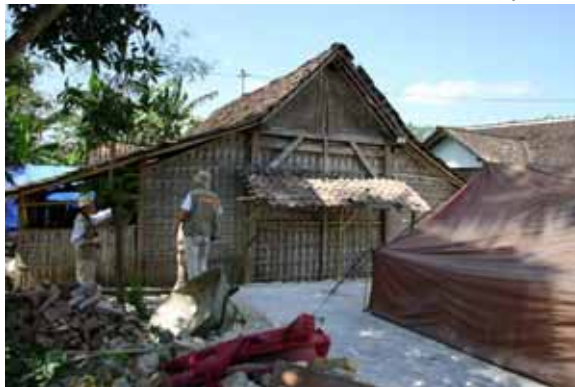
Photo 8 Bamboo-net wall house

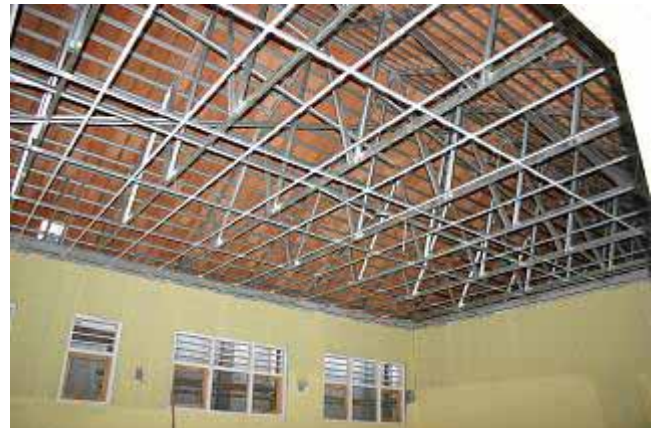
Roofing framework and beams along the top ends of walls are seen.

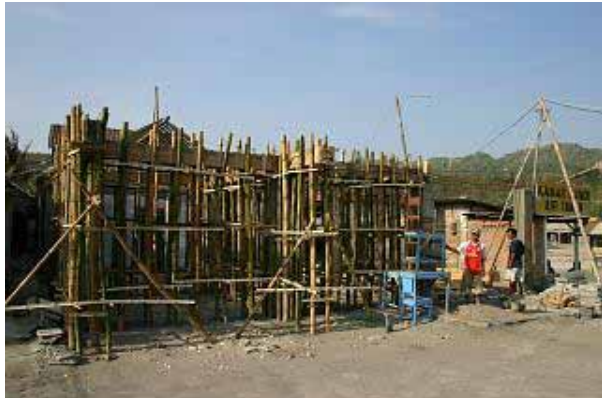
House at Parangtritis Beach. RC frame is observed.

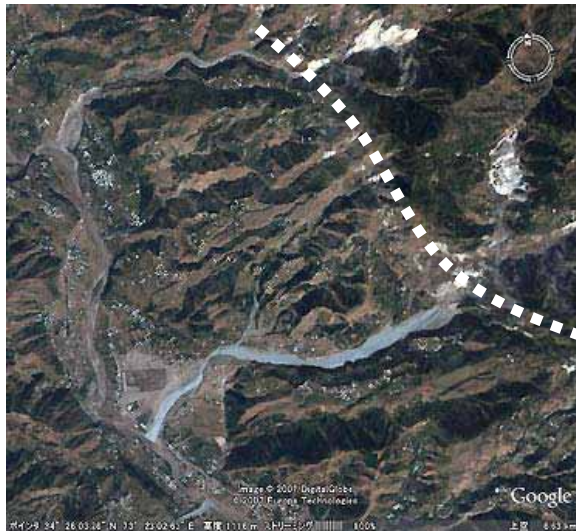
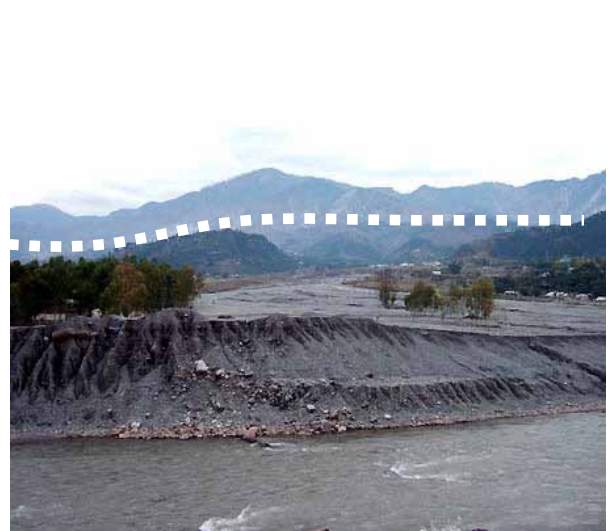
Fig. 1 Debris deposit from activated fault in Kashmir (Ghari Habibullah village): White broken lines show the activated fault in the Oct. 8, 2005, Kashmir Earthquake, Pakistan.
