A RECONNAISSANCE REPORT
ON
THE PISCO, PERU EARTHQUAKE OF AUGUST 15, 2007

2007 Pisco, Peru Earthquake Reconnaissance Team

Japan Society of Civil Engineers (JSCE),

October 2007

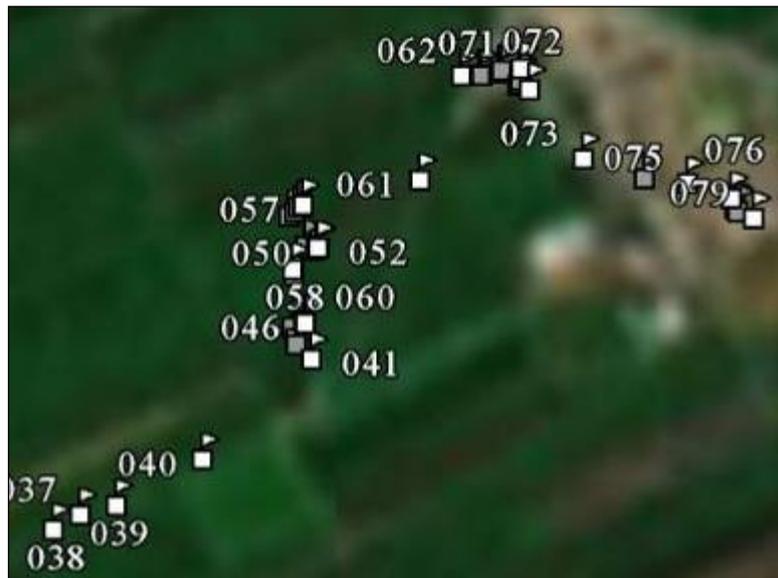
There are 3 clusters of cracks in Fig. 3.3. The first cluster of points 37 to 40 indicated smaller lateral spreading failures along the dirt road (road 746) leading from the Pan-American Highway to Nuevo Monte Rico. There was drainage ditch on the north side of the road towards which lateral spreading occurred over a length of over 200 meters. On the south side of the dirt road there was a sewage pipe, leading from Nuevo Monterrico towards the ocean, which broke, likely due to the lateral spreading, and related soil displacement induced a lot of cracks in the cotton field next to the road (see Fig. 3.4). These cracks cause a lot of trouble for the farmers to irrigate their fields, since the water went into ground through the cracks, instead of being distributed through small irrigation canals to the whole field.

Fig. 3.3. Google earth view of San Luis Annex Nuevo Monterrico with GPS points.

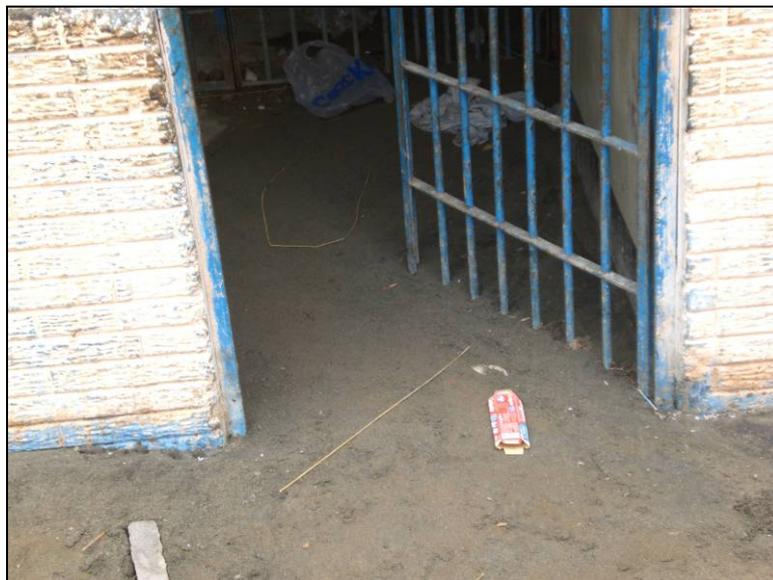
It is worthy to mention that Chinchá Prison, located in the North of Tambo de Mora, suffered extensive damage due to liquefaction. The surrounding wall collapsed (see Fig. 3.30) and the prison cells exhibited large settlements (see prFig. 3.31). Due to the risk of additional damages, the local government decided to set free the prisoners. This fact suggests that location of this public building deserve further review as long as the social consequences of its failure were also considerable.

prFig. 3.31. Sand inside prison cell. (Courtesy of Julio Kuroiwa)

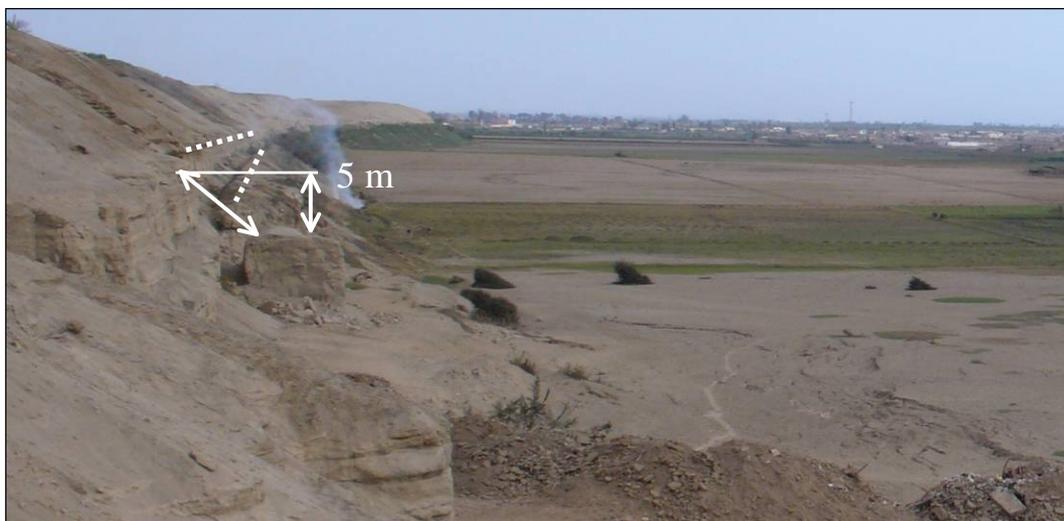
In the northern part (close to Microtremor point 1) a lot of over 20 meter long cracks with grayish sand ejecta were observed. Cracks and up to 3 meter differential settlements (see Fig. 3.33) were seen closer to the Canete formation. Here light brown/beige seemingly liquefied soil covered parts of some of the vertical scarps. The liquefied area extends from the central park (Plaza de Armas) of Tambo de Mora all the way to Pan-American highway in the north, which is a distance of more than 7 km. A large block seemingly had moved downwards from the Canete formation and this movement downward continued as marked by the dashed lines as seen in Fig. 3.34. However, there was vegetation between the block and the slope, so this movement did not happen in the 2007 earthquake.

Fig. 3.34. Block moved seemingly moved down and towards ocean some 5 meters, however there was vegetation between the block and the slope, so this did not happen in the 2007 earthquake.

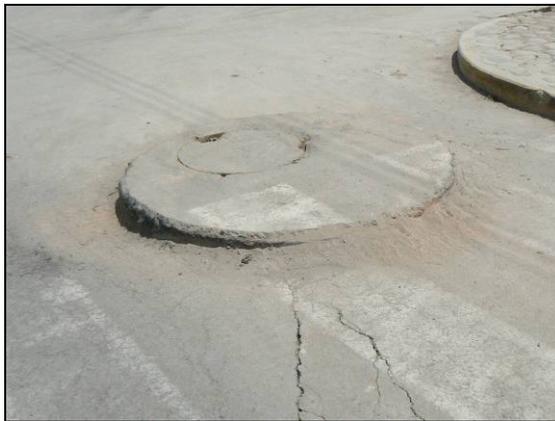
The sewer system in Pisco, whose conditions were already poor before the earthquake, was drastically affected due to ground deformation and liquefaction. As shown in Fig. 3.39 and Fig. 3.40, central and southwest areas of Pisco had broken sewer pipes due to ground settlements and dislocated manholes were wide spread. Fig. 3.41 (Rodriguez et al [16]) also shows a lateral spreading movement along the coastline in the south of Pisco.

Fig. 3.40. Manhole pushed up and surrounded by ejected fine sand. Northwest of Pisco (S13 42.343 W76 13.029)

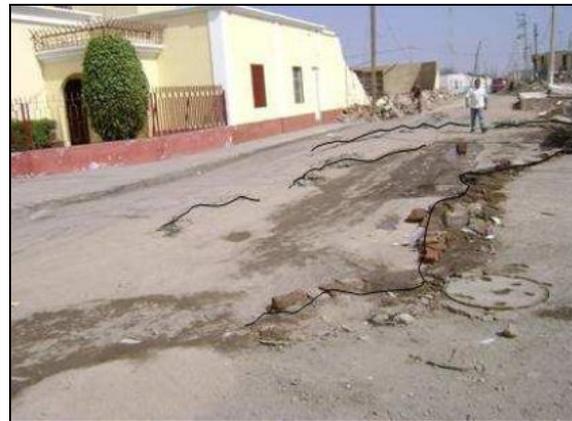
Fig. 3.41. Sub parallel cracks with lateral spread along the streets in the southwest of Pisco (Rodriguez et al [16])

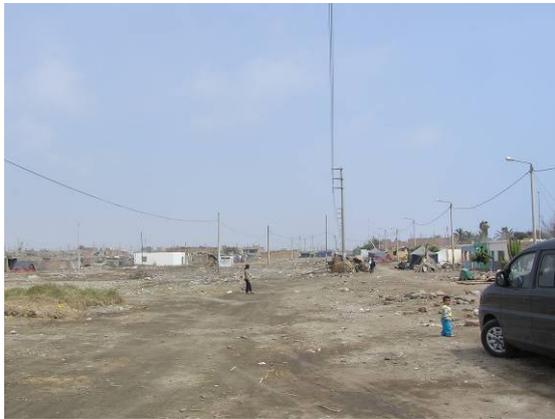
Fig. 3.47. (Point 2_UT) The number of standing buildings is small, high level of damage.

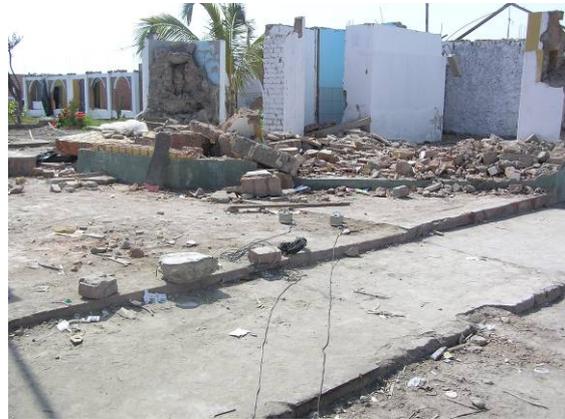
Fig. 3.48. (Point 5_UT) At San Martin Av. where many nearby adobe houses were about to collapse

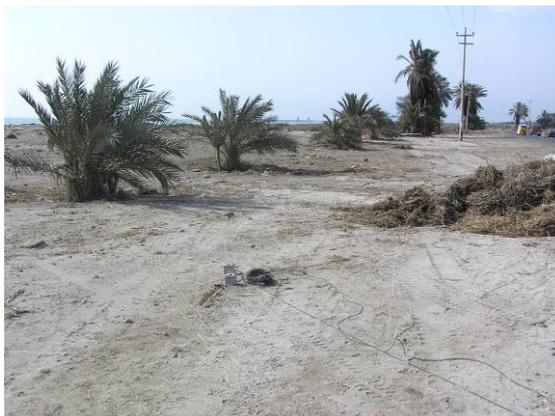
Fig. 3.49. (Point 7_UT) In front of the beach "Camino San Andres". Non-inhabited area.

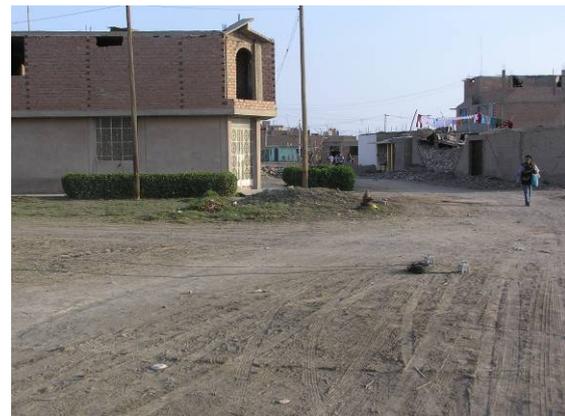
Fig. 3.50. (Point 13_UT) Less affected area with one and two story houses almost undamaged

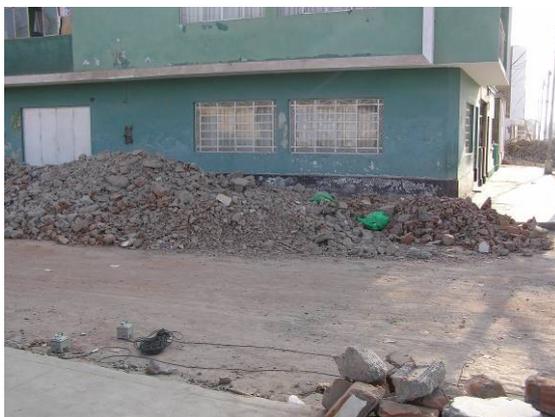
Fig. 3.51. (Point 11_UT) At the intersection with San Martin Av, close to

Alexander Humbolt School. Few collapsed in surrounding structures. houses, debris deposited on the left side of the road.

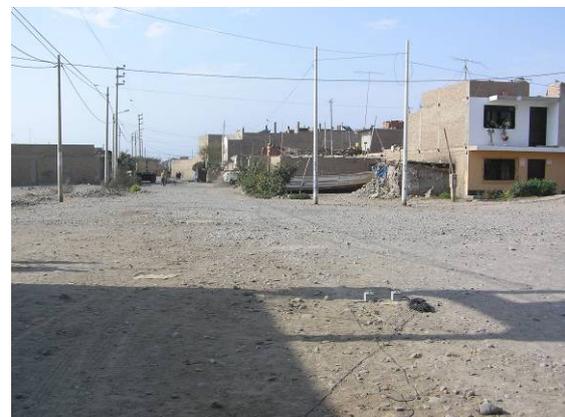
Fig. 3.52. (Point 8_UT) In front of Communal gathering place. Few damages

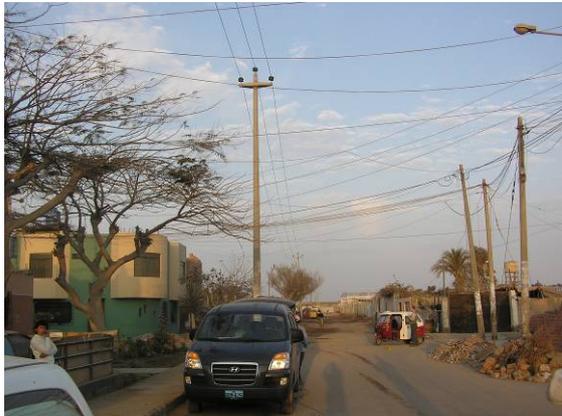
Fig. 3.53. (Point 15_UT) Two blocks from the main square. Contrasting large amounts of debris from nearby collapsed buildings on the right side while almost undamaged houses on the left.

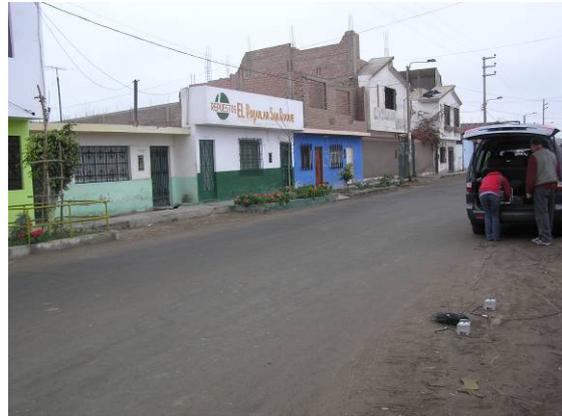
Fig. 3.54. (Point 17_UT). Less evident damage. However, one block northwards there was a totally collapsed adobe house, and a masonry house less severely damaged but it underwent large settlements due to soil deformation.

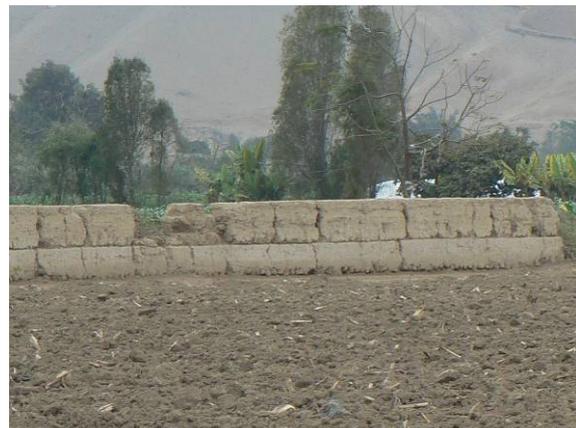
Fig. 4.2 Rammed earth or *tapial*. Note the vertical and horizontal cold joints showing different construction stages

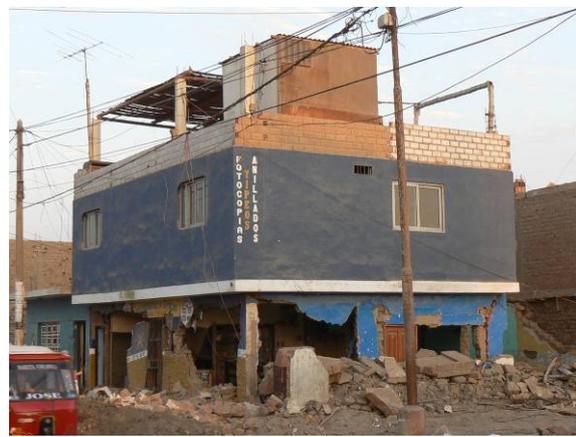
Fig. 4.8 House with 1st story made of adobe and 2nd story made of confined masonry. In this case, RC columns were cast in the existing adobe walls to support the 2nd story.

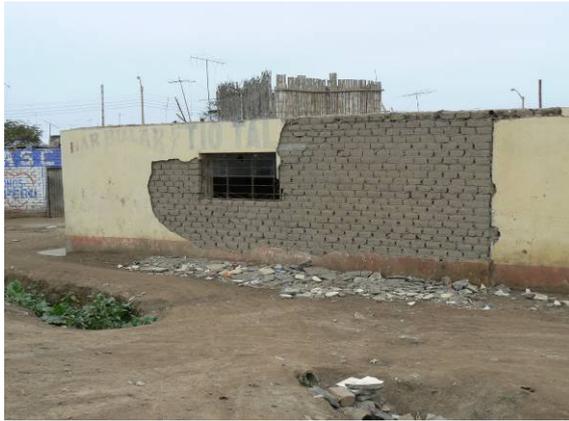
Fig. 4.17 Adobe house with plaster spalling (San Luis, Canete)

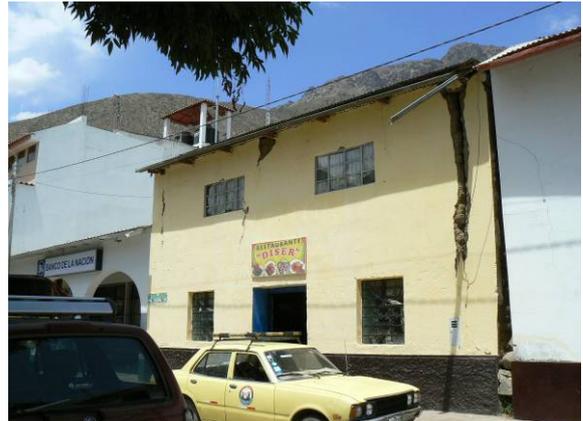
Fig. 4.18 Adobe house with cracks at wall intersections (Huaytara, Huancavelica)

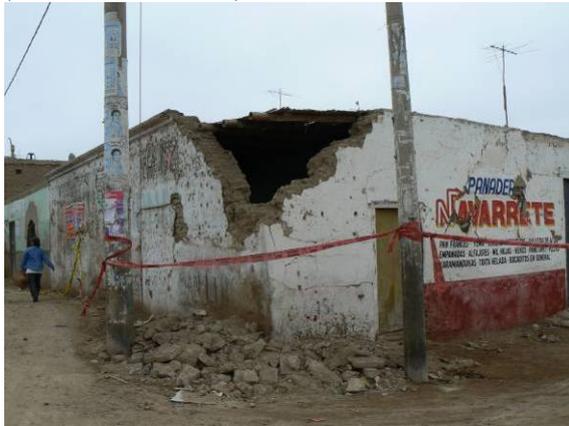
Fig. 4.19 Corner collapse in adobe house (San Luis, Canete)

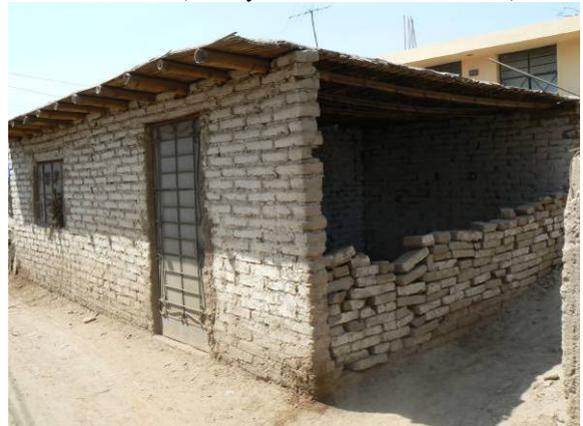
Fig. 4.20 Wall partial collapse. Walls supporting the roof are standing. This was observed at several locations (Ica).

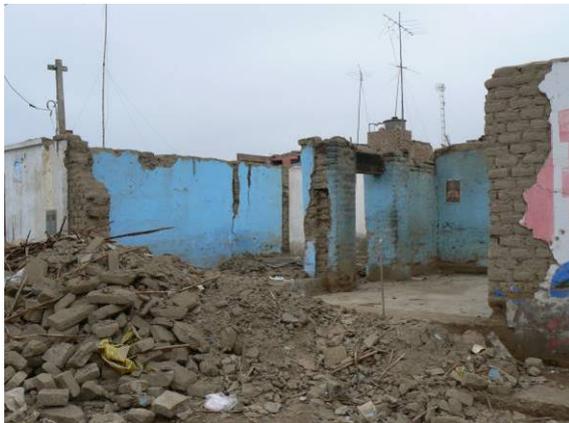
Fig. 4.21 Collapsed adobe house (Nuevo Monterrico, Canete)

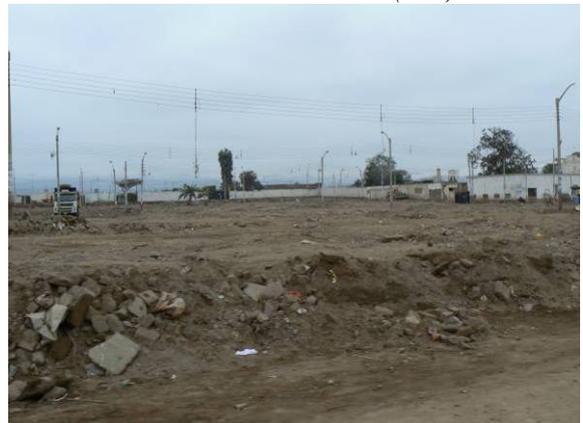
Fig. 4.22 Totally collapsed adobe houses (Hualcara, Canete) – The hanging electric lines show the location where houses used to be.

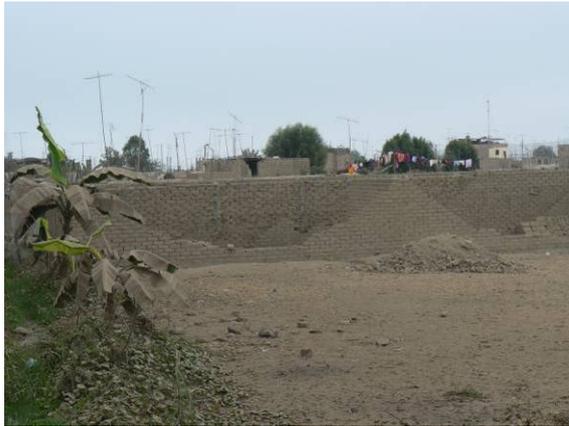
Fig. 4.23 RC confined adobe wall (in the back), survived the quake, and unconfined adobe wall (front) failed out-of-plane (San Luis, Canete)

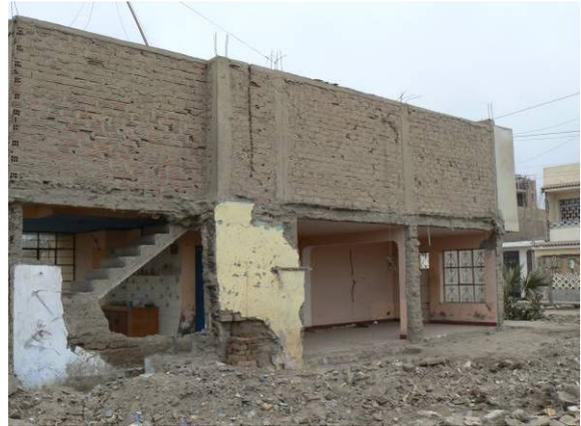
Fig. 4.24 The house shown "borrowed" the wall of the neighboring adobe house, which collapsed. Only the RC columns built to support the 2nd floor survived. (Pisco, Ica)

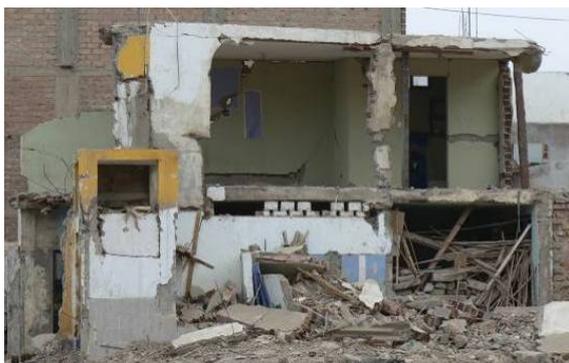
Confined masonry houses designed and built according to the building code did not suffer major damage. All the damaged structures had some type of deficiency. The most common were the use of bricks with horizontal alveolus for load bearing walls (locally called *pandereta* and prohibited by the code in this region), lack of confinement of parapets and façade walls, insufficient wall density, badly distributed stiffness (in plan and elevation), and a poor understanding of the confined masonry construction procedure. Another deficiency found was the lack of steel reinforcement in the confining beam or the lack of confining beam altogether.

Fig. 4.25 Load bearing wall made of pandereta bricks and poor steel reinforcement in the confinement (Pisco, Ica)

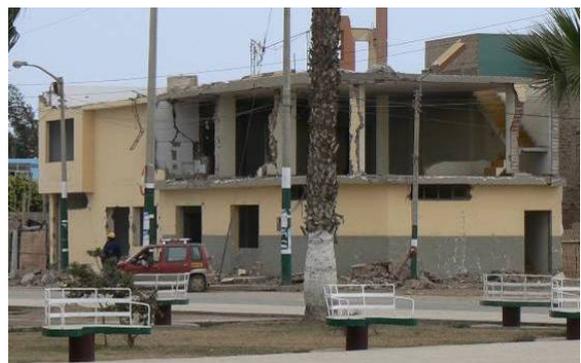
Fig. 4.26 Collapsed façade wall due to lack of confinement (Sunampe, Chincha)

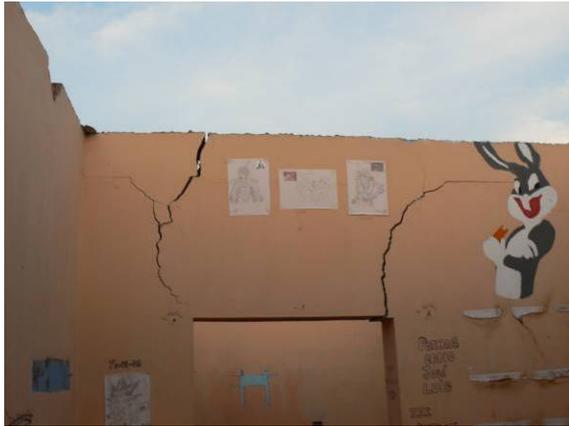
Fig. 4.27 Lack of confining beam (Tambo de Mora, Chincha)

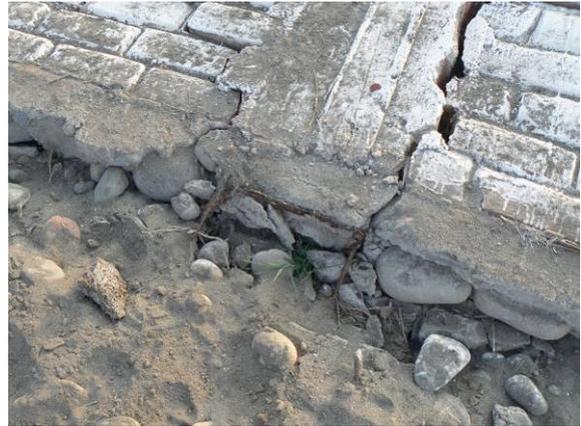
Fig. 4.28 Corroded column reinforcement (Tambo de Mora, Chincha)

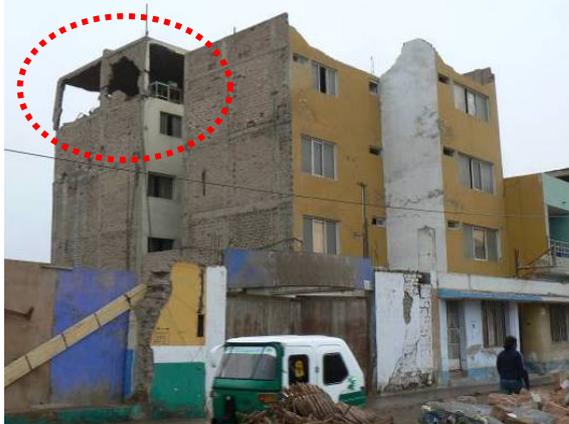
Fig. 4.29 5-story confined masonry building apparently built in several stages (Pisco, Ica)

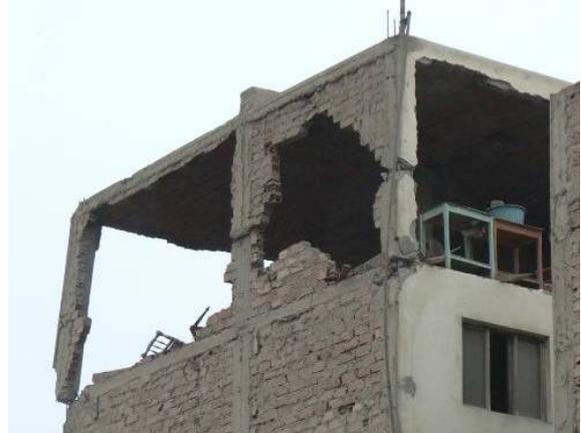
As mentioned earlier, the assumption that brick wall and RC confinement work together, which is accurate if constructed in the right way, does not hold if the RC elements are built first and then the brick wall is laid. The size and steel reinforcement of RC confinements is not enough if the RC skeleton is the main structural system.

Fig. 4.30 Detail of the 5th story of the building to the left. Note the small amount of reinforcement in the columns. The failure pattern suggests that the columns were built first and then the brick wall.

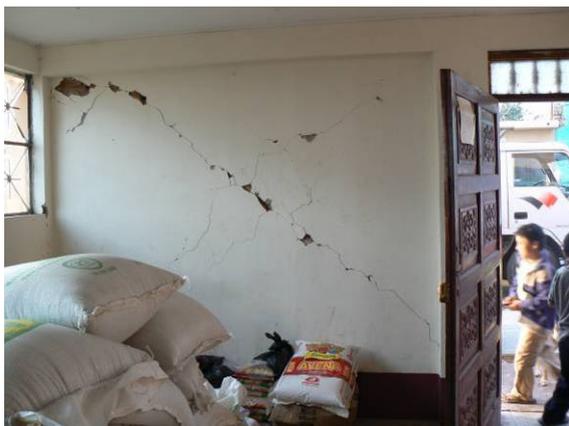
Fig. 4.31 Shear failure of masonry wall due to excessive interstory drift

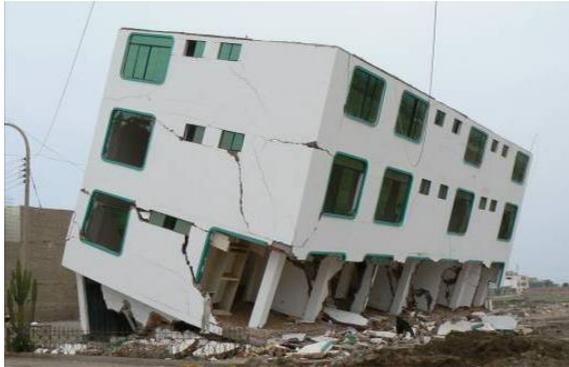
A few apartment buildings made of RC were found in the affected areas and in some of the cases, the structure was a mixture of confined masonry and RC. Fig. 4.32 shows an apartment building with a car parking in the first floor. The RC columns used to leave space for the cars to access had smaller stiffness than the back wall, a solid

confined masonry element. This generated a torsion effect imposing the columns a demand larger than their capacity.

Fig. 4.32 Apartment building with inadequate stiffness distribution (Pisco, Ica)

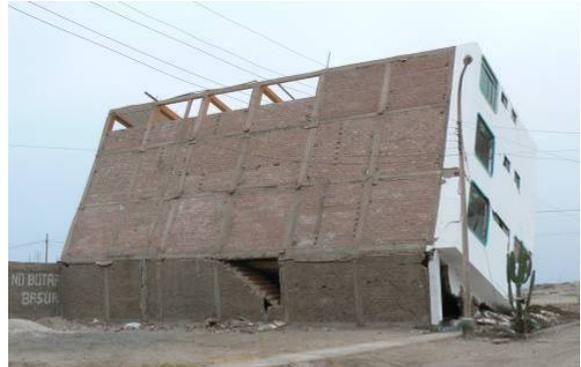
Fig. 4.33 Back view of the building shown in previous picture

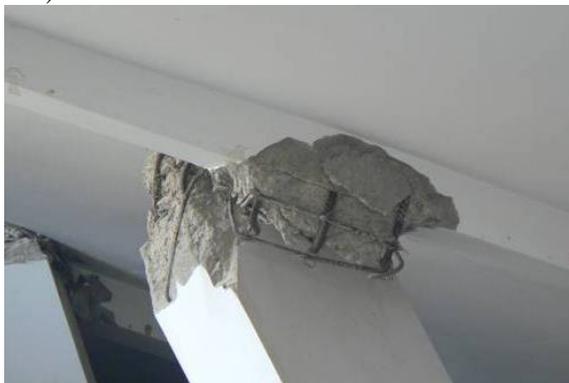
Fig. 4.34 Beam-column joint detail of building in Fig. 4.32.

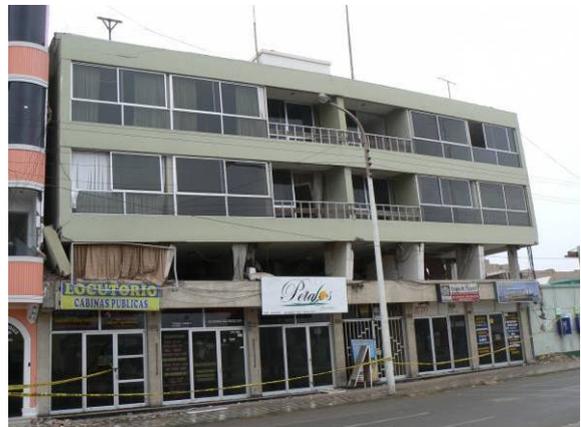
Fig. 4.35 Soft-story failure due to insufficient stiffness in one direction (Pisco, Ica)

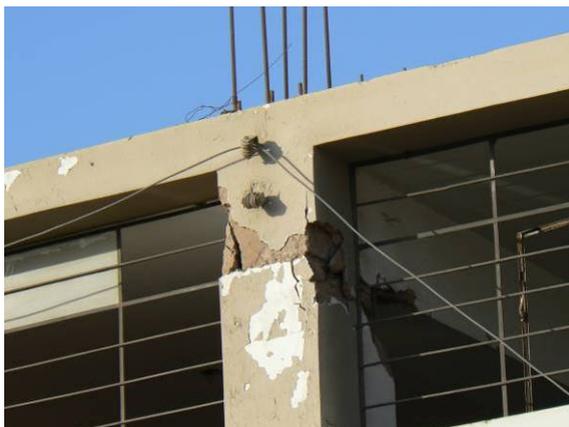
Fig. 4.36 Shear failure of beam-column joint (Parcona, Ica)

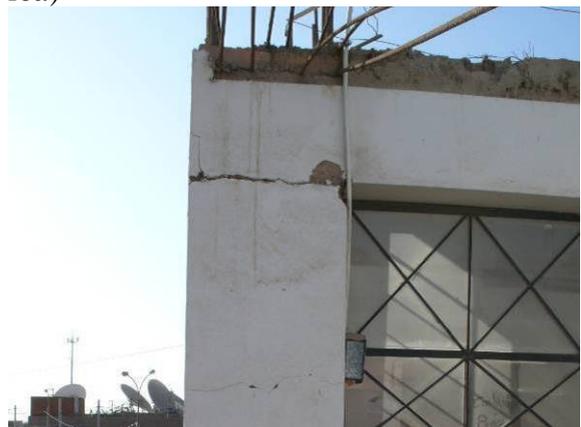
Fig. 4.37 Weak cold joint between column and beam/slab (Parcona, Ica)

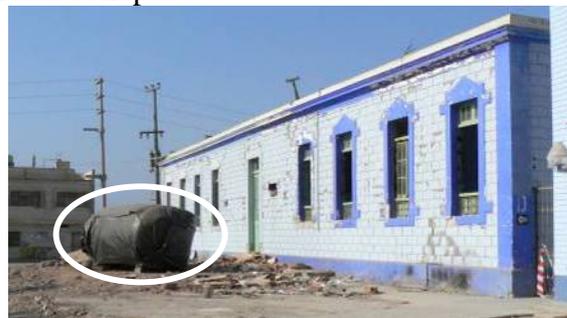
Fig. 4.39 Heavily damaged building. Note the hyperbaric chamber on the back

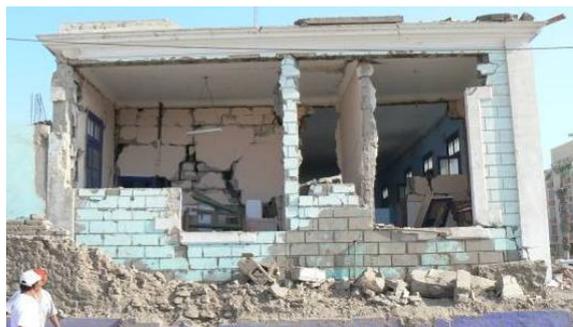
Fig. 4.40 Concrete block wall collapsed out-of-plane

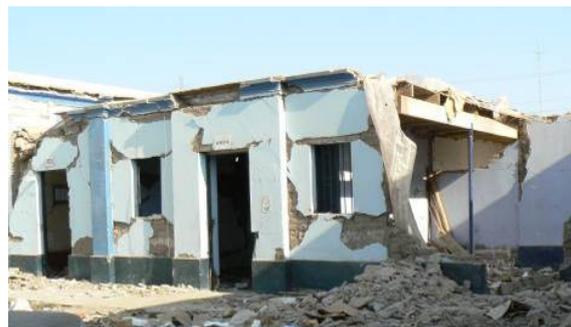
Fig. 4.41 A hospital building made of non-reinforced adobe was heavily damaged

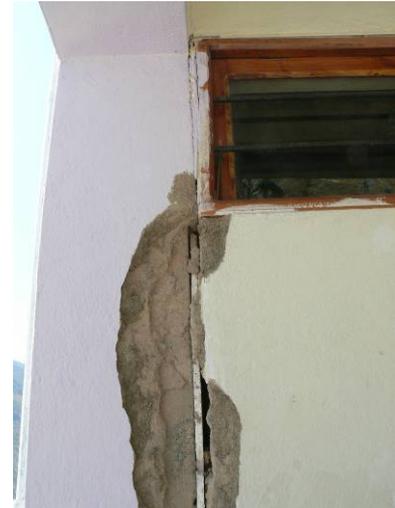
Fig. 4.43 Detail of the joint connection, (San Juan Bautista school, Huaytara)

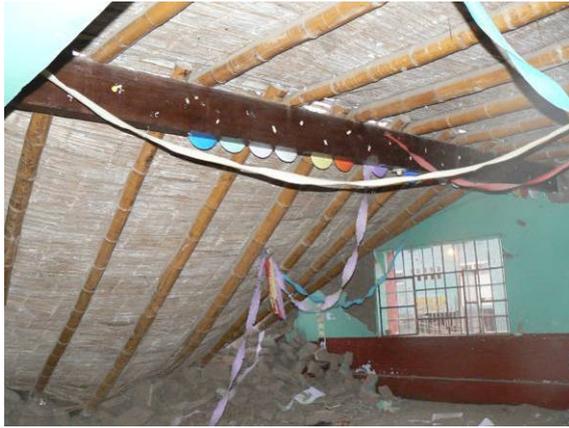
All of the adobe classrooms at Beatita de Humay School were left useless. Adobe walls and straw mat roofs collapsed. Fortunately, at the time of the earthquake there were no students in the facility and therefore nobody was injured there. The columns of a RC building with masonry panels exhibited mild shear failure.

Fig. 4.46 Elementary school classrooms made of adobe were heavily damaged (Beatita de Humay School, Humay)

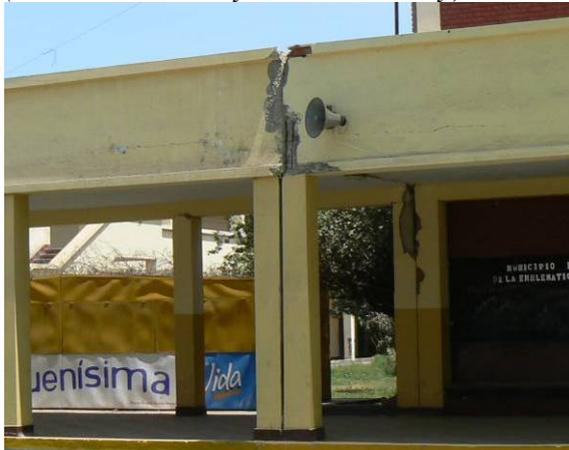
The infrastructure of the San Luis Gonzaga de Ica School exhibited typical damages of RC structures such as pounding between buildings, lack of column shear reinforcement, insufficient separation between partitions and structure, and insufficient expansion joints between structural units. Also, some unreinforced brick parapets collapsed.

Fig. 4.48 Pounding between buildings (San Luis Gonzaga School, Ica)

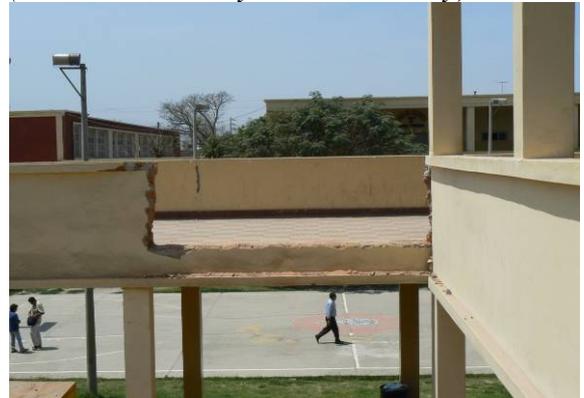
Fig. 4.49 Parapet overturning (San Luis Gonzaga School, Ica)

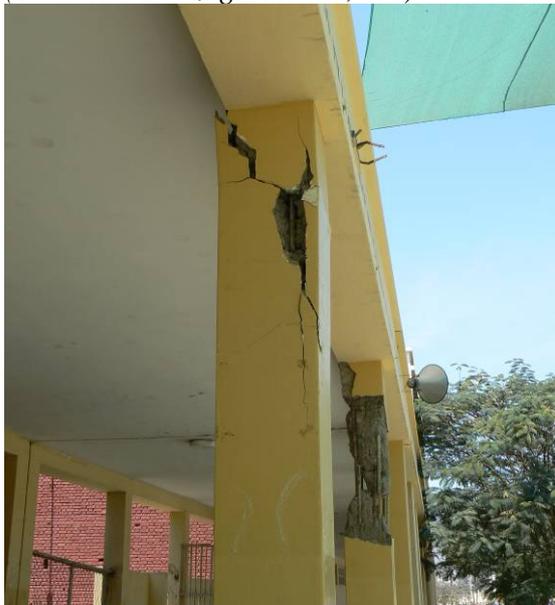
Fig. 4.50 Lack of shear reinforcement in columns (San Luis Gonzaga School, Ica)

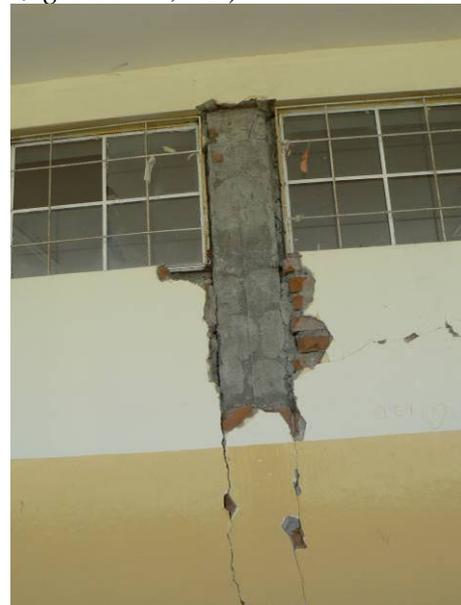
Fig. 4.51 Insufficient clearance between masonry panels and RC structure (San Luis Gonzaga School, Ica)

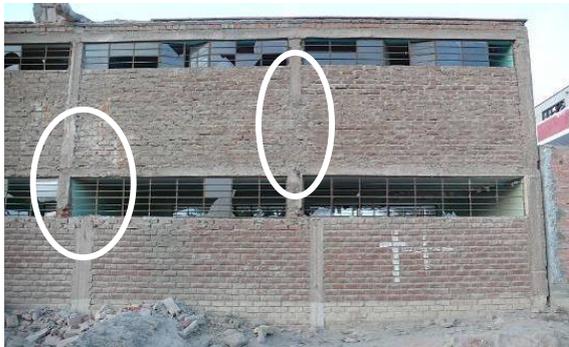
In general, the design/construction quality of the schools visited during the survey was very varied. For example, at Los Molinos in Ica, a very new and well constructed school (shown in Fig. 4.6) was found next to another which obviously did not followed any design or construction standard. Fig. 4.52 shows one of the building walls in which it is seen that columns in the 1st floor are not aligned with the columns in the 2nd floor. Furthermore, one of the columns is interrupted

Fig. 4.52 Bad construction example in Los Molinos, Ica

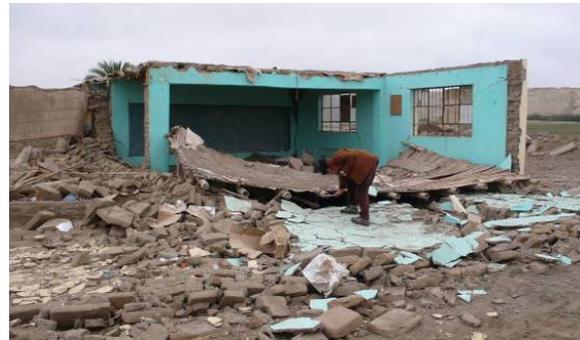
Many classrooms made of non reinforced adobe were also found as well as schools built in places unsuitable for construction due to poor soil conditions, such as Tambo de Mora marine deposits. Although it is difficult to control informal housing construction there, public buildings, especially schools should never be built in these places.

Fig. 4.53 Classroom at Tambo de Mora marine deposits, Ica.

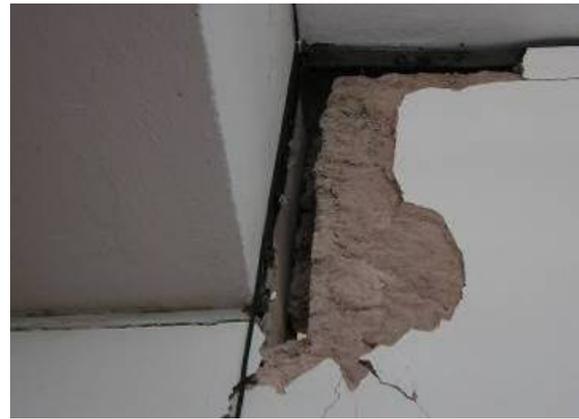
The RC frame structure was built in two stages: the first floor in 1998 and the second floor in 2002. Although it did not suffer major structural damage, some of the brick partitions cracked and needed repairing. In the 1st story, where partitions suffered more damage, the joint left between structure and wall was not wide enough in some cases and in others filled with mortar. This limited the freedom of the structure to deform. The joints in the second floor were wider and thus partition damage here was less.

Fig. 4.55 Joint between brick partition and RC structure filled with mortar

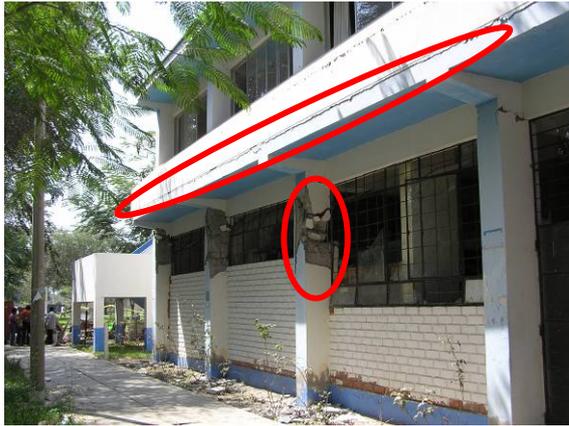
One of the most damaged buildings in the campus was that of the Chemistry Faculty. These were among the first buildings in the university constructed more than forty years ago. In here, short column effect and poor shear reinforcement detailing were observed. Also, parapets with no anchorage to the structure were damaged although they did not collapse.

Fig. 4.58 Chemistry Faculty Building with short column failure and parapet damage

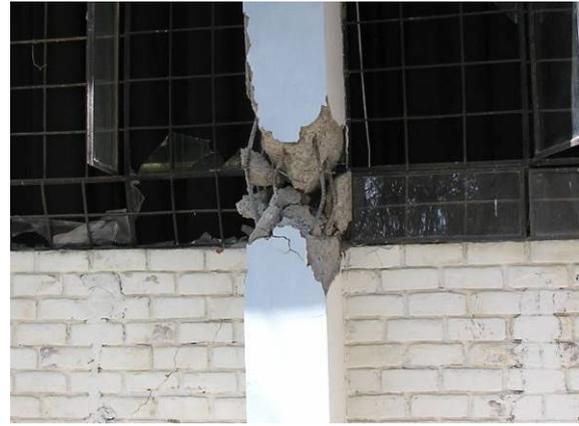
Fig. 4.59 Insufficient shear reinforcement

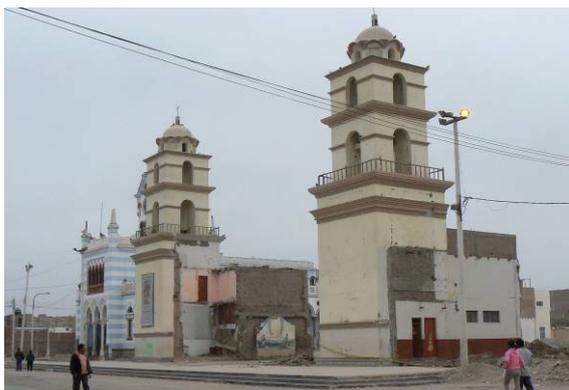
Fig. 4.60 San Clement Church (Pisco)

This survey did not focus in surveying churches in detail. However, it was obvious from our field work that these structures performed very badly. Reportedly, more than 30% of the fatalities due to this earthquake were caused by the collapse of the San Clemente Church in Pisco. In this church, only the portion which had been rebuilt recently did not collapse. A block away from it, only a couple of the 850mm-thick adobe walls of the Compania de Jesus Church were left standing.

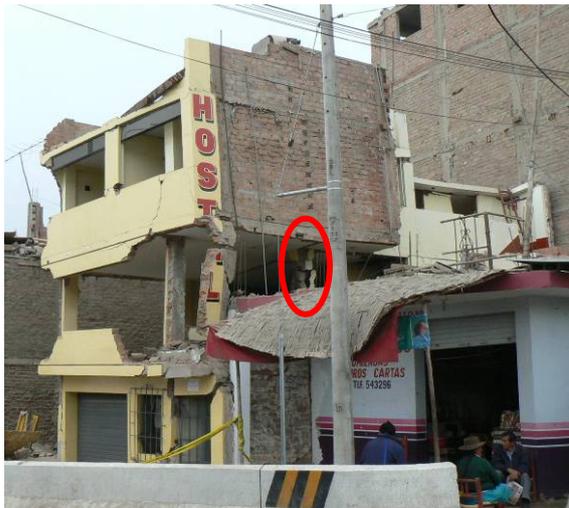
Fig. 4.62 and 4.63 show one small hotel that was observed during the field survey. Insufficient shear reinforcement in the columns among other deficiencies was observed.

Fig. 4.62 Heavily damaged hotel (San Clemente, Ica)

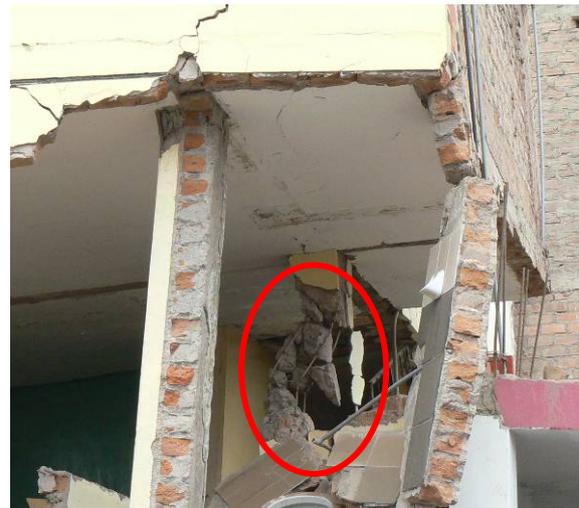
Fig. 4.63 Insufficient column shear reinforcement.

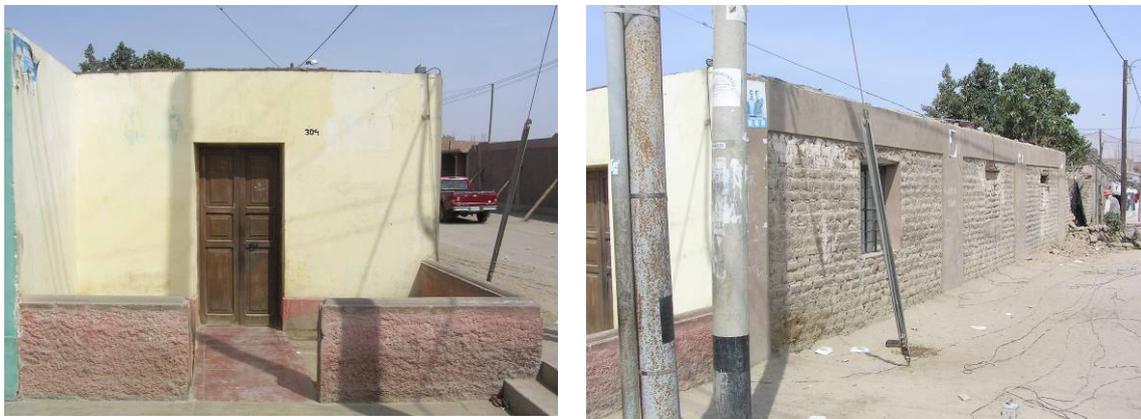
Fig. 4.66. Front and side of Guadalupe retrofitted adobe house.

The fairly symmetric house is a one story building with a shared wall, two façade walls aligned with Callao Street and Rimac Street, respectively, and three internal walls. The roof is made of straw mat with bamboo joists. There was no evidence of foundation, however, based on an interview survey, it was found that, in this region, it is common to dig a 60cm-deep trench, place thick adobes inside, and then build walls on top of them. It may be possible that this “foundation” was used when the house was originally constructed.

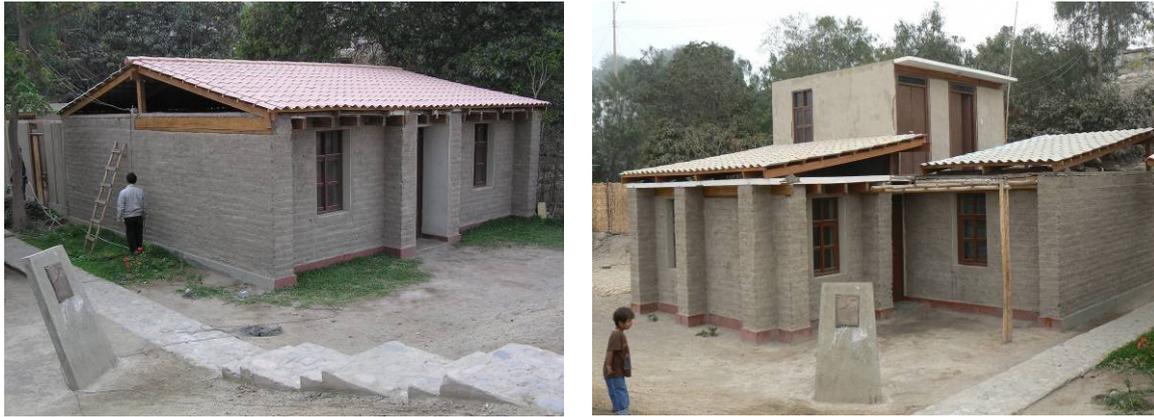
Fig. 4.72. Pacaran reinforced adobe houses.

After the Pisco Earthquake, the houses seemed to be in good condition, although some cracks in the plastering of the *quincha* panels on the second floor were observed. It is important to mention that the number of damaged houses in Pacaran was not as large as other cities inside of the affected area. However, some nearby public buildings made of adobe collapsed due to the shake.

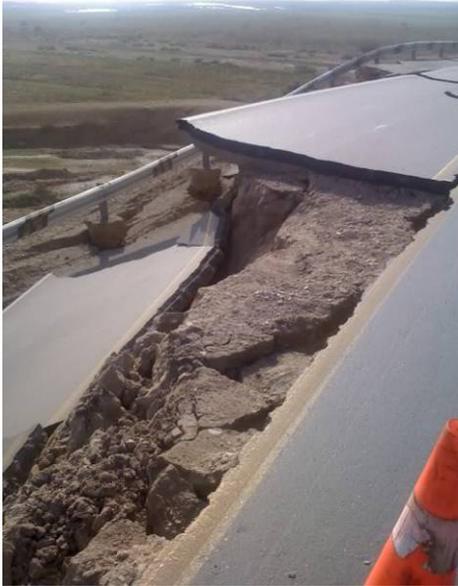
Fig. 5.2. Slope failure caused by liquefaction induced lateral spreading

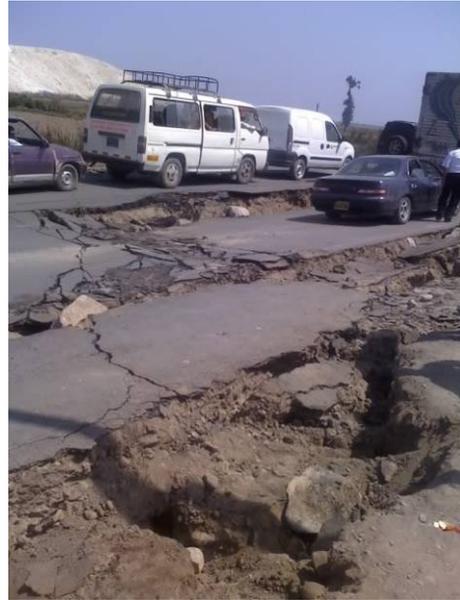
Fig. 5.3. Liquefaction induced embankment failure

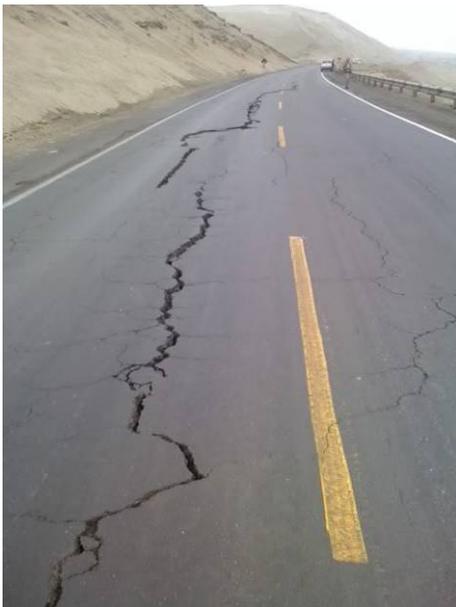
Fig. 5.4. Cracking along the pavement due to landslide induced movement

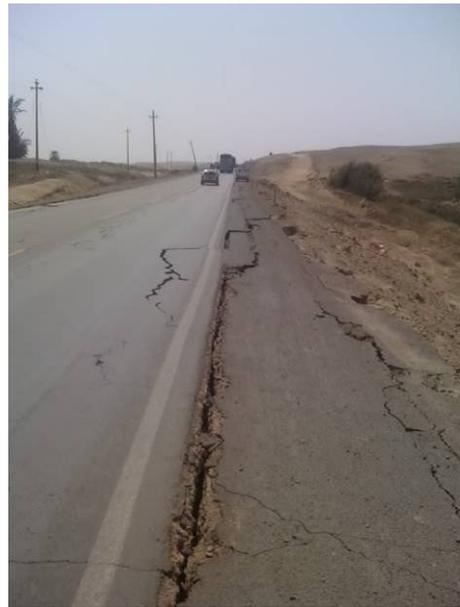
Fig. 5.5. Shoulder settlement and displacement

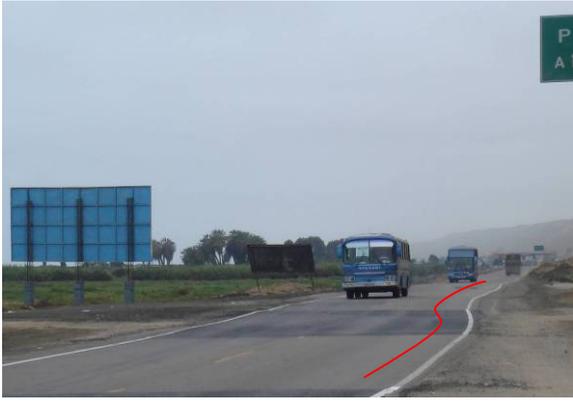
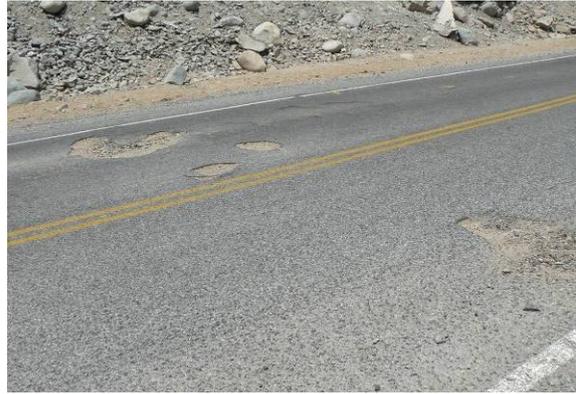
Typical road damage induced by the earthquake may be categorized as: slope failure, embankment failure, longitudinal cracking, settlement, shoulder settlement/displacement, road distortion and pot holes. Most of damages are caused by failure of the unstable foundation due to liquefaction. Fig. 5.2 to Fig. 5.7 show typical damage examples.

Fig. 5.6. Road distortion due to liquefaction *Fig. 5.7 Pot holes caused by rock falls induced lateral spreading*

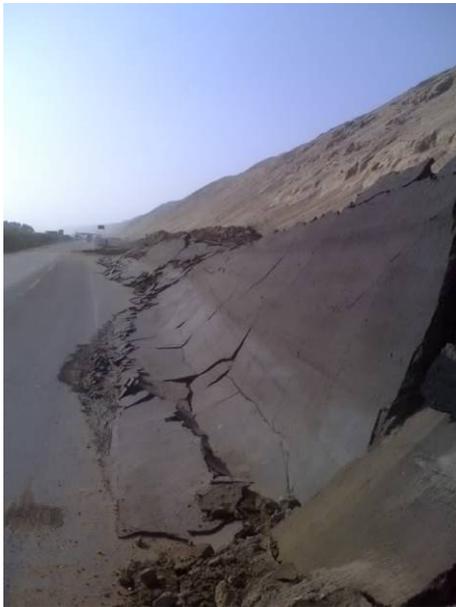
Fig. 5.8 Lifted shoulder at Playa Jahuay. South Pan-American Highway

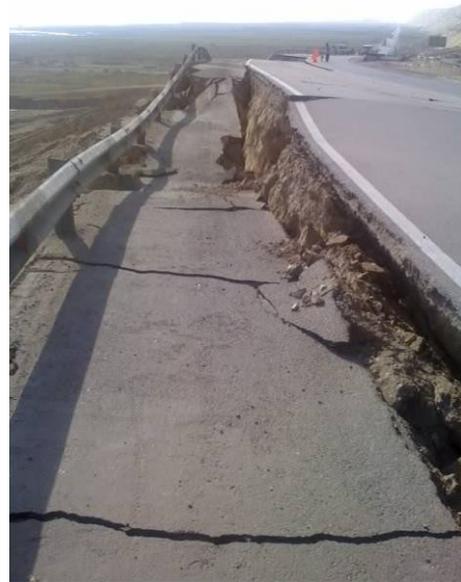
The South Pan-American Highway was heavily damaged where it turns west to enter Chincha City. This location coincides with the limit where the Canete Formation meets a marine deposit. The Pleistocene Canete formation consists of alternating layers of sand and silt stones, with marine or eolic deposits above it. Widespread liquefaction observed in this area may have caused much of the road damage. At this location, uplifting of the slope side shoulder occurred. This is likely due to loss of the base support of the slope, which then moved towards the road (see Fig. 5.8) lifting it up. Liquefaction /lateral spreading induced loss of base support caused the slope failure damage shown in Fig. 5.9.

Fig. 5.9 Road failure due to lateral spreading at the foot of the slope. South Pan-American Highway

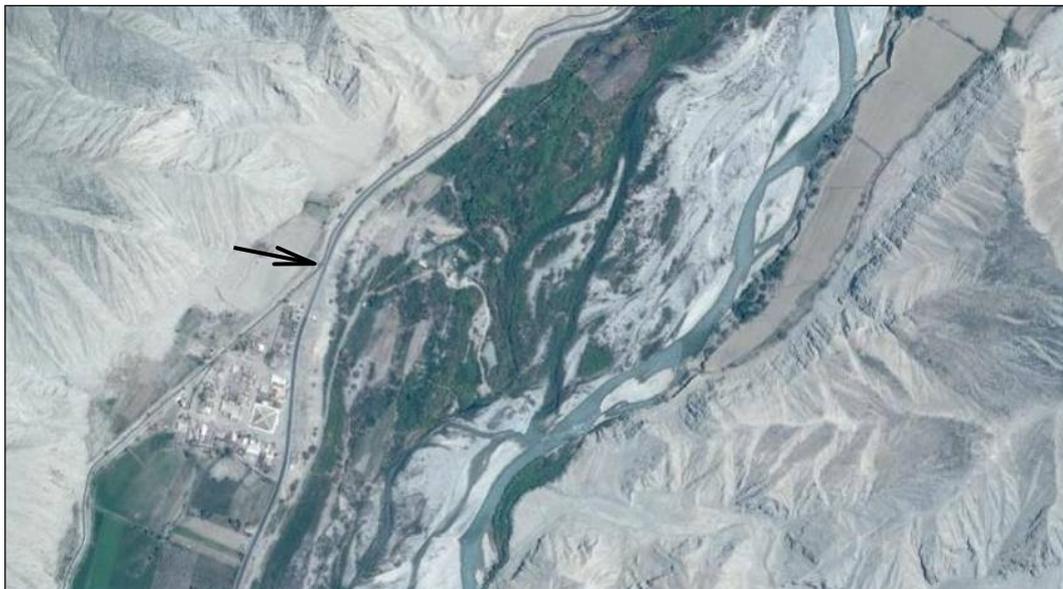
A slope failure was observed at the Km.23 of the Canete-Yauyos road. This is the exact point where the road and an irrigation channel meet. Although there was no evidence suggesting channel damage or water leakage, the possibility that its presence may have somehow affected the slope stability needs further assessment.

Fig. 5.11. Google earth view with black arrow indicating the slope failure at Canete-Yauyos road (Km. 23) (13° 3'3.08"S, 76°13'32.85"W).

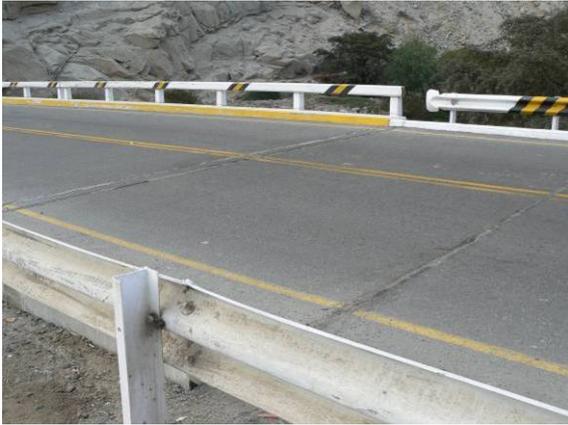
Fig. 5.14 Mild settlement of the fill behind abutment (La Quinga Bridge, Los Libertadores Highway)

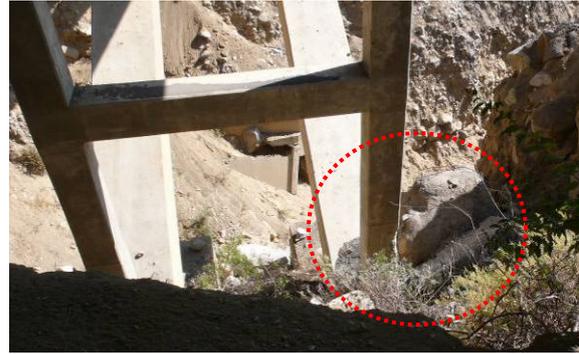
Fig. 5.15 Rock impacted on bridge substructure (Tsej Tji Bridge, Los Libertadores Highway, close to Huaytara)

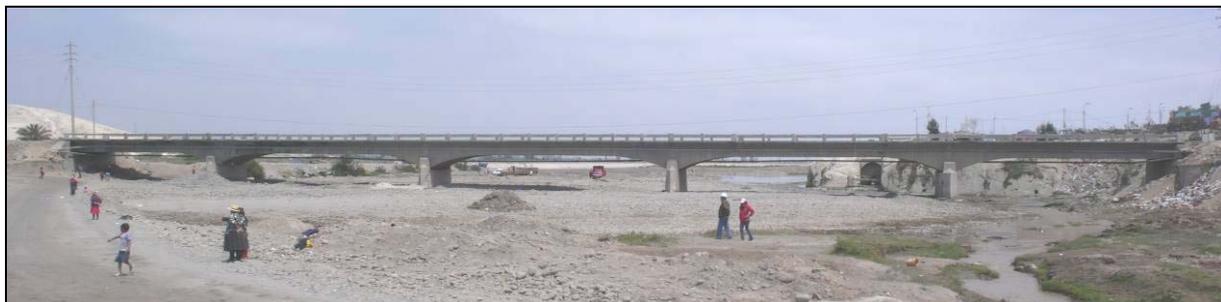
Fig. 5.17 Overview of the bridge (downstream direction)

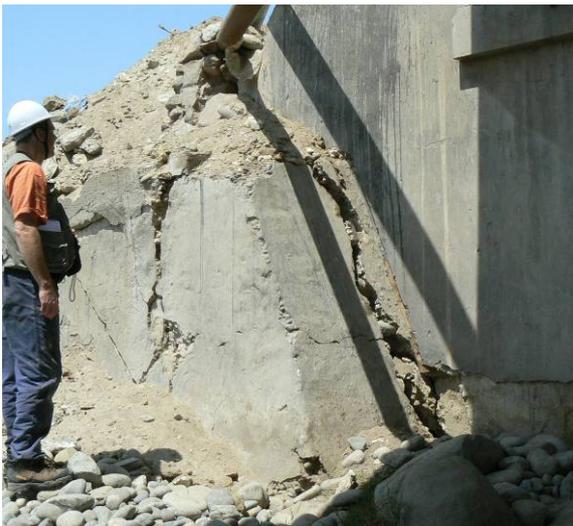
The southern abutment tilted towards the north some 7% due to the Pisco earthquake [5] and settlement and cracking of the embankment also occurred. The intermediate pillars also rotated. Although the north abutment was not as damaged as the southern, settlement of the backfill was observed there. The geological formation at the bridge north access belongs to the Miocene/early Pliocene age whereas alluvial deposits are found in the south.

Fig. 5.20 South abutment, upstream

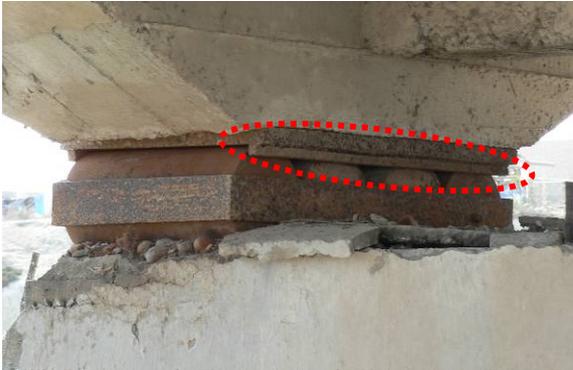
The bridge superstructure is supported on fixed and movable bearings as shown in Fig. 5.16. The movable bearings are made of steel rollers as shown in Fig. 5.22 and Fig. 5.23. Note the steel stoppers installed to prevent the movement in the bridge transverse direction. The steel bearings were quite corroded.

Fig. 5.22 Movable bearings on the pillars
