A RECONNAISSANCE REPORT
ON
THE PISCO, PERU EARTHQUAKE OF AUGUST 15, 2007

2007 Pisco, Peru Earthquake Reconnaissance Team

Japan Society of Civil Engineers (JSCE),

October 2007

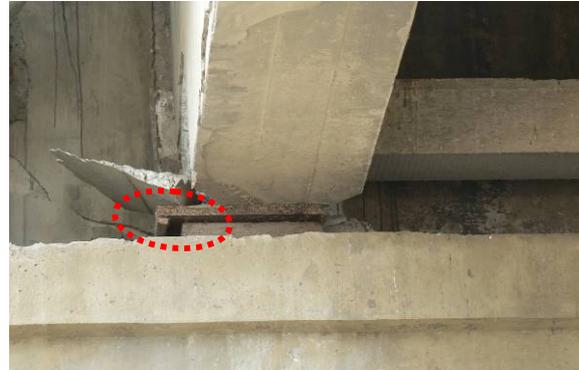
The bridge superstructure is supported on fixed and movable bearings as shown in Fig. 5.16. The movable bearings are made of steel rollers as shown in Fig. 5.22 and Fig. 5.23. Note the steel stoppers installed to prevent the movement in the bridge transverse direction. The steel bearings were quite corroded.

Fig. 5.23 Movable bearing at the southern abutment

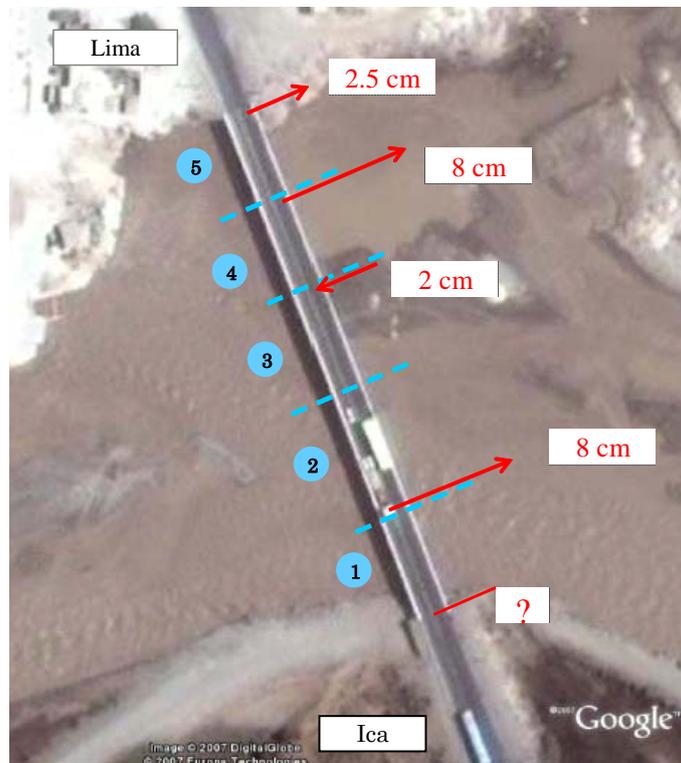
The bridge superstructure permanently moved upstream as shown in Fig. 5.24. The blue dots represent the superstructure sections and the measurements indicate relative displacements between adjacent sections or between superstructure and abutments. At the movable bearings on the abutment, the steel fittings separated from the concrete structure (Fig. 5.23). The stoppers on the pillar movable support, bottom, were not found. The lateral movement of the bridge caused damage to the concrete wings of the pillars, especially that with the movable bearing. These wings had very little steel reinforcement.

Fig. 5.24 Google earth view of the displacement of the bridge superstructure.

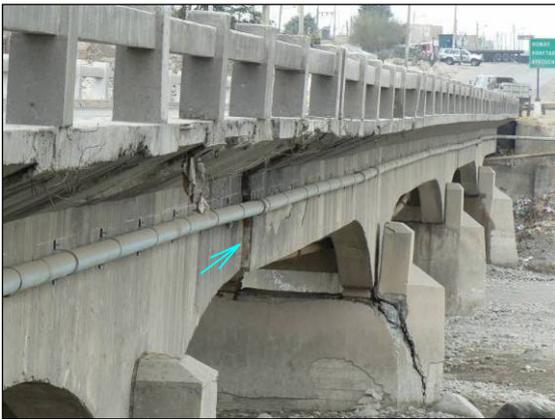
Fig. 5.25 Bridge slab displacement (picture taken towards the north). Arrow indicates the gap corresponding to the southern 8 cm gap shown in Fig. 5.24

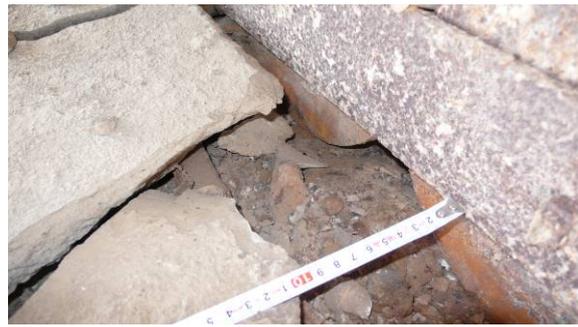
Fig. 5.26 No bottom steel stoppers were found at the pillar movable bearing.

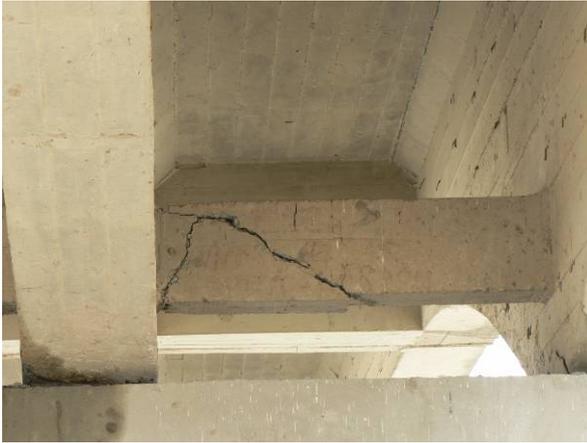
The displacements and rotations of the bridge segments concentrated stresses on the superstructure transverse beams which suffered cracking.

Fig. 5.29 Damaged transverse beams

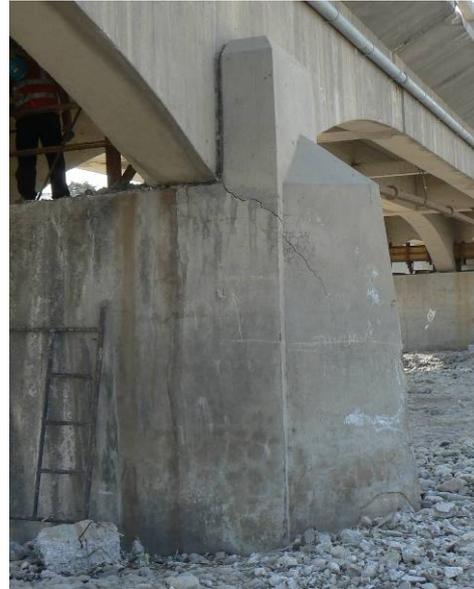
Fig. 5.30 Cracks in the wing of the pillar with fixed bearing

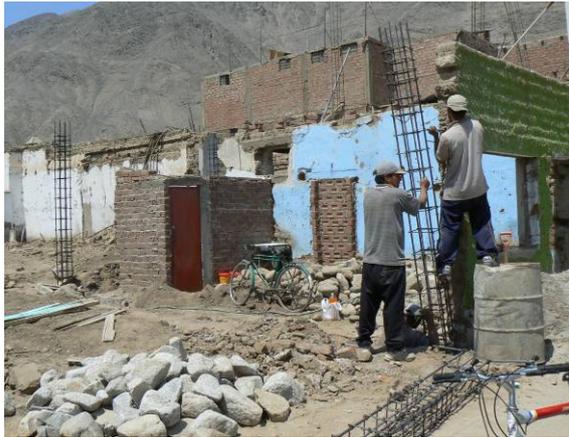
Fig. 6.11 Front adobe wall, which did not collapse during the earthquake, is reused in the new structure with some “reinforcement”

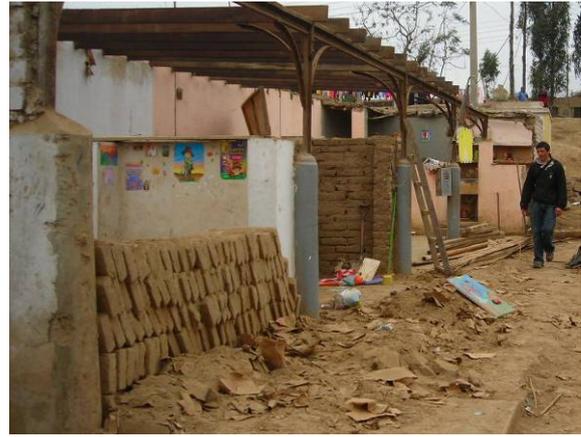
Fig. 6.12 Adobes from collapsed walls are kept to be used as construction material

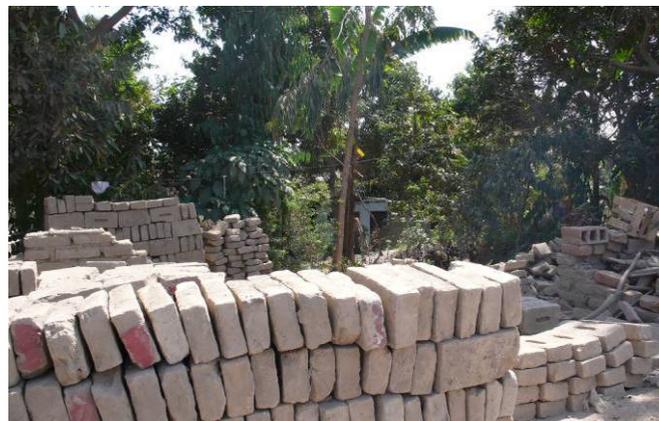
Fig. 6.13 Units from collapsed walls piled up ready to start the reconstruction
